# Executive Summary of Flood Study and Conceptual Design Basis Reports by GEI

## Introduction

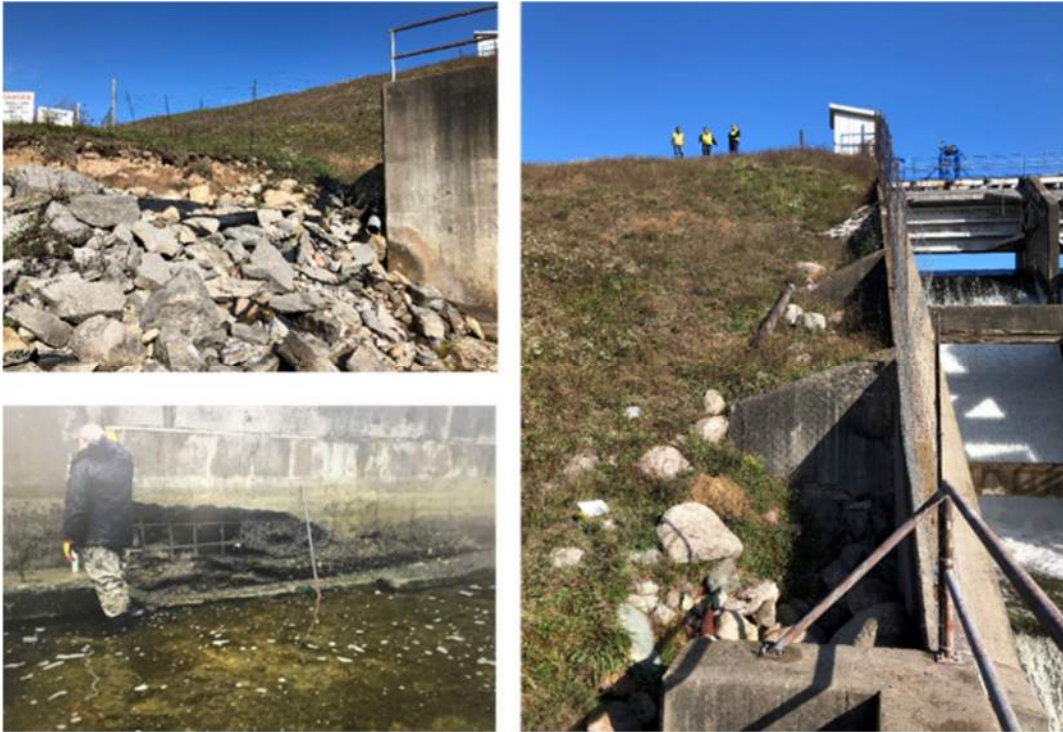
**Exhibit 3 – Inspection Photographs of Secord Dam**

There are several fundamental dam safety issues that must be addressed before the water level can be permanently raised:

- Insufficient spillway discharge capacity to meet regulatory criteria, including State of Michigan requirements.
- Inadequate downstream embankment slope and seepage stability.
- Inadequate height and length of the downstream spillway training walls to prevent overtopping and reduce erosion during high flow events.
- Embankments leak excessively and lack internal filters and drains to protect against seepage-induced internal erosion.
- Inadequate embankment slope armoring to prevent damage from erosion and back cutting during floods.
- Areas of structurally unsound concrete at spillway and powerhouse that need repair and stabilization.
- Restore dam to have a permanent low-level outlet to base pass flows during winter and provide a means to draw down the impoundment below the spillway sill elevation.

**Primary Spillway Modifications**

The existing Tainter gate spillway will be partially demolished and the two (2) Tainter gates will be replaced with two (2) hydraulically operated crest gates at sill El. 734.8 to increase the spillway capacity. The new left crest gate will be 18-feet-wide by 16-feet-high and the new right crest gate will be 21-feet-wide by 16-feet-high.

The downstream slope will be flattened to improve stability and an upstream sheet pile seepage cutoff from dam crest into the clay hardpan foundation will be installed across right and left embankment dams. The downstream overlay fill will include an internal filter and drainage layers will be installed to protect against seepage-induced internal erosion. The drainage systems will discharge to a weir to allow monitor seepage rates.

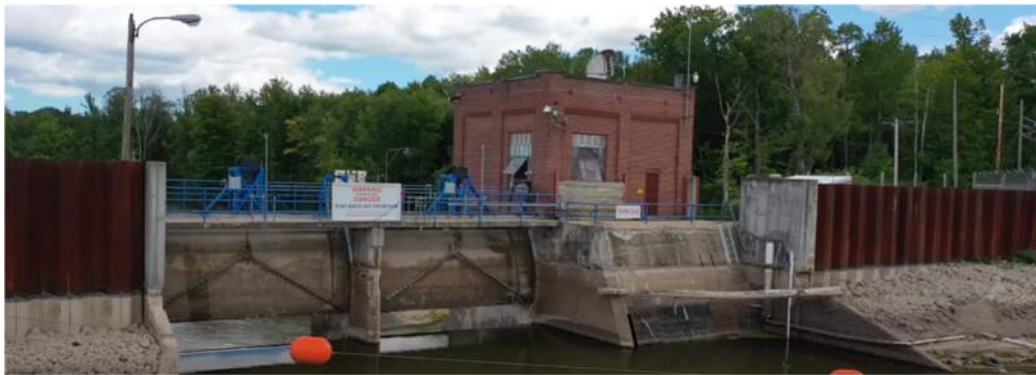
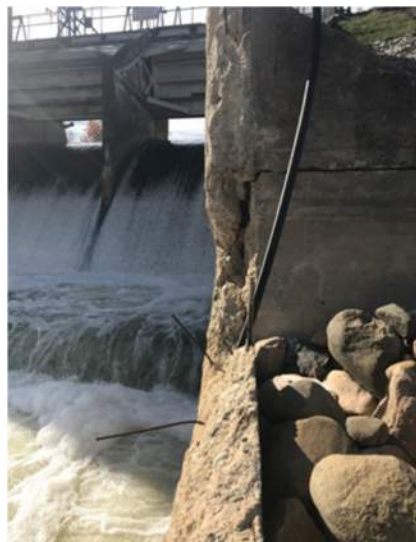
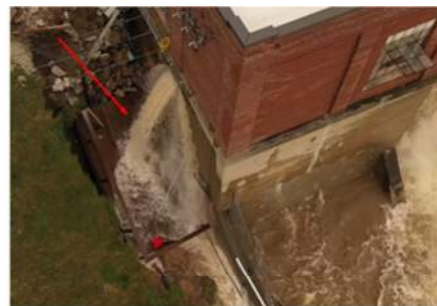
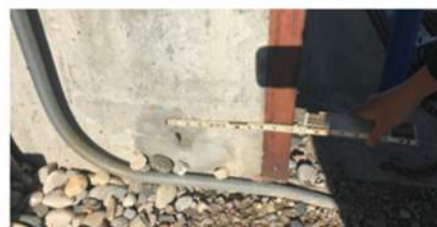
### Exhibit 7 – Inspection Photographs of Smallwood Dam Spillway and Powerhouse

There are several fundamental dam safety issues that must be addressed before the lake levels can be permanently raised:

- Insufficient spillway discharge capacity to meet regulatory criteria, including State of Michigan requirements.
- Structurally unsound spillway roadway and deteriorated training wall concrete due to age and freeze-thaw damage.
- Lack of height and length of the downstream spillway training walls to reduce dam toe erosions during high tailwater.
- Embankment lacks filters and drains to protect against seepage-induced internal erosion.
- Inadequate embankment slope armoring to prevent damage from erosion and back cutting during floods.
- Restore dam to have a permanent low-level outlet.

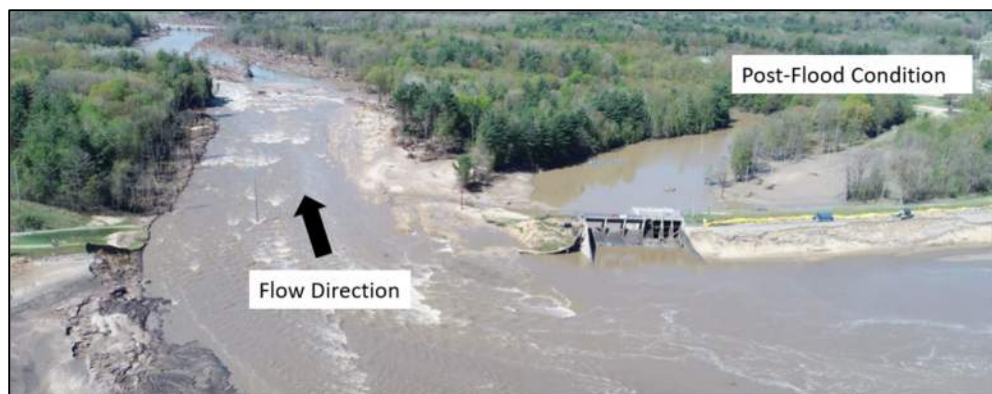
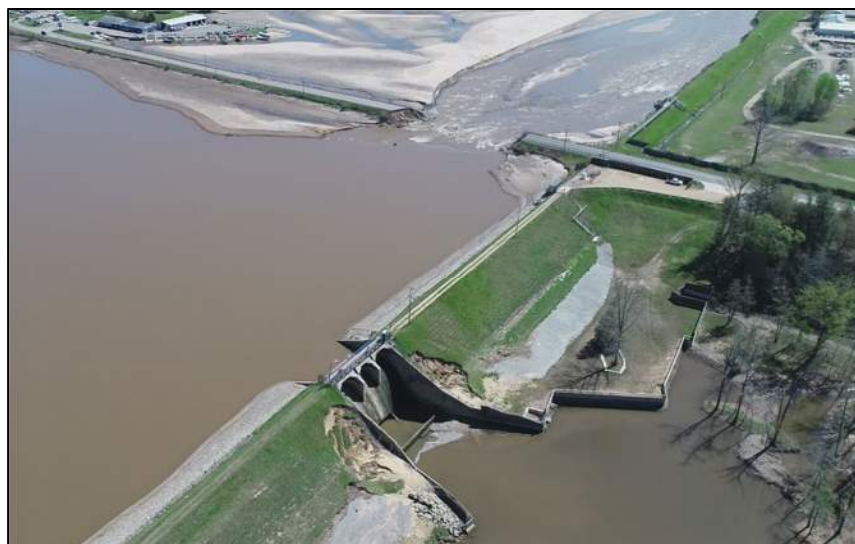
**Exhibit 11 – Aerial View of Edenville Dam Failure**

The May 2020 Flood caused catastrophic damage to the Edenville Dam, including:

- Left embankment breached.
- Powerhouse and equipment damaged.
- Both the Tobacco and Edenville Tainter gated spillways damaged.
- Inadequate height and length of the downstream spillway training walls to prevent overtopping and reduce erosion at the dam toe during high flow events.
- Upstream slope of embankments have heel area scoured and undermined due M-30 breach channel flows.
- M-30 bridge and causeway between the rivers was washed out.
- No low-level outlets.

Interim repairs are being implemented under a FLTF Memorandum of Understanding with the State of Michigan and NRCS at both the Tobacco Spillway and the Edenville Spillway. The objective is to restore flow into the original Tobacco and Tittabawassee River channels and reduce on-going erosion. Construction of the interim measures is currently underway at Tobacco Spillway. Lowering the Edenville Spillway down to the base slab with the two powerhouse units left-in-place, and constructing a dam across the left embankment breach area is planned for 2021. Our goal is to incorporate the major elements of these interim repairs into the permanent, long-term design.

The following major repairs / reconstruction activities are planned to permanently restore pre-flood lake levels.

- Construct new primary (gated) spillways at Tobacco and Edenville spillways.
- Construction a new labyrinth-type (ungated) auxiliary spillway at the north embankment breach.
- Reconstruct / repair damaged embankments.
- Stabilize and raise remaining embankments.
- Develop a new low-level outlet at the existing powerhouse location.

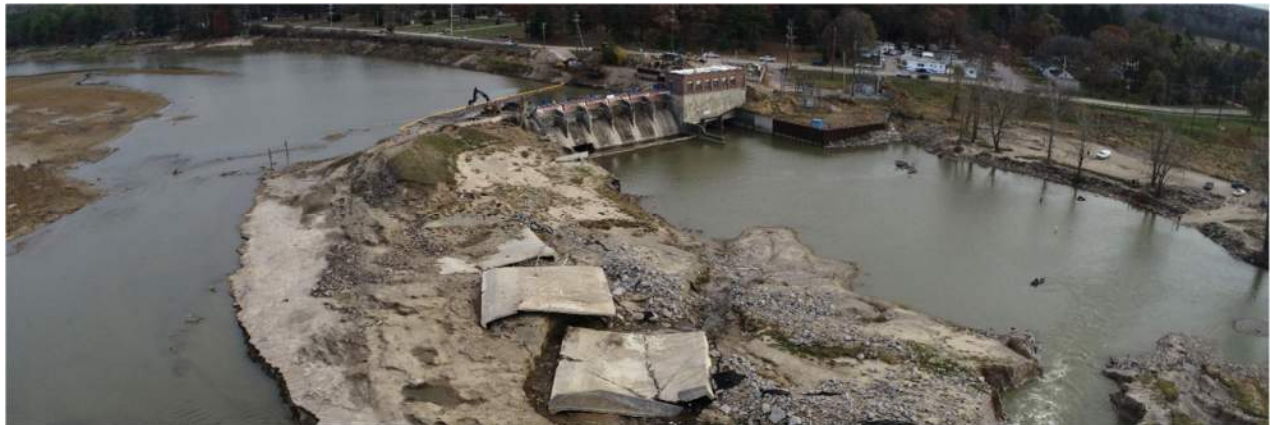
**Exhibit 17 – Aerial View of Sanford Dam Failure**

The breaching of Edenville Dam during the May 2020 Flood resulted in a cascading breach failure of downstream Sanford Dam. Major damage includes:

- Left and right embankments overtopped.
- Right embankment breached.
- Powerhouse and equipment damaged.
- Fuse plug auxiliary spillway failed.
- Tittabawassee River flows through breach channel (former right embankment).

The NRCS has identified that interim repairs, stabilization and sediment removal at Sanford Dam may also be eligible for NRCS Emergency Watershed Protection (EWP) Program funding. Design of interim repairs is planned for 2021. Our goal is to incorporate the majority of the interim stabilization repairs into the permanent, long-term repairs.

The following major repairs / reconstruction activities are planned to permanently restore pre-flood lake levels.

- Construct new primary (gated) spillways at the existing spillway location.
- Construction a new labyrinth-type (ungated) auxiliary spillway at the right embankment breach.
- Reconstruct breached embankments.
- Stabilize and repair remaining embankments.
- Develop a new low-level outlet at the existing powerhouse location.
