INVESTIGATION OF FAILURES OF EDENVILLE AND SANFORD DAMS

SEPTEMBER 13, 2021

Executive Summary

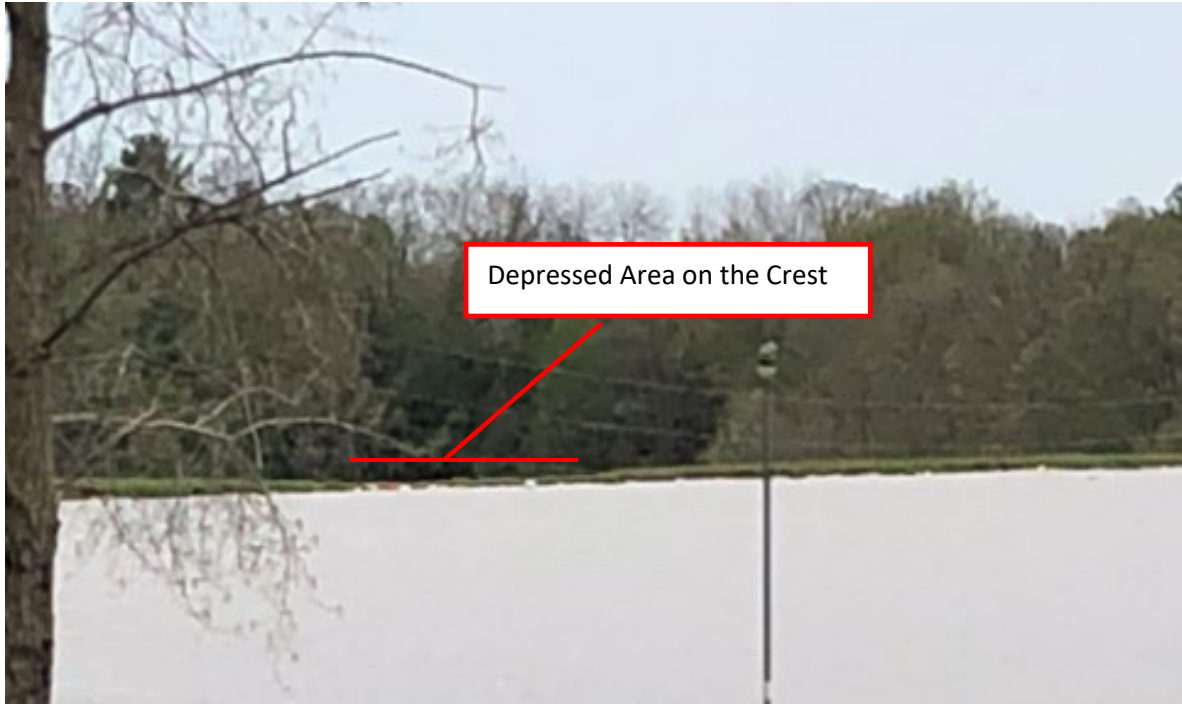
Figure 5: Photograph showing depression in the crest of the Edenville left embankment at 5:20 p.m., Tuesday, May 19, 2020

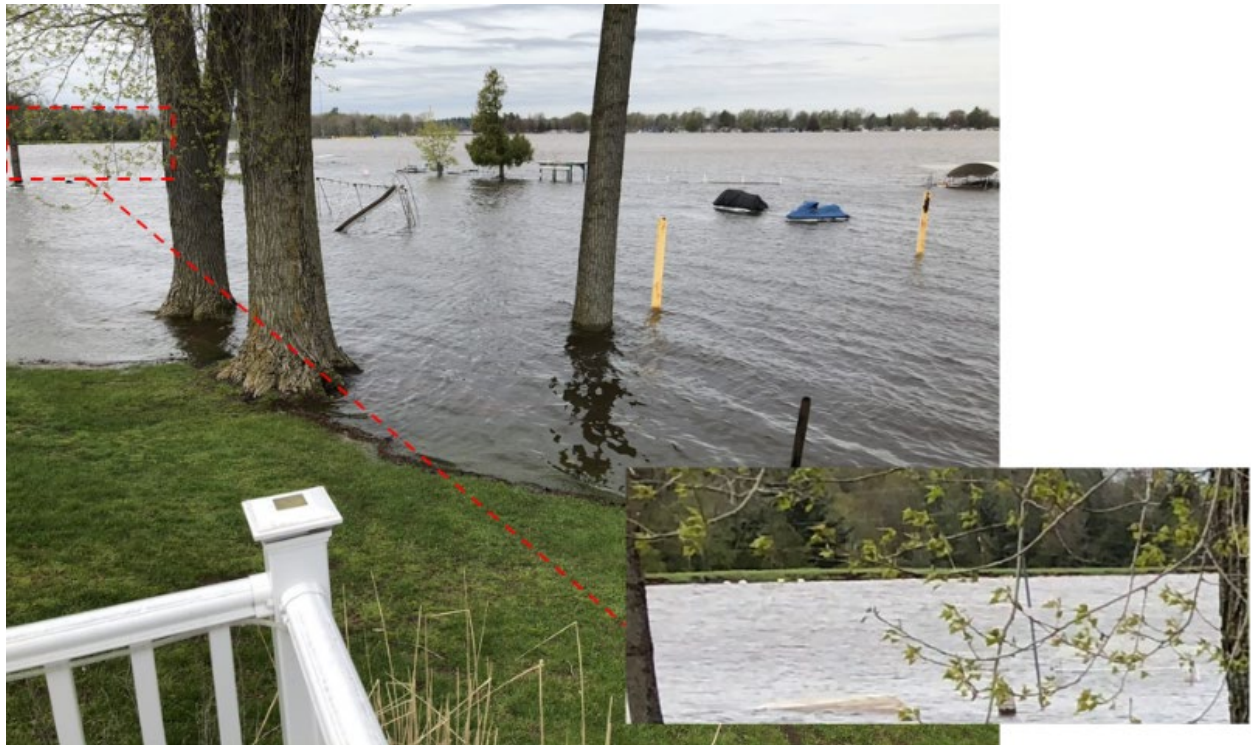
Figure 6: Photograph showing the crest of the Edenville left embankment at 2:52 p.m., Tuesday, May 19, 2020

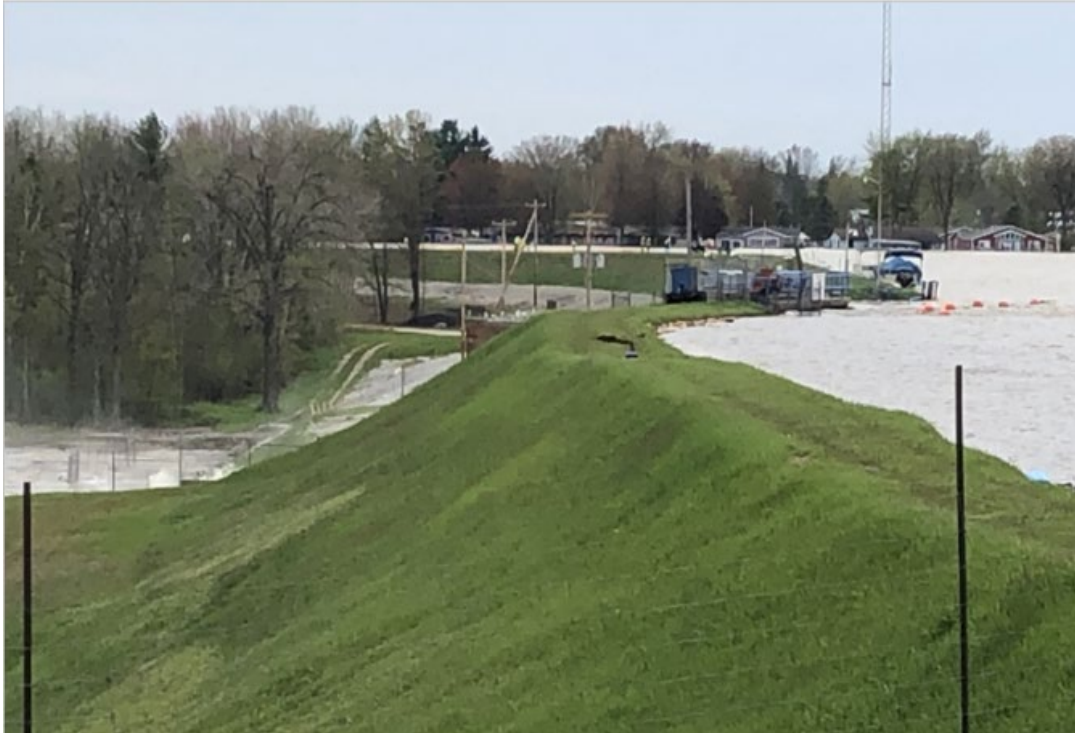
After observing the depression in the crest, several residents walked to the Consumers Energy substation located downstream of the Edenville left embankment. The photograph of the downstream side of the embankment in Figure 7 was taken at 5:31 p.m. that day. The photograph shows the depression in the crest, but otherwise does not show any significant signs of distress in the embankment. Figure 7 shows a lighter colored area near the toe of the embankment at the ultimate failure location. The IFT considered the possibility that this light color might indicate seepage, but after reviewing other photographs and talking with eyewitnesses, the IFT concluded that it does not appear to be seepage. Historical photographs showed significant variability of color on the face of the embankment. However, because Figure 7 is a distant view of the embankment, the possibility that the color difference represents seepage cannot be totally ruled out.

Figure 7: Photograph showing the downstream side of the Edenville left embankment at 5:31 p.m., Tuesday, May 19, 2020

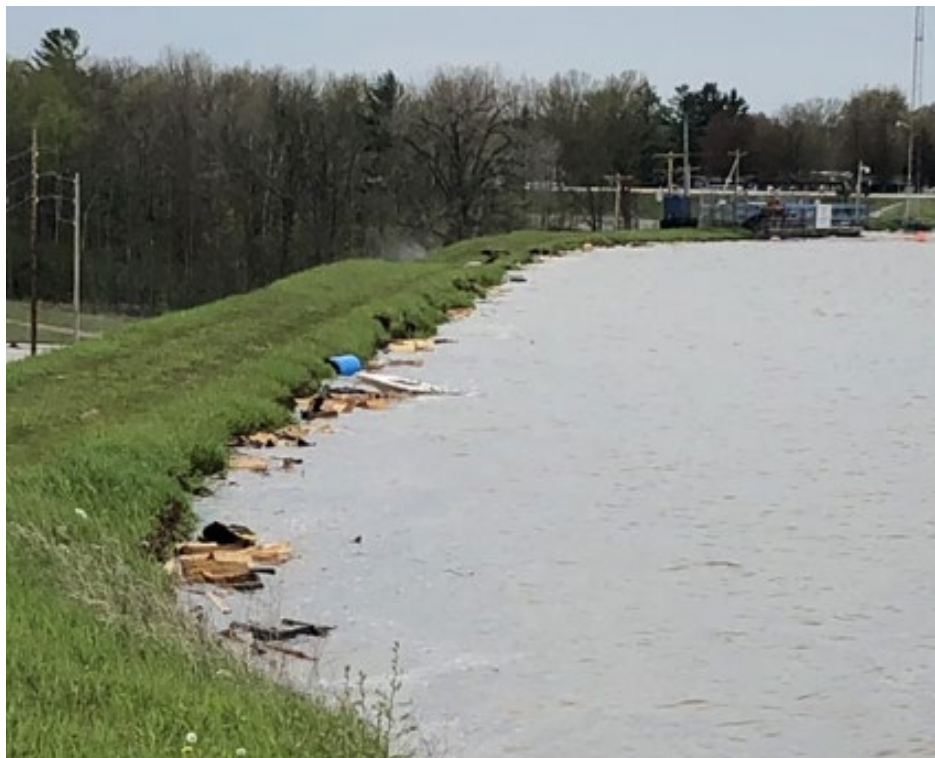
Figure 8 shows a view of the depression in the crest from upstream at 5:33 p.m. The photograph in Figure 8 also shows the erosion that had occurred on the upstream slope of the embankment.

Figure 8: Enlarged photograph showing the upstream side of the Edenville left embankment at 5:31 p.m., Tuesday, May 19, 2020

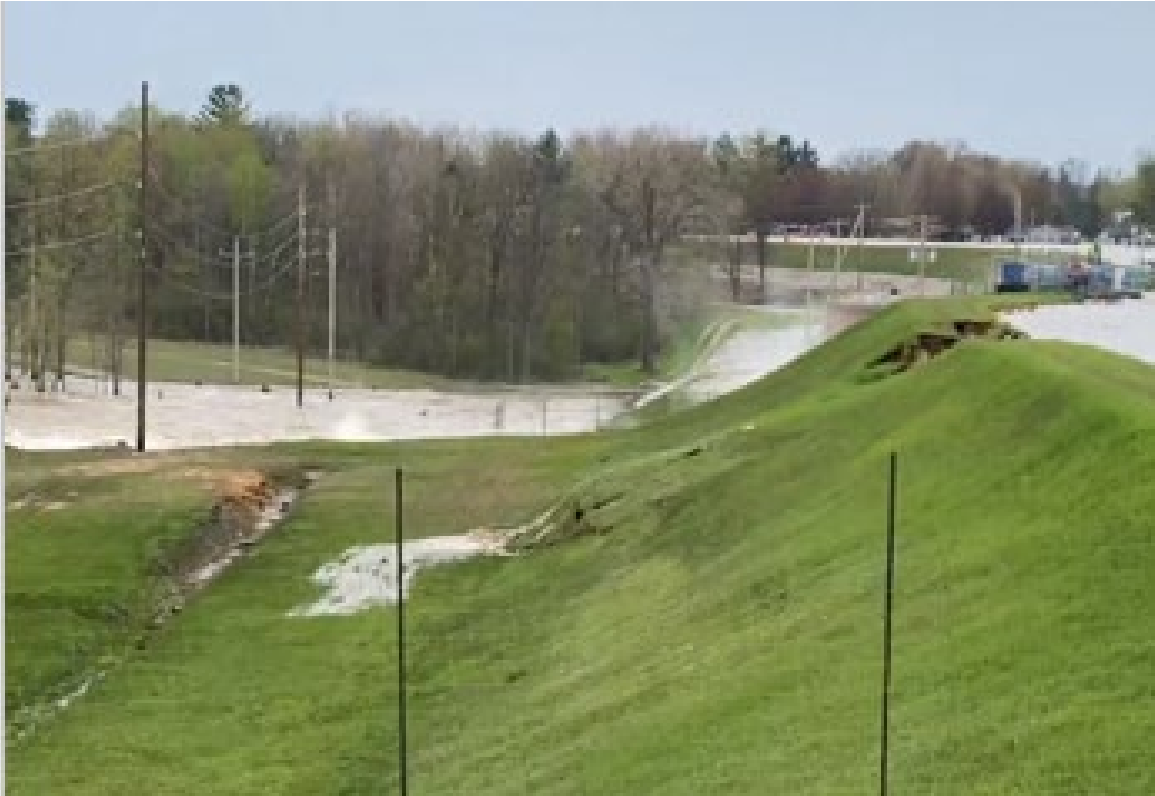
Shortly after the photographs shown in Figure 7 and Figure 8 were taken, the eyewitnesses report observing a stream of water flowing down the downstream face of the dam. This observation prompted one of the eyewitnesses, a local resident, to begin a video recording on his phone at 5:35 p.m. His video is referred to in this report as “the dam failure video.” Several still images from the video are shown in Figure 9 through Figure 17.

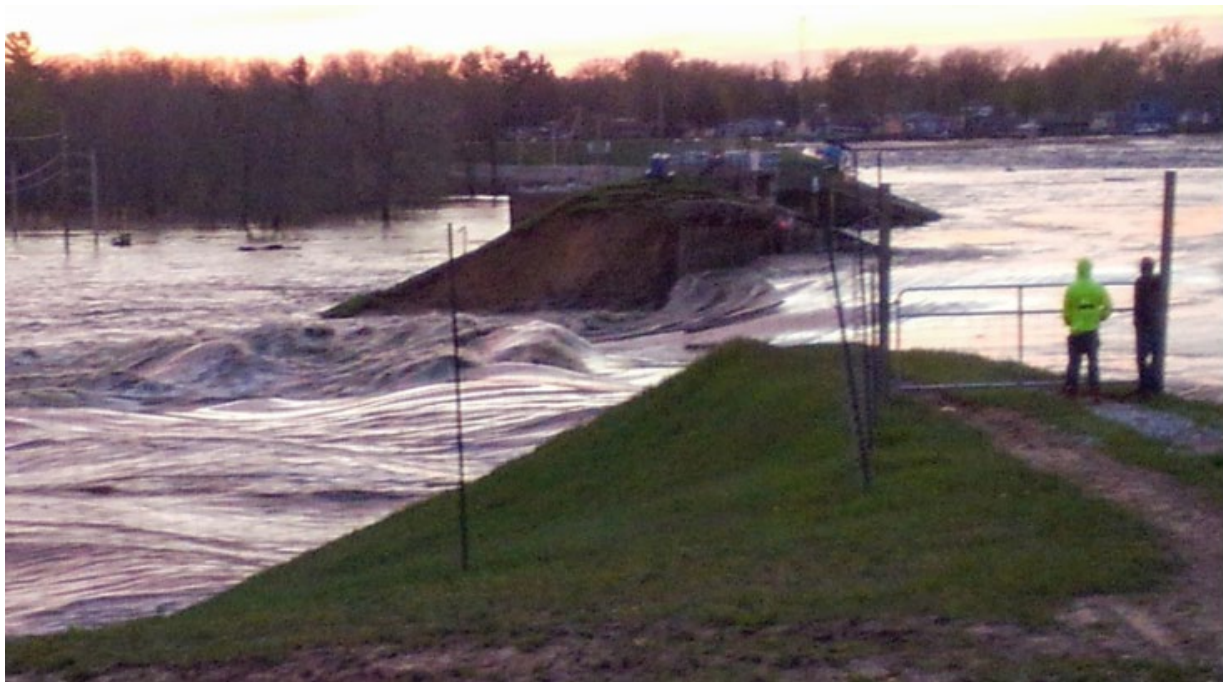
Over the next several hours the breach widened, and Wixom Lake was drained. Four images of the widening of the breach are shown in Figures 18 through 21.

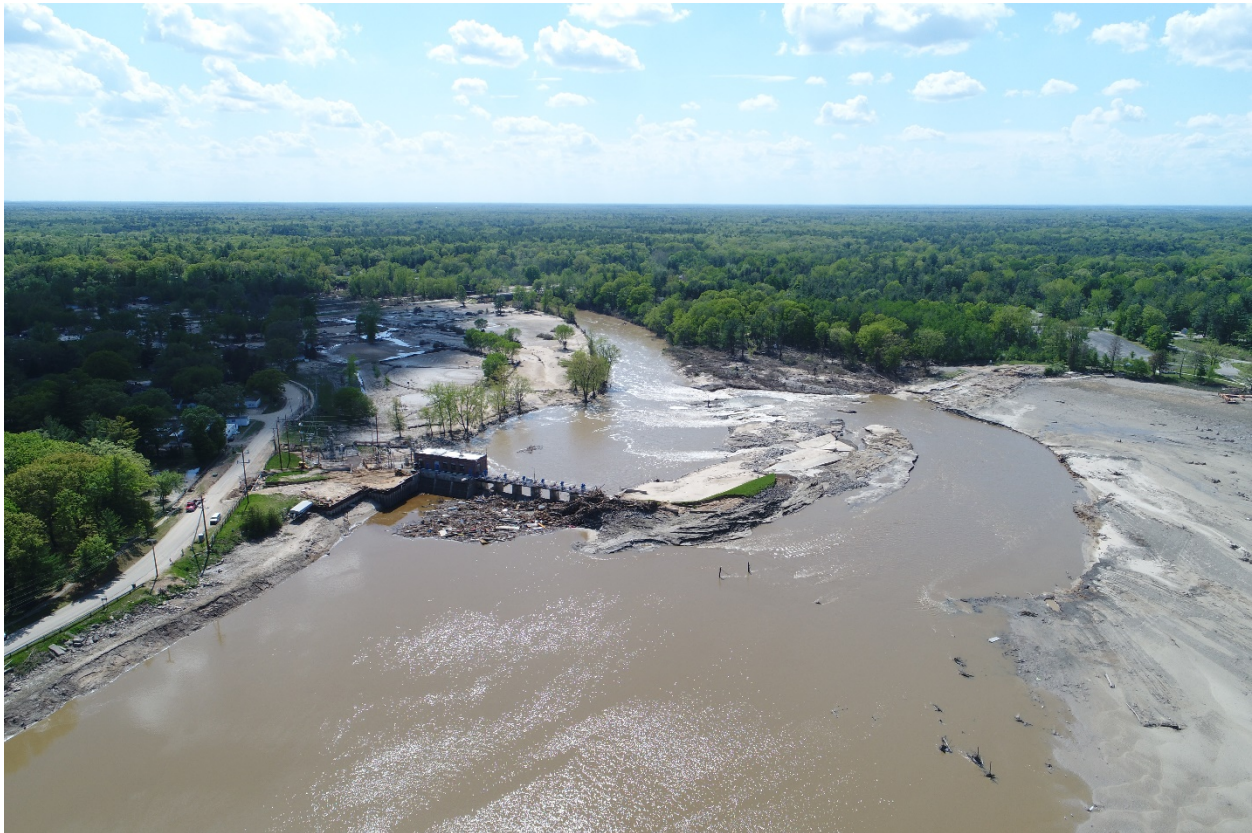
reached El. 636.8, the low spot on the embankment crest, and continued to rise. Shortly afterward, an overtopping failure of Sanford Dam occurred, and the failure flood from Edenville Dam plus the contents of Sanford Lake were released, inundating the areas downstream. A view of the failed Sanford Dam is shown in Figure 22.

Figure 22: Sanford Dam failure, viewed from upstream (photo courtesy of EGLE)
