August 6, 2021

Four Lakes Task Force: Edenville Dam Rehabilitation Edenville Dam, Gladwin and Midland Counties, Michigan

EDENVILLE DAM CONCEPTUAL DESIGN

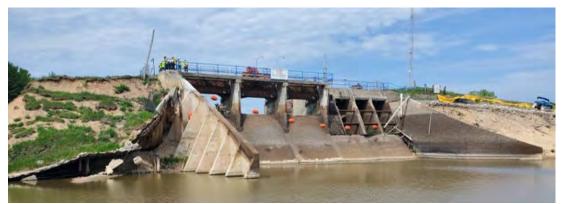
Photo 1. Tittabawassee Spillway upstream, on May 25, 2021 after completion of initial stabilization modifications.

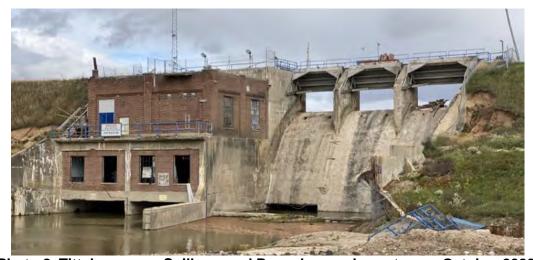
Photo 2. Tittabawassee Spillway and Powerhouse downstream, October 2020.

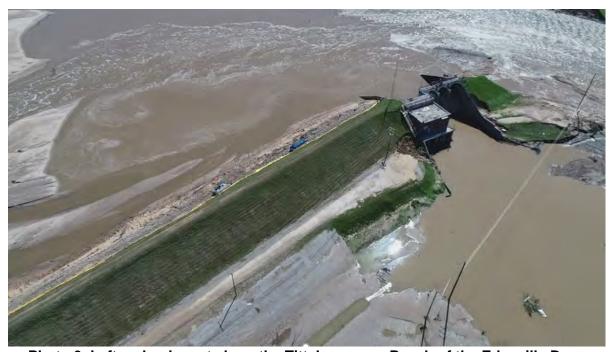
The (former) left embankment was approximately 680-feet long, with maximum structural height of 46 feet near the spillway (see Photo 3). The embankment was reportedly constructed of native, poorly graded sand from onsite sources. The embankment slopes are 2.5H:1V on the upstream slope and 2H:1V on the downstream slope. Riprap protection was placed along the upstream slope of the embankment. A failed steel sheet pile cutoff wall once extended from the left upstream side of the Tainter gate spillway into the upstream slope of the left embankment for approximately 80 feet. The remaining right embankment is approximately 2,800-feet long, with a maximum structural height of 46 feet near the spillway. The embankment slopes are 2.5H:1V on the upstream slope and 2H:1V on the downstream slope. Riprap protection is placed along the upstream slope of the embankment. A steel sheet pile cutoff wall extends from the left upstream side of the spillway into the upstream slope of the left embankment for a distance of approximately 65 feet. A toe filter drain was constructed by the previous owner on the downstream slope of the right embankment in 2005 due to observed seepage. The original embankment plan overlain on a 2020 aerial is provided as Figure 3 (attached).

Photo 3. Left embankment along the Tittabawassee Reach of the Edenville Dam.

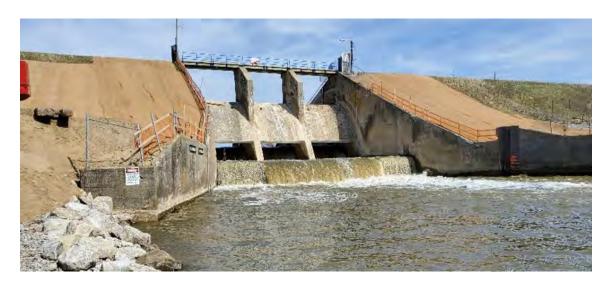
Photo 4. The Tobacco River reach of the Edenville Dam on March 30, 2021 after completion of initial stabilization modifications.

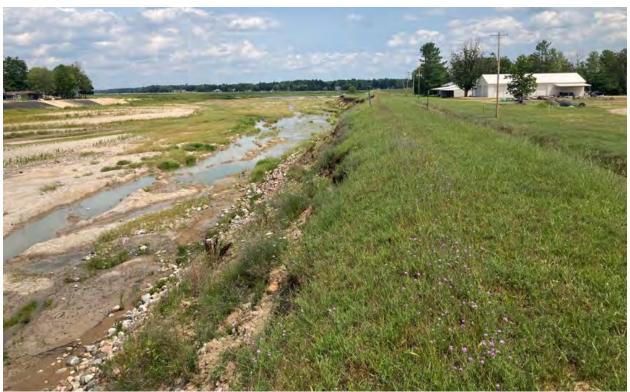
The right embankment is approximately 2,050-feet long, with a maximum height of 46 feet near the spillway (see Photo 6). The embankment was constructed of native, poorly graded sand from onsite sources. The embankment slopes are 2.5H:1V on the upstream slope and 2H:1V on the downstream slope. A steel sheet pile cutoff wall extends from the left upstream side of the spillway into the upstream slope of the left embankment for a distance of approximately 75 feet. In addition, there is a short steel sheet pile section in the upstream slope of the right embankment located approximately 900 feet to the right (west) of the Tobacco spillway. A toe filter drain was constructed by the previous owner on the downstream slope of the right embankment in 2005 due to observed seepage. The original embankment plan overlain on a 2020 aerial is provided as Figure 3 (attached).

Photo 6. Right embankment overview facing east, on the east side of the Tobacco reach of the Edenville Dam.

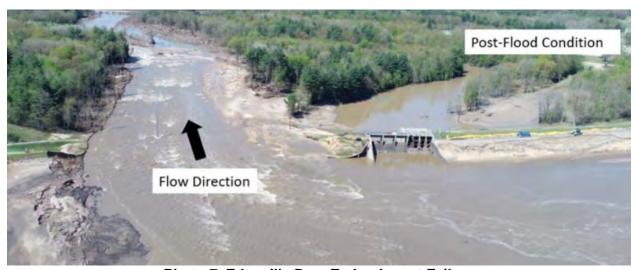
Over a two-day period from May 16 to May 18, 2020, the Tittabawassee and Tobacco River watersheds incurred heavy rainfall totals, ranging from 6 to 8 inches concentrated in Gladwin and Midland Counties. Saturated ground conditions combined with additional rainfall starting in the evening of May 18th through the early afternoon of May 19th, 2020, resulted in the Tittabawassee and Tobacco Rivers surpassing flood stages in many areas. During the flood event, Boyce opened all six (6) Tainter Gates (Tobacco Bays No. 1 through No. 3, and Tittabawassee Bays No. 4 through No. 6) were opened (8 feet to 9 feet) to keep up with the flows of the Tittabawassee River. At approximately 5:30 p.m. Eastern Standard Time (EST), the Wixom Lake water surface elevation rose to El. 680.6 within 1.5 feet of the embankment crest (El. 682.1) and a portion of the left embankment failed due to saturation of the downstream shell and excessive seepage gradients that resulted in a downstream slope failure that breached the dam crest and caused an uncontrolled release of the reservoir. The internal erosion failure of the left embankment resulted in a breach channel that extended approximately 500 feet from the left abutment to immediately adjacent to the Tittabawassee Tainter gate spillway. The flood wave was conveyed south through approximately 1,300-feet long, 400-foot-wide and 40-feet-deep (from the former embankment crest) breach channel formed by the failure. The left embankment failure and breach channel are illustrated in Photo 7.

Photo 7. Edenville Dam Embankment Failure

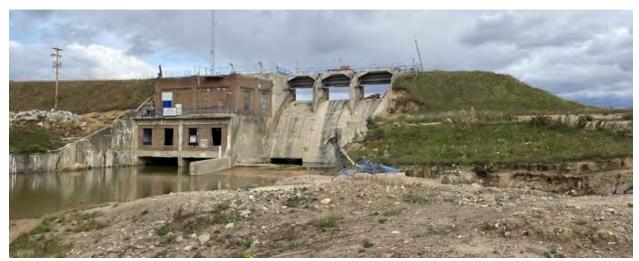
During the failure, the Tittabawassee River side of the impoundment drained rapidly. Increased flow and velocities resulted in the scour and erosion of the embankments. The headwaters of the Tobacco River bypassed the limited capacity of the Tobacco Tainter gate spillway and head cut a breach channel that extended from the M-30 Bridge to the Tittabawassee River breach channel. The downstream embankment adjacent to the concrete training walls and toe of the embankment were severely damaged from high tailwater circulation, splash, and spray erosion above the downstream training walls. The splash and spray and high tailwater elevation resulted in significant erosion and loss of embankment material on the downstream embankment slope flanking the spillways with tailrace training wall lengths and heights.

Photo 8. Tittabawassee Reach overview post-flood, October 2020.

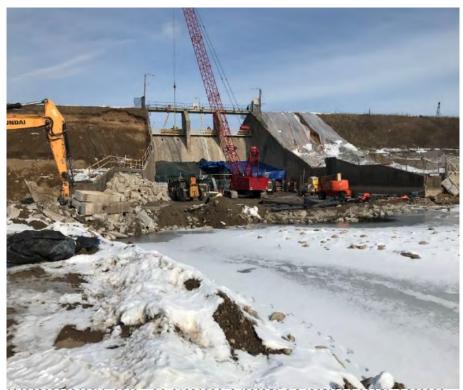
Photo 9. Phase I Interim Stabilization at Tobacco Spillway

The ongoing Edenville Dam interim stabilization consists of two construction phases as part of the State of Michigan EGLE, Water Resources Division Conditional Permit (Emergency Permit). The permit was issued on November 19, 2020, and includes permit conditions for Wixom Lake (Edenville Dam impoundment), and the Tobacco and Tittabawassee Rivers. Phase I construction of the Edenville Dam stabilization is currently underway on the Tobacco spillway and includes lowering the existing Tainter gate spillway, reinforcing the training walls and restoring the natural flow path of the Tobacco River. The Phase I construction is expected to be completed in in Summer 2021 (see Photo 9).
