Conceptual Design Basis Report Rehabilitation of Edenville Dam

Gladwin County, Michigan

March 17, 2021

GEI Project No. 2002879, Task 4

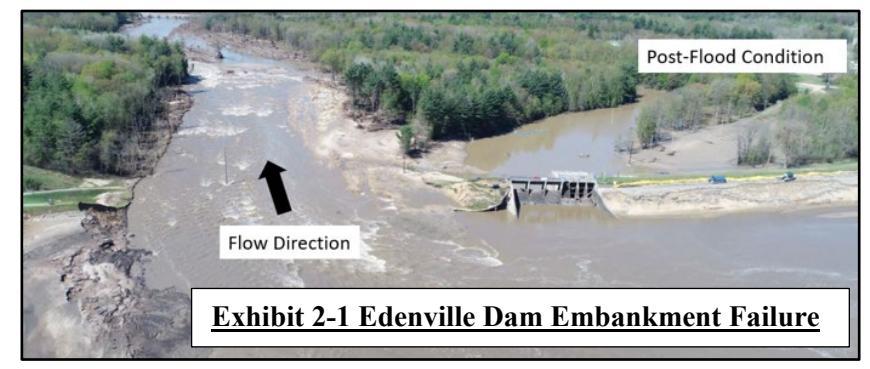
with additional rainfall starting in the evening of May 18th through the early afternoon of May 19th, 2020, resulted in the Tittabawassee and Tobacco Rivers surpassing flood stages in many areas. During the flood event, Boyce opened all six (6) Tainter Gates (Tobacco Bays No. 1 through No. 3, and Tittabawassee Bays No. 4 through No. 6) were opened (8 feet to 9 feet) to keep up with the flows of the Tittabawassee River. At approximately 5:30 p.m. Eastern Standard Time (EST), the Wixom Lake water surface elevation rose to El. 680.6 within 1.5 feet of the embankment crest (El. 682.1) and a portion of the left embankment failed due to saturation of the downstream shell and excessive seepage gradients that resulted in a downstream slope failure that breached the dam crest and caused an uncontrolled release of the reservoir.

The internal erosion failure of the left embankment resulted in a breach channel that extended approximately 500 feet from the left abutment to immediately adjacent to the Tittabawassee Tainter gate spillway. The flood wave was conveyed south through approximately 1,300-feet-long, 400-foot-wide and 40-feet-deep (from the former embankment crest) breach channel formed by the failure. The left embankment failure and breach channel are illustrated in **Exhibit 2-1**. During the failure, the Tittabawassee River side of the impoundment drained, rapidly forcing increased flow and velocities through the M-30 Bridge resulting in scour and

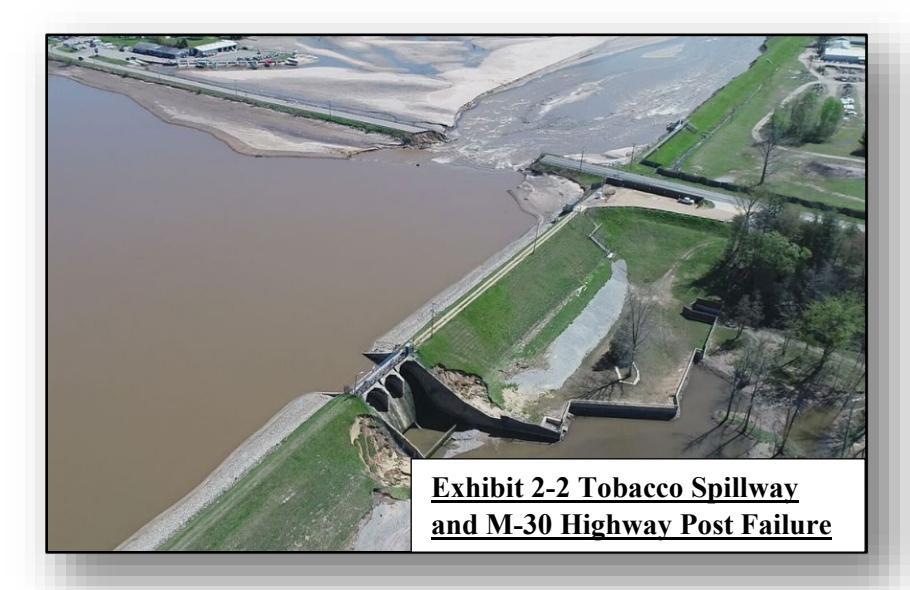
erosion that eventually led to the failure of the M-30 Bridge (See **Exhibit 2-2**). The headwaters of the Tobacco River bypassed the limited capacity of the Tobacco Tainter gate spillway and head cut a breach channel that extended from the M-30 Bridge to the Tittabawassee River breach channel.

The downstream embankment adjacent to the concrete training walls and toe of the embankment were severely damaged from high tailwater circulation, splash, and spray erosion above the downstream training walls. The splash and spray and high tailwater elevation resulted in significant erosion and loss of embankment material on the downstream embankment slope flanking the spillways with tailrace training wall lengths and heights (see **Exhibit 2-2**).

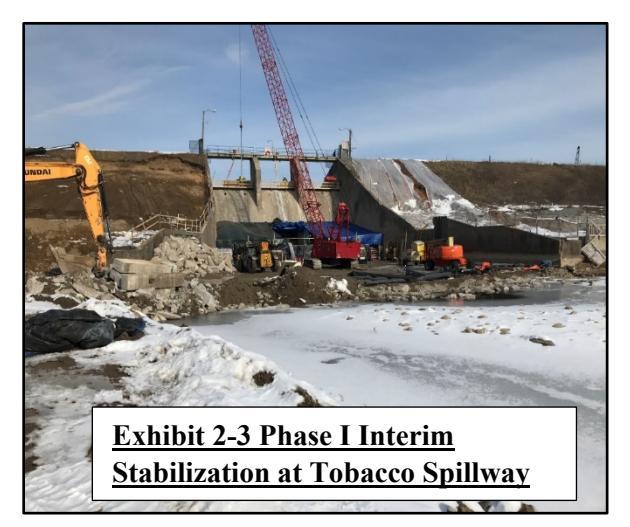
Phase I construction of the Edenville Dam stabilization is currently underway on the Tobacco spillway and includes lowering the existing Tainter gate spillway, reinforcing the

training walls and restoring the natural flow path of the Tobacco River. The Phase I construction is expected to be completed in in Summer 2021 (see **Exhibit 2-3**).
