**EDENVILLE DAM PERMIT APPLICATION  
- STREAM IMPACTS AND PROPOSED OFFSETTING PROJECTS -**

**APPENDIX B - IMPACTED STREAM SITE PHOTOS FOR WIXOM LAKE**

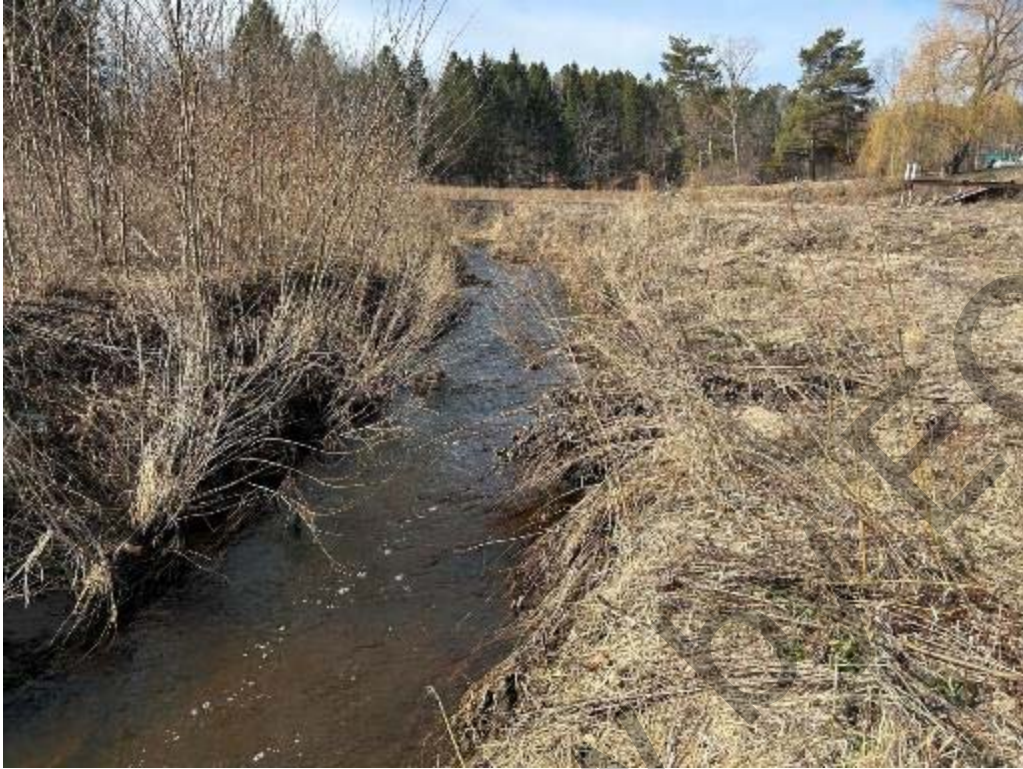
- Site 1 (Bear Creek): 1,989 feet of Bear Creek was dewatered downstream of Freeman Road following the failure of the Edenville Dam. Bear Creek is intermittent and the culvert beneath Freeman Road is slightly perched. The stream makes a relatively steep descent from Freeman Road to the Tobacco River. The lower reach of the stream is experiencing severe bank and bed erosion.

Site 1 – Looking upstream near former lake edge.

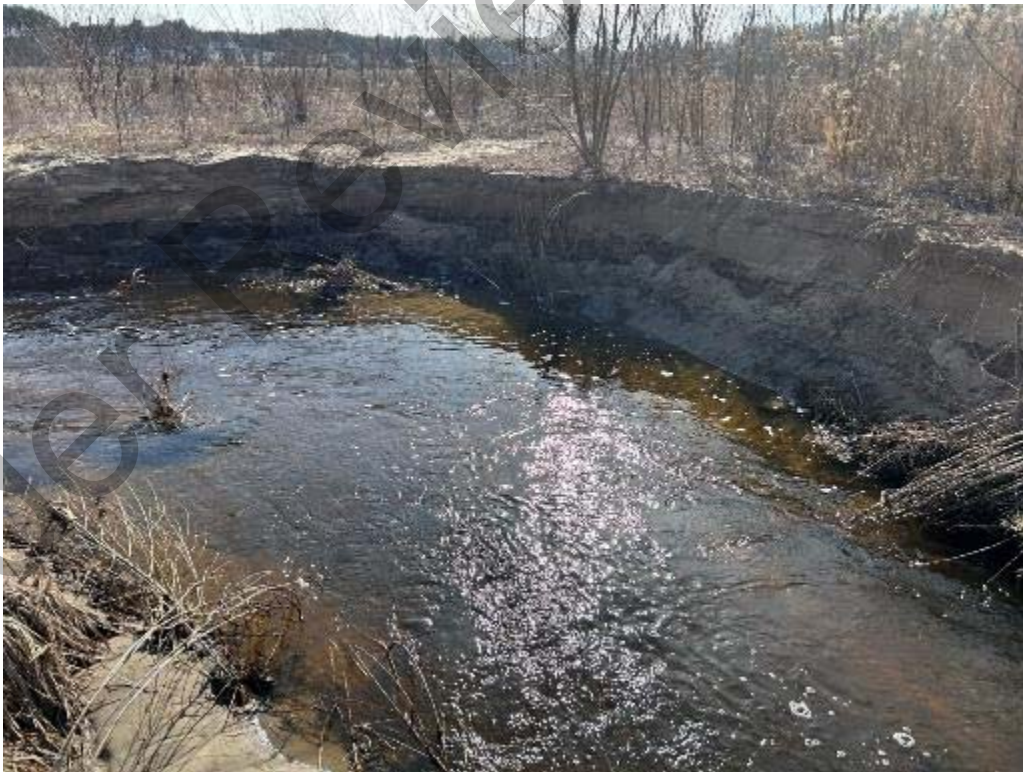
Site 1 – Severe bank erosion.

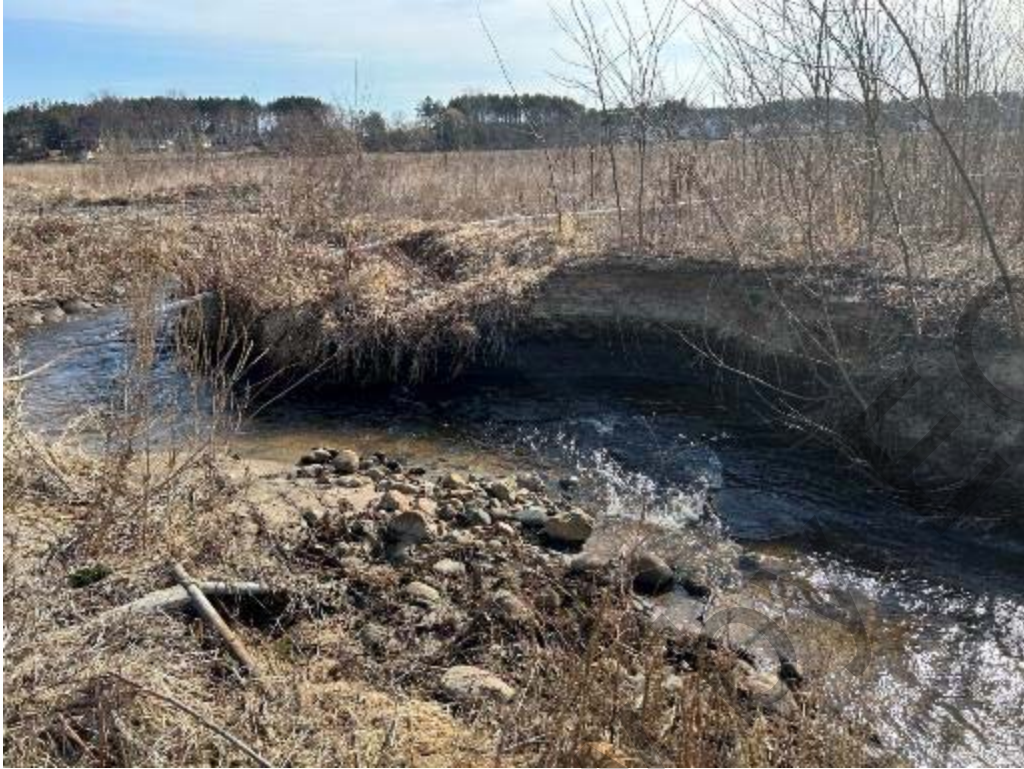
Site 1 – Looking downstream toward Tobacco River; headcutting and bank erosion.

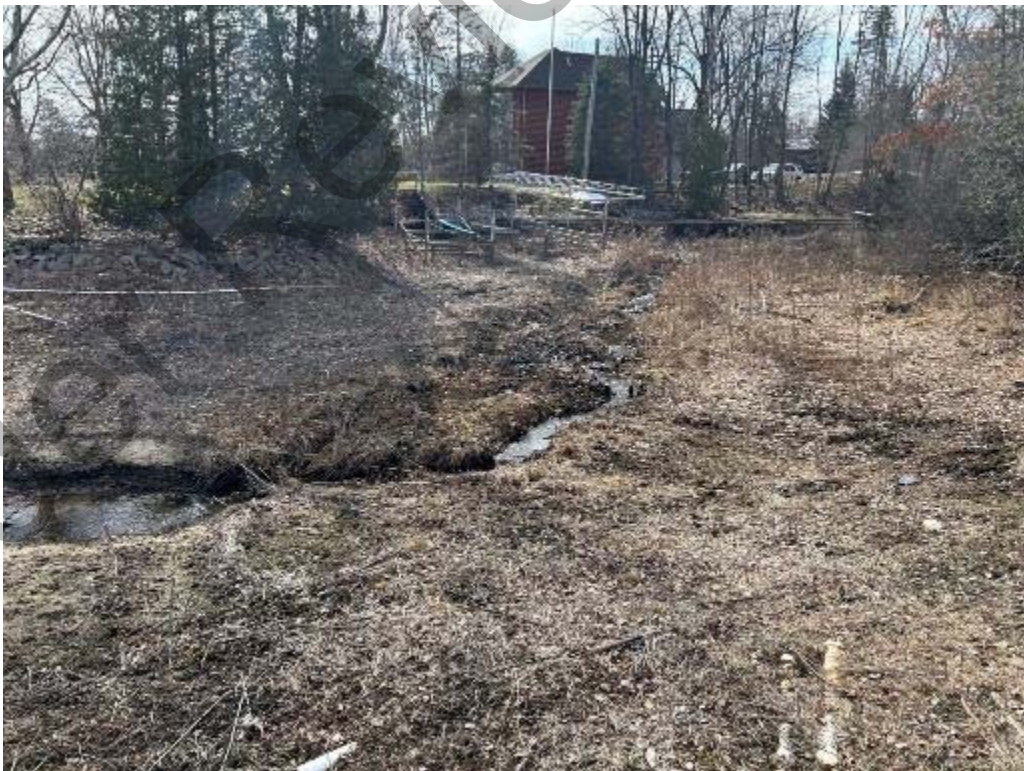
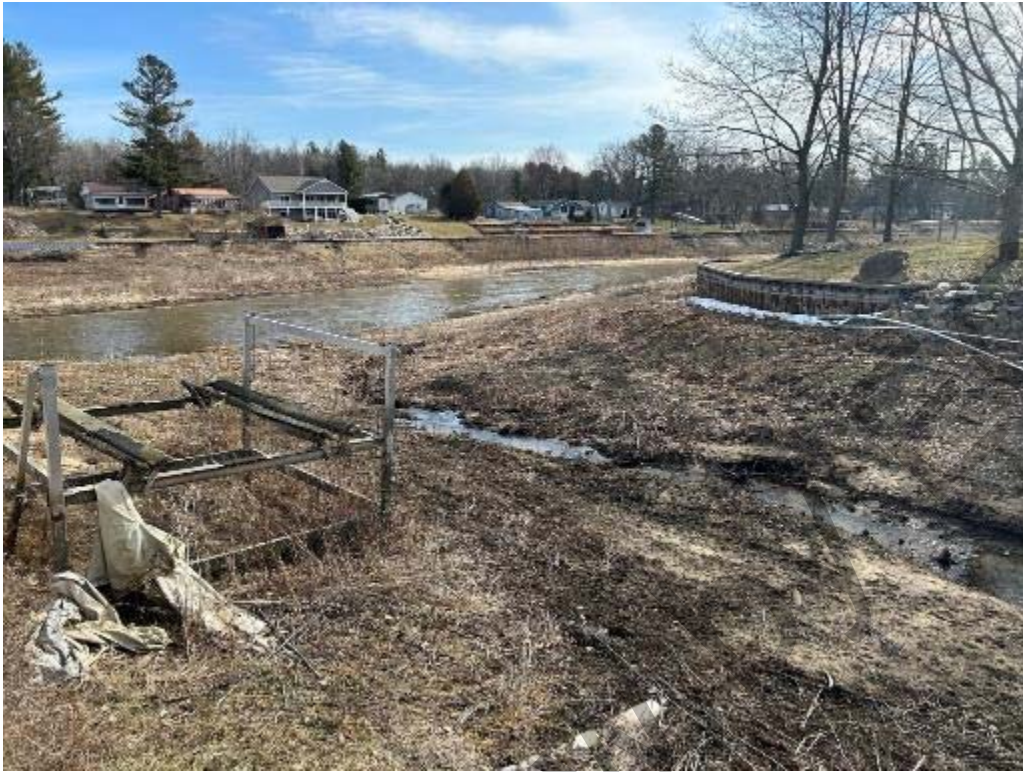
- Site 2: This site contains a small, intermittent channel about one to two feet in width, flowing through a densely vegetated floodplain. The channel was completely dry during summer inspection. Headcutting is ongoing.

Site 2 – Looking upstream.

Site 2 – Looking downstream.

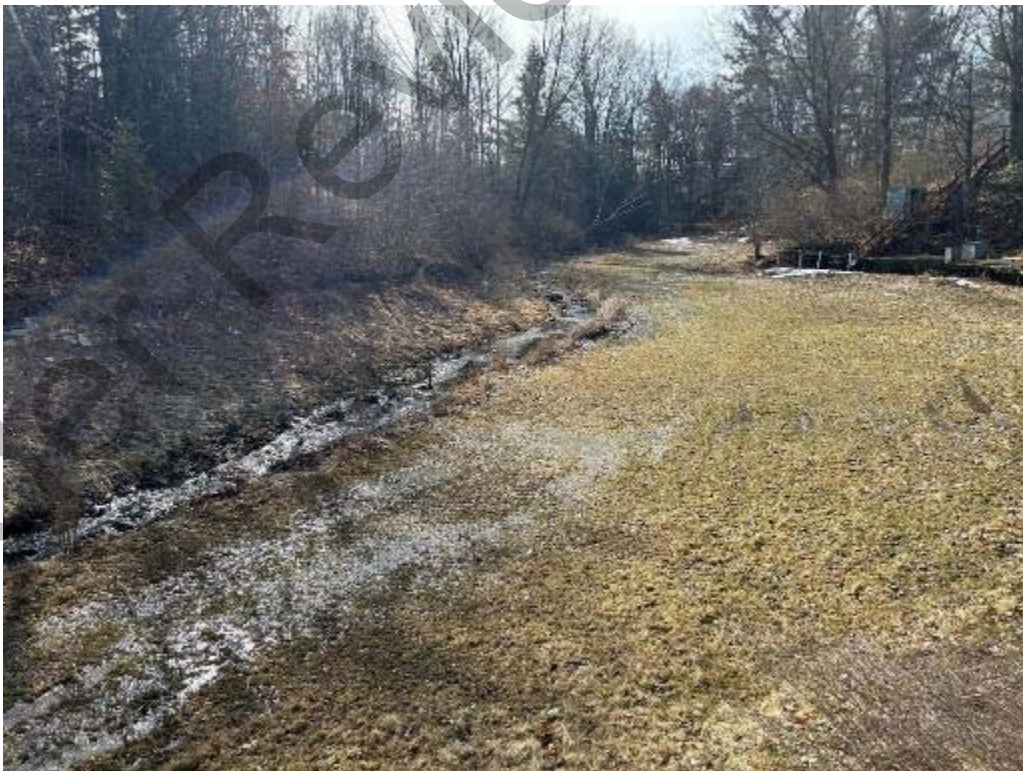
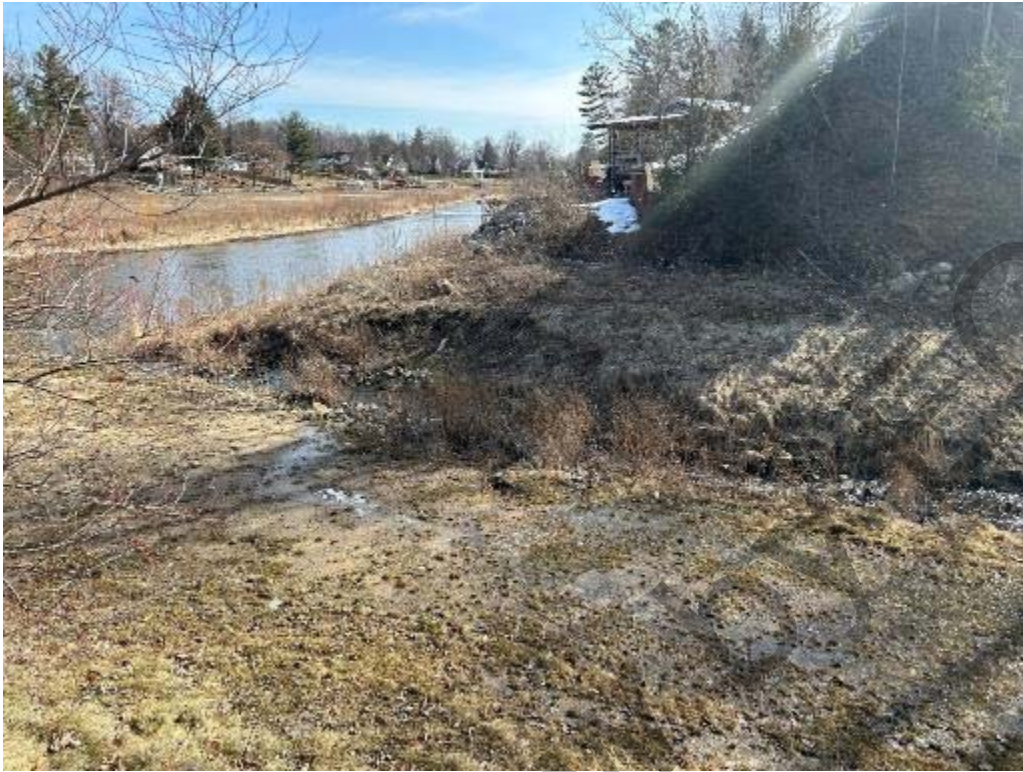
- Site 3: This is a small, intermittent stream channel that experienced a rapid drop in elevation between the Highland Cove Road crossing and the Tobacco River. The channel is quite well-adjusted to the landscape but offers little in terms of ecological value.

Site 3 – Looking upstream.

Site 3 – Looking downstream toward Tobacco River.

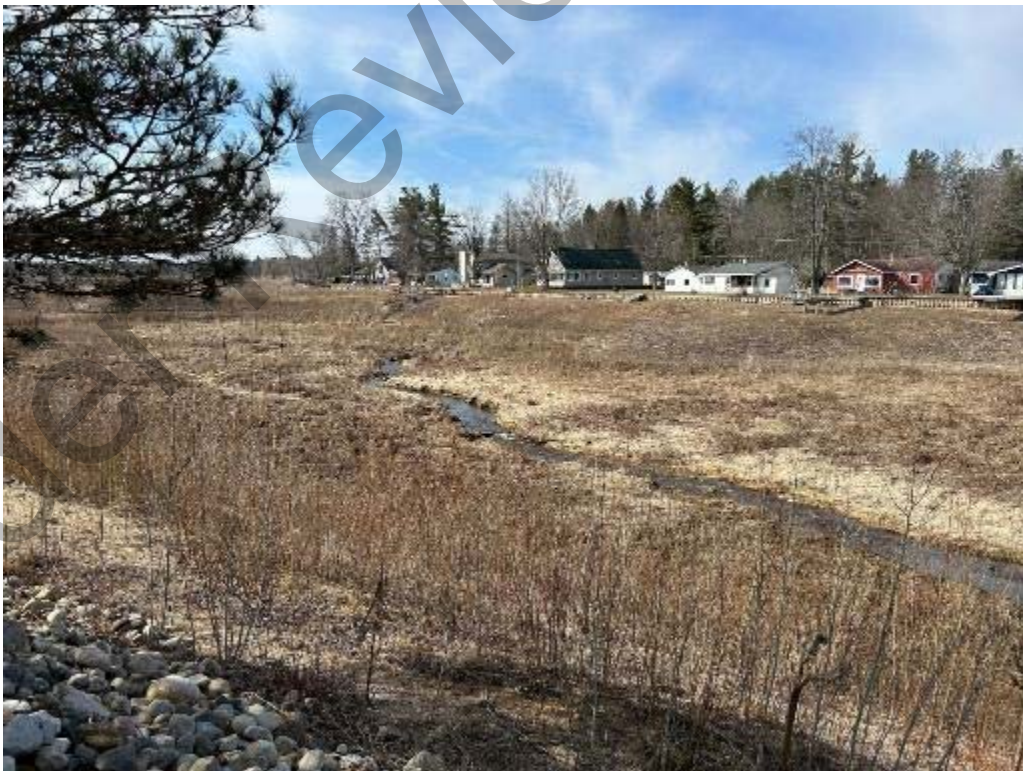
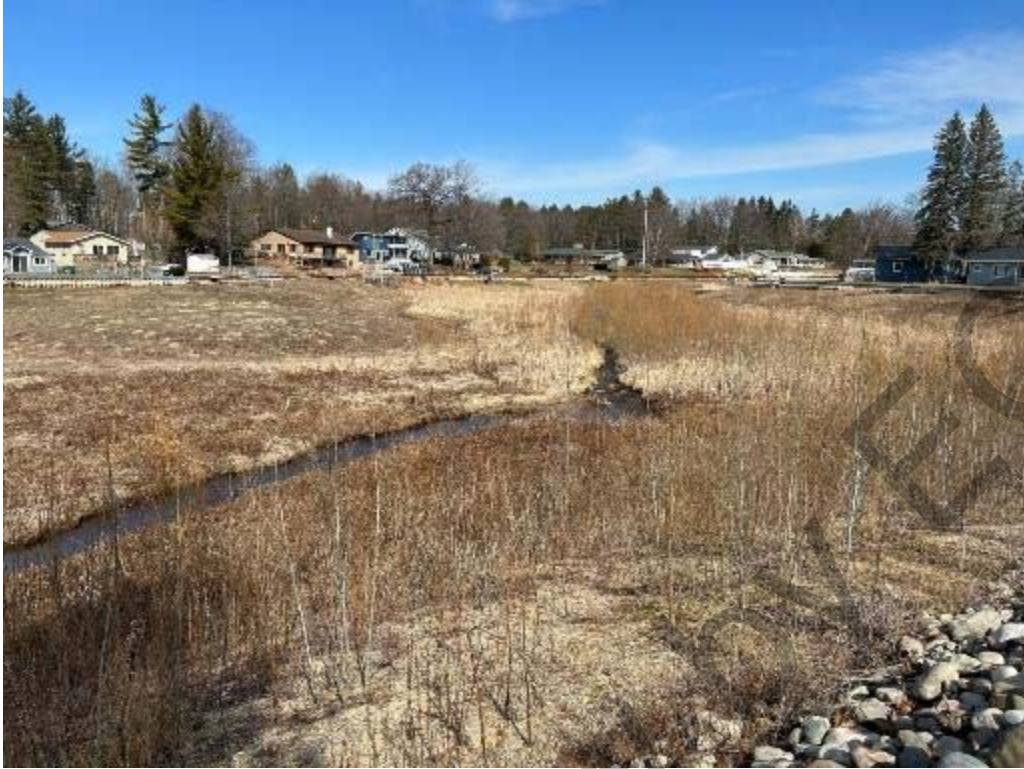
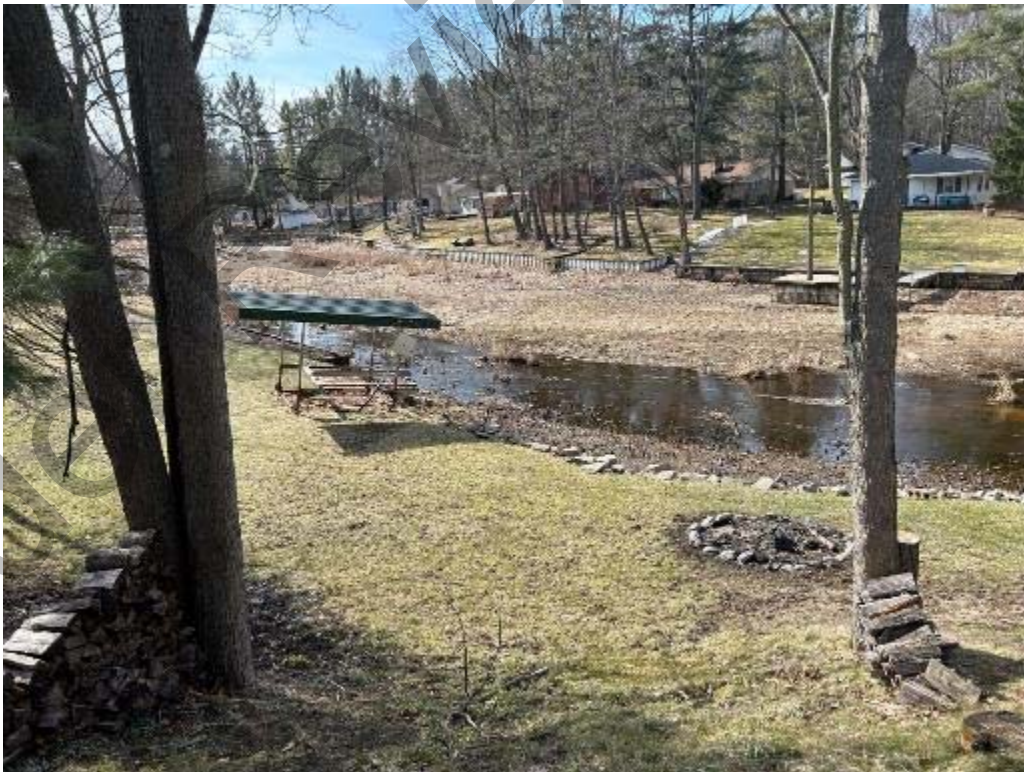
- Site 4: This intermittent stream passes beneath Hunter Road, where the crossing is perched about four inches. During the summer period, there was a trickle of flow at Hunter Road, but the streambed was completely dry by the time it reached the Tobacco River. The channel is relatively well-adjusted to the surrounding floodplain, but headcutting is still present and active.

Site 4 – Looking downstream.

Site 4 – Looking upstream.

Site 4 – Looking across and downstream.

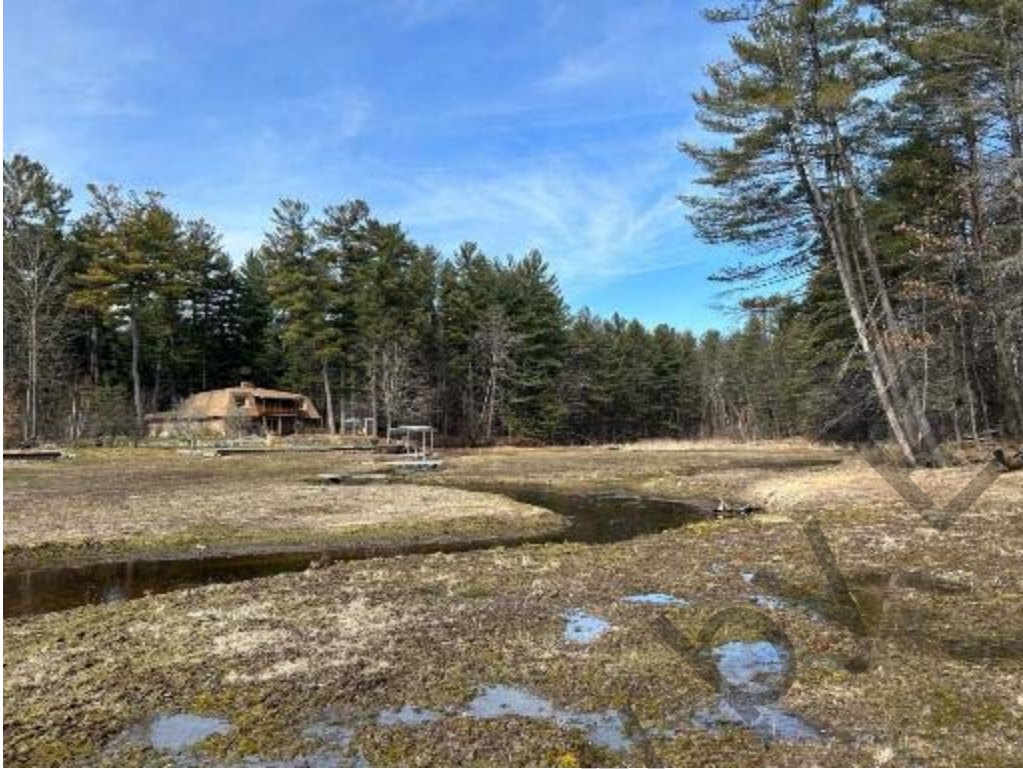
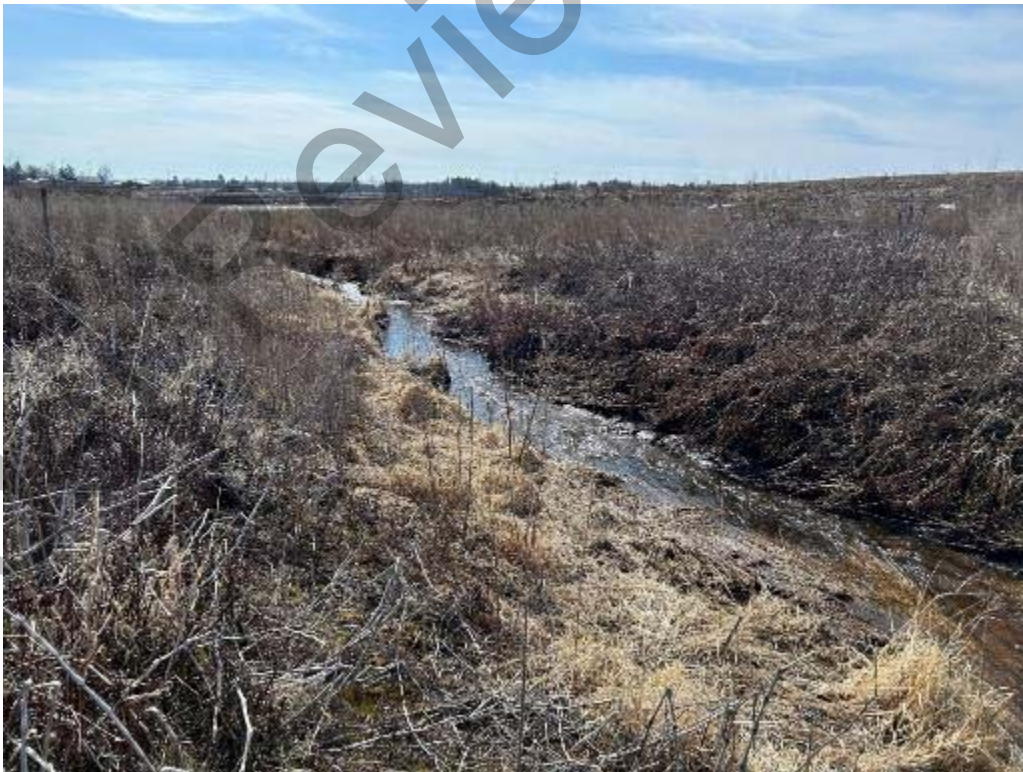
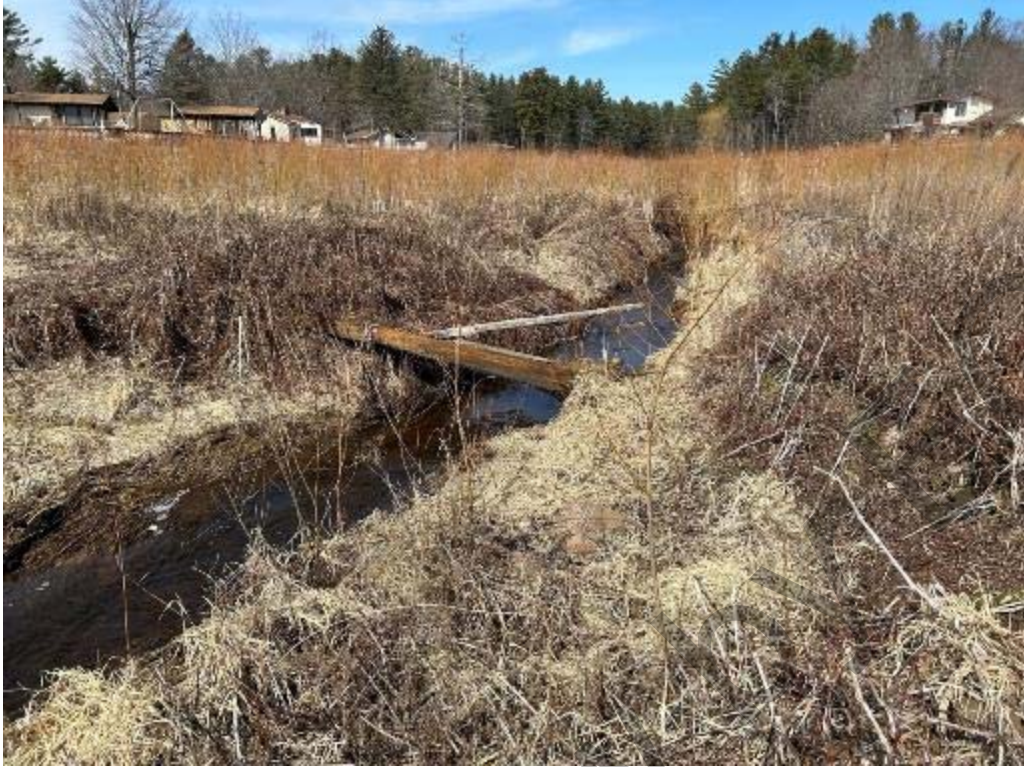
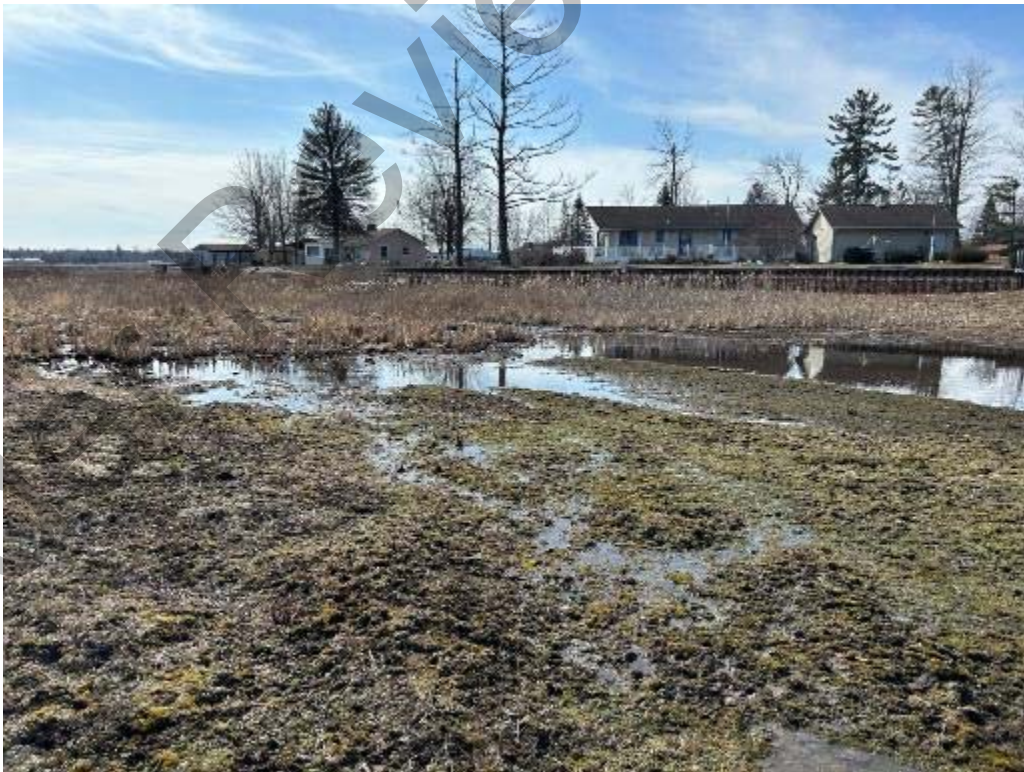
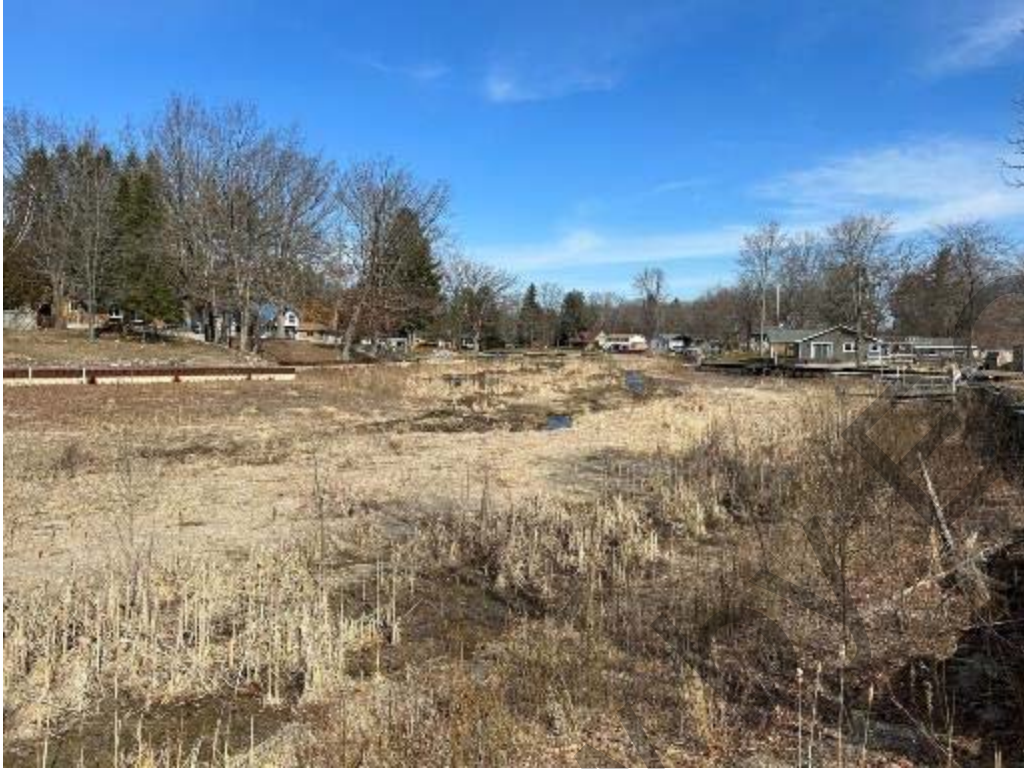
- Site 5 (Coolidge Drain): This site is very similar in nature to Site 4, with an intermittent channel flowing through the exposed bottomland floodplain. The channel is adjusting well to the landscape but still contains active headcuts.

Site 5 – Looking upstream.

Site 5 – Looking downstream toward Tobacco River.

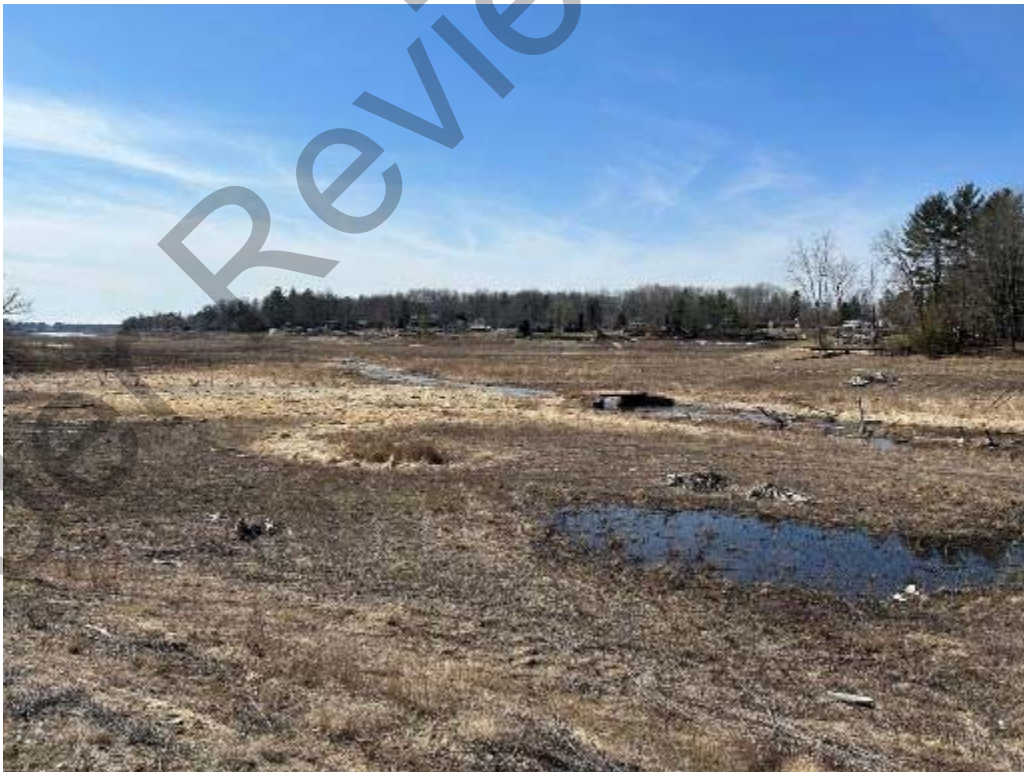
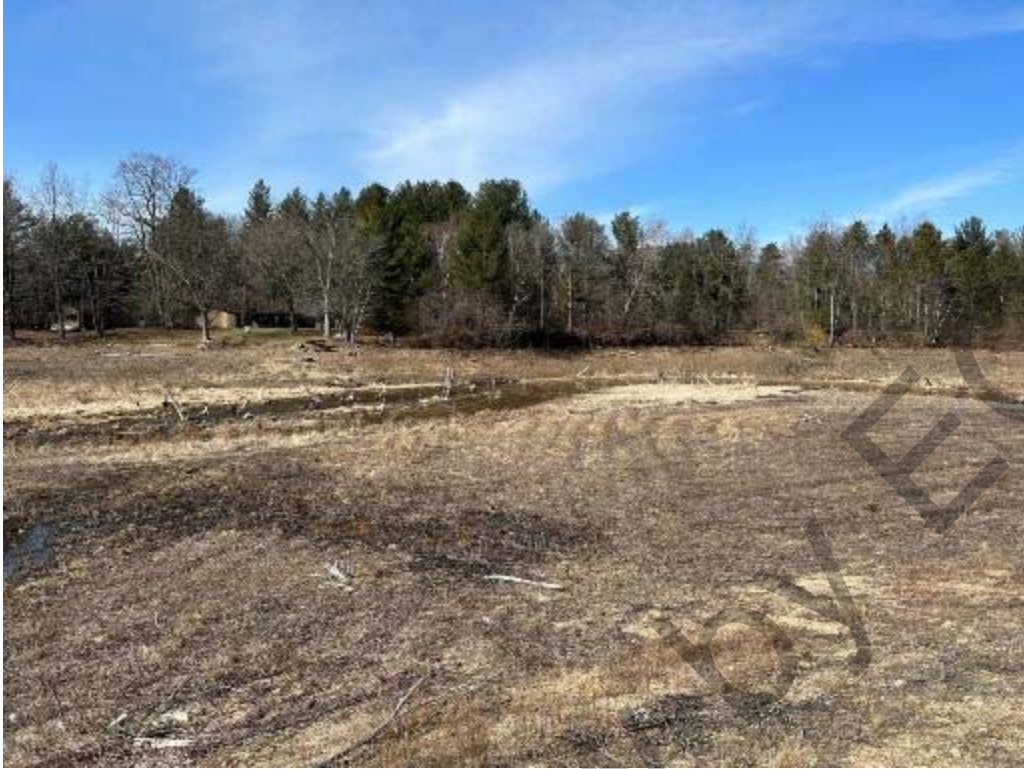
- Site 6 (Little Cedar River): This is one of the larger tributaries to enter Wixom Lake, but the flow is intermittent as evidenced by the lack of flowing water between standing pools of water in the summer. Small fish were observed in the pools. During spring flows, the channel was running near bankfull and had the appearance of a nice, functioning stream.

Site 6 – Looking downstream.

Site 6 – Looking upstream.

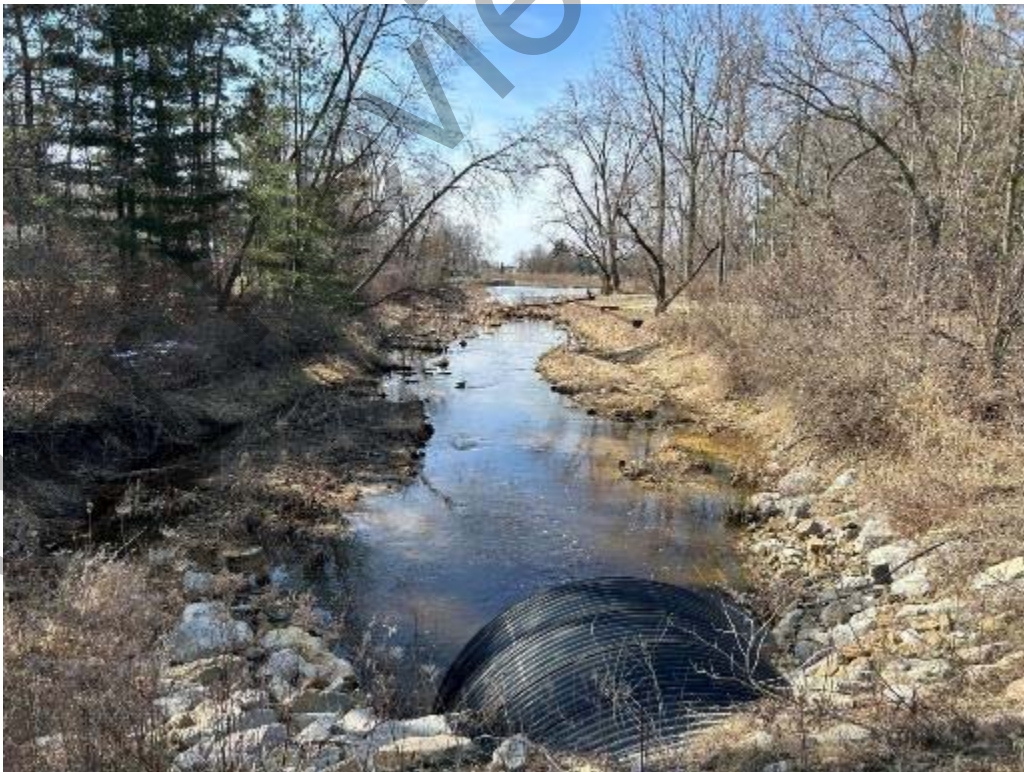
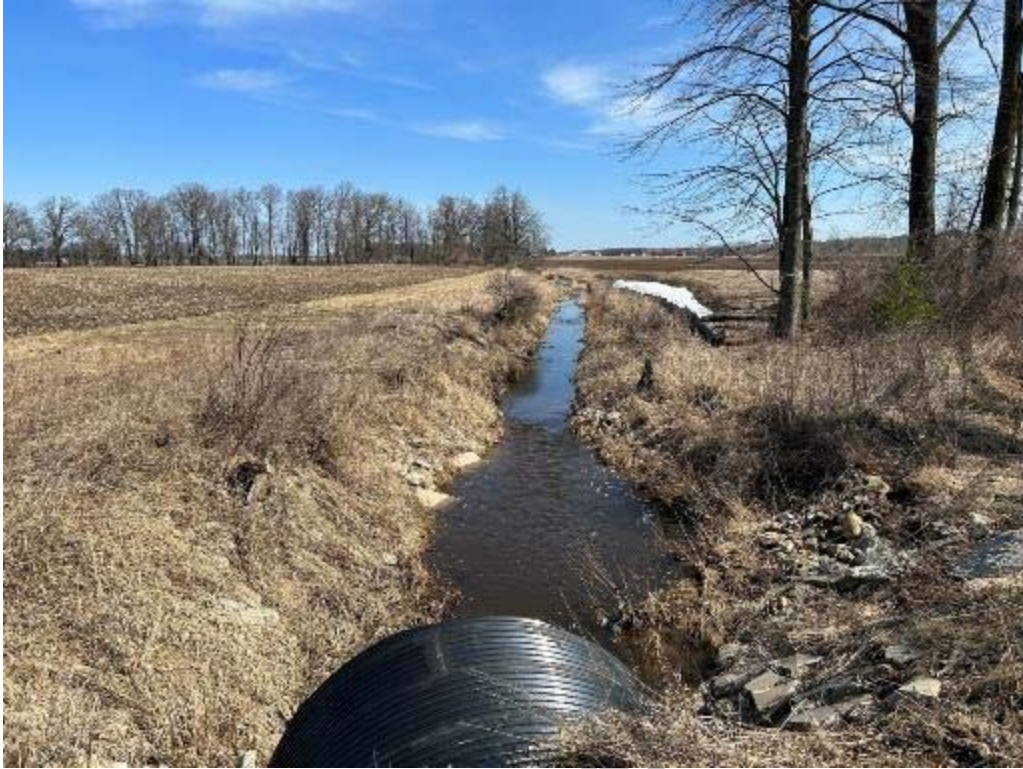
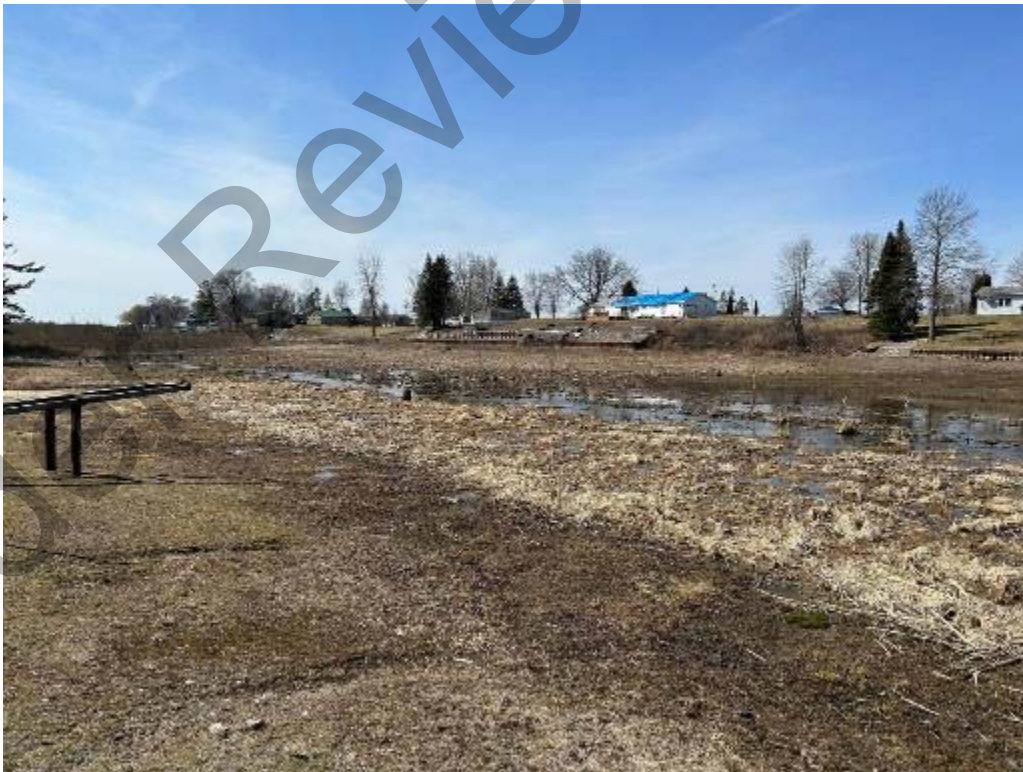
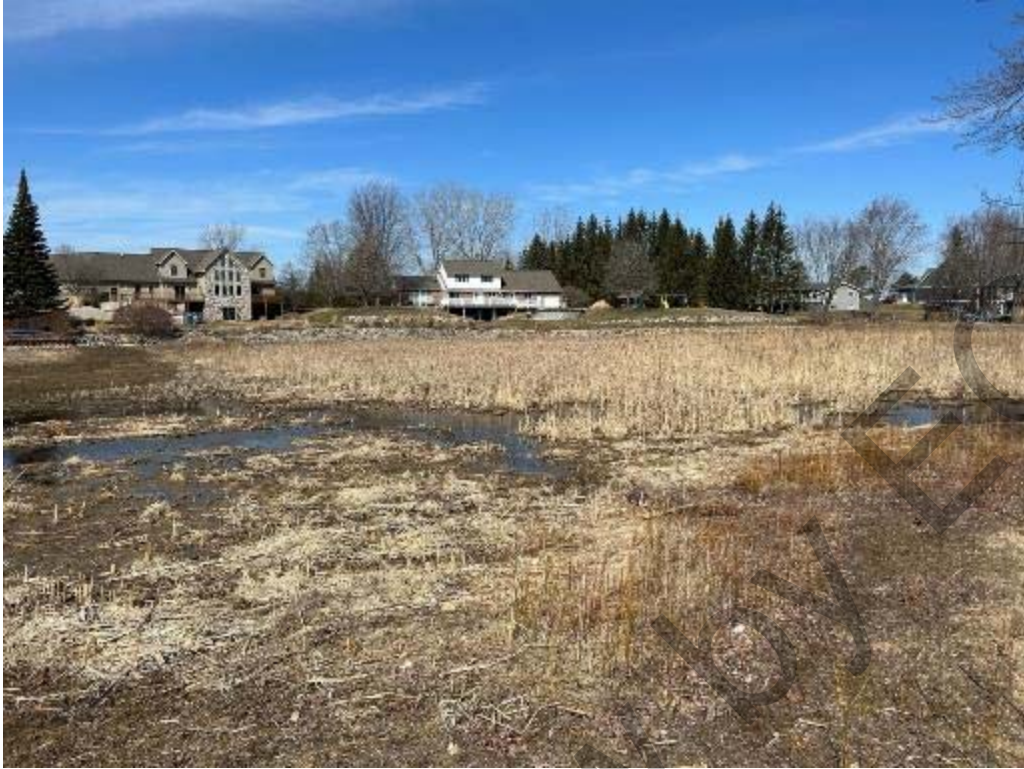
- Site 7 (Ortner Drain): The Ortner Drain is a trapezoidal ditch flowing through open cropland upstream of Red Oak Street. During initial inspections, there were small pools of standing water but no flow, making this an intermittent channel. Small fish were observed in pools. Downstream of Red Oak Street, the channel disappears into dense wetland vegetation in several areas.

Site 7 – Looking downstream from Red Oak St.

Site 7 – Looking upstream from Red Oak St.

Site 7 – Looking downstream from Heron Cove Dr.

Site 7 – Looking upstream from Heron Cove Dr.

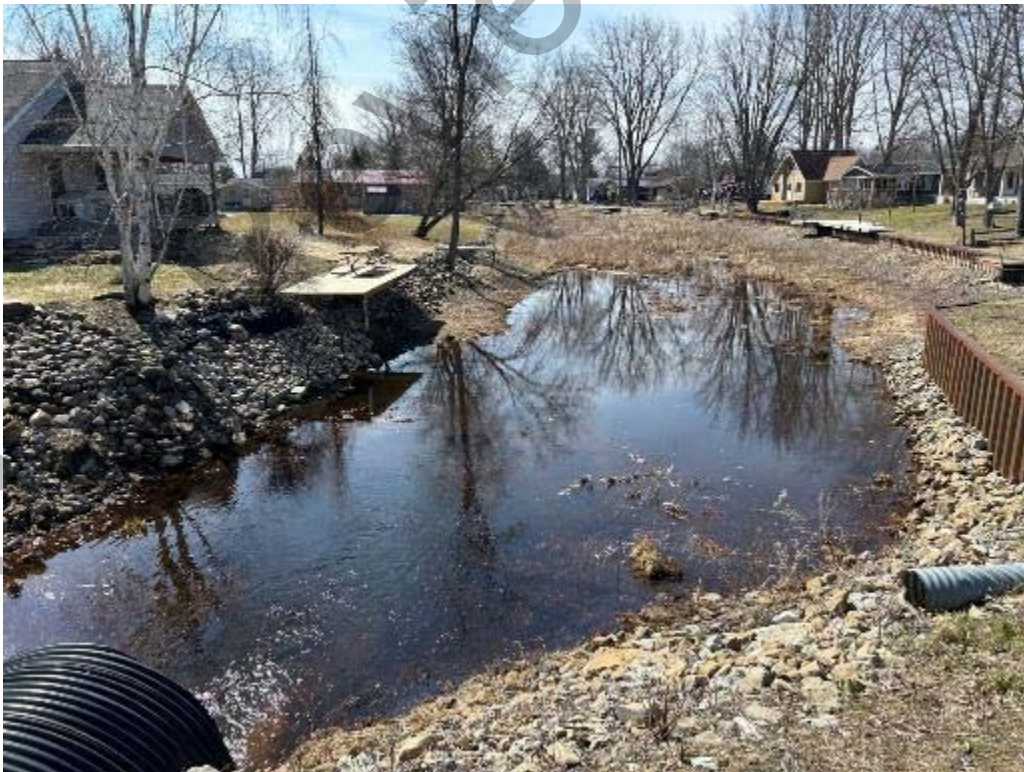
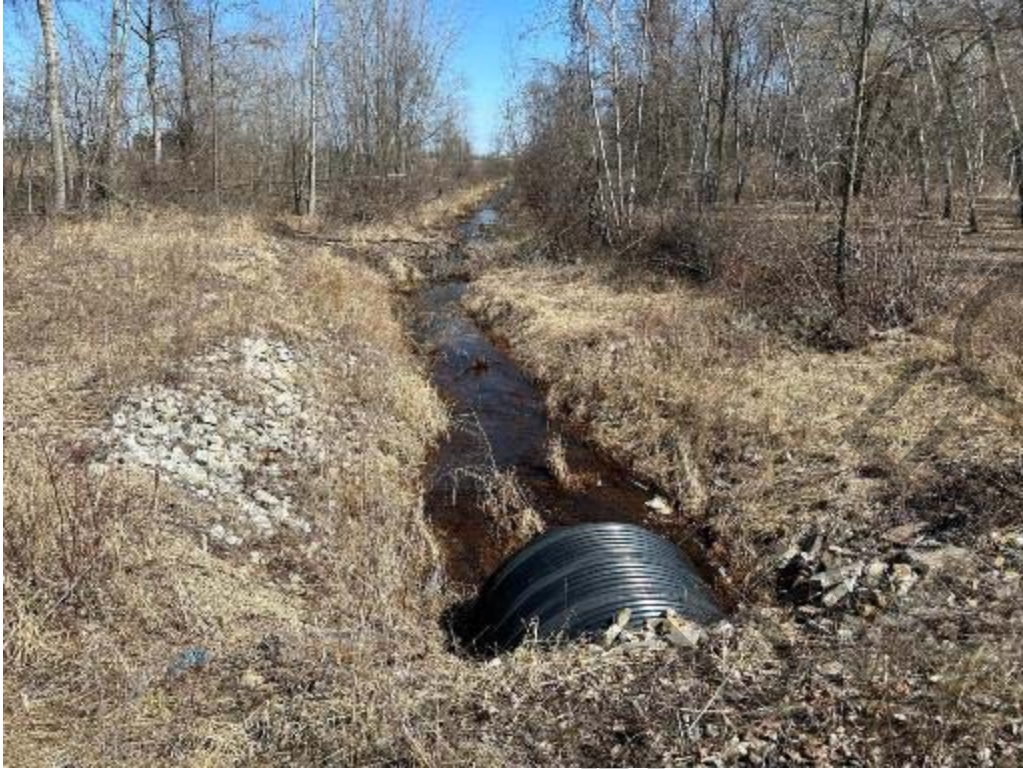
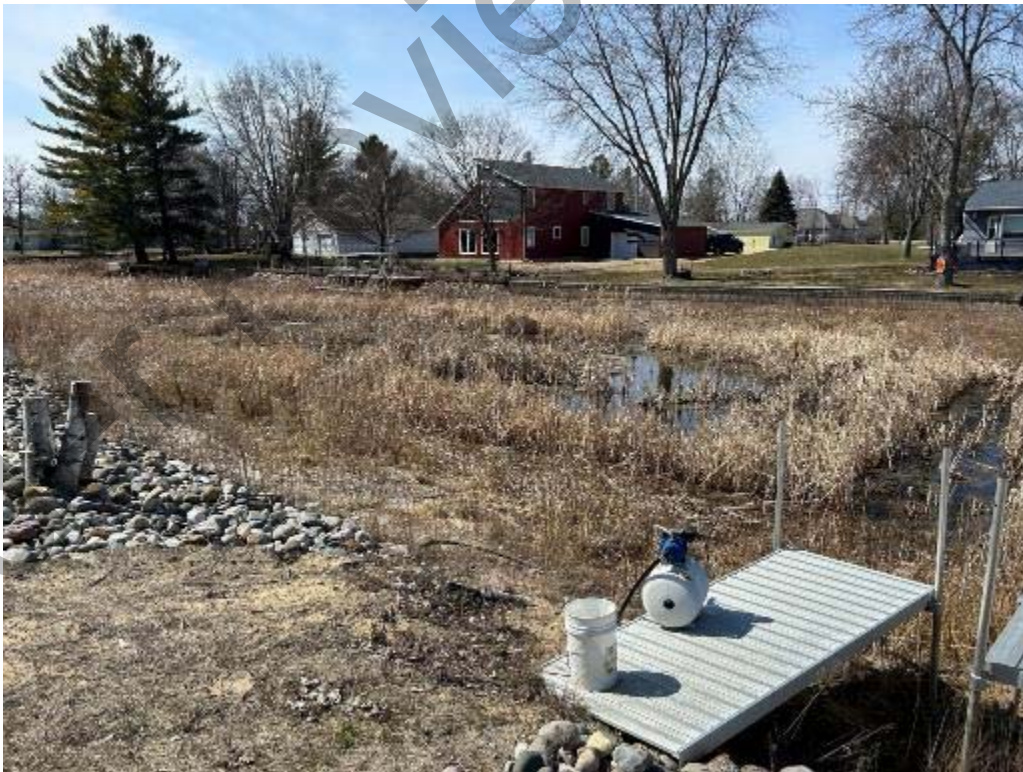
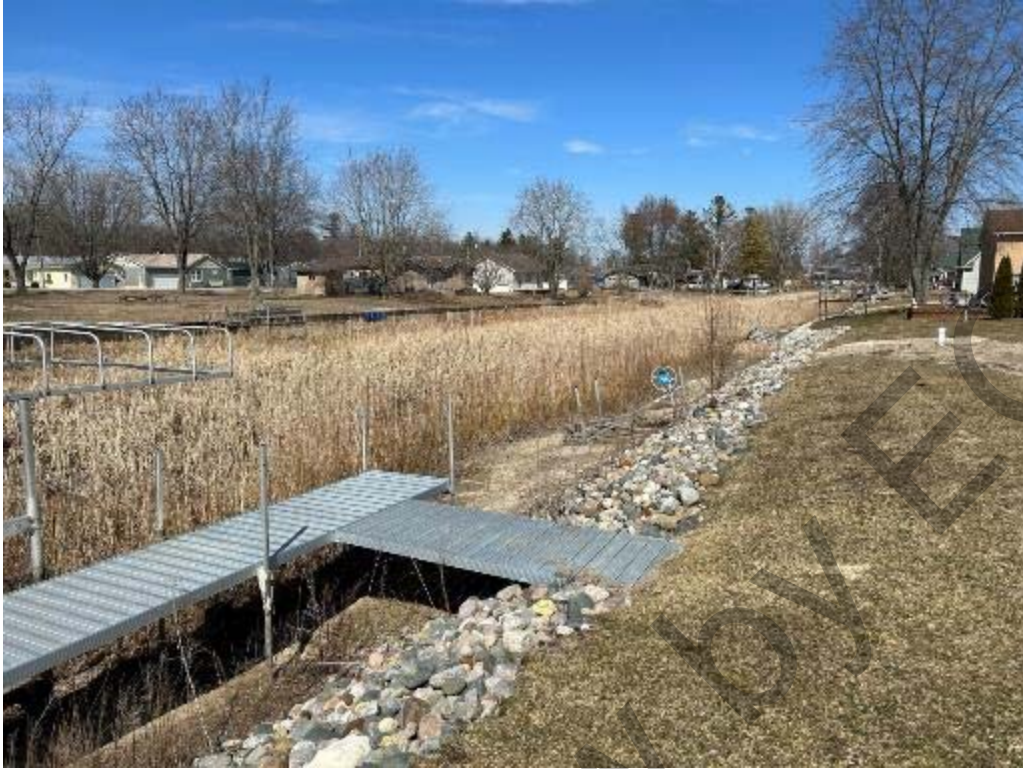
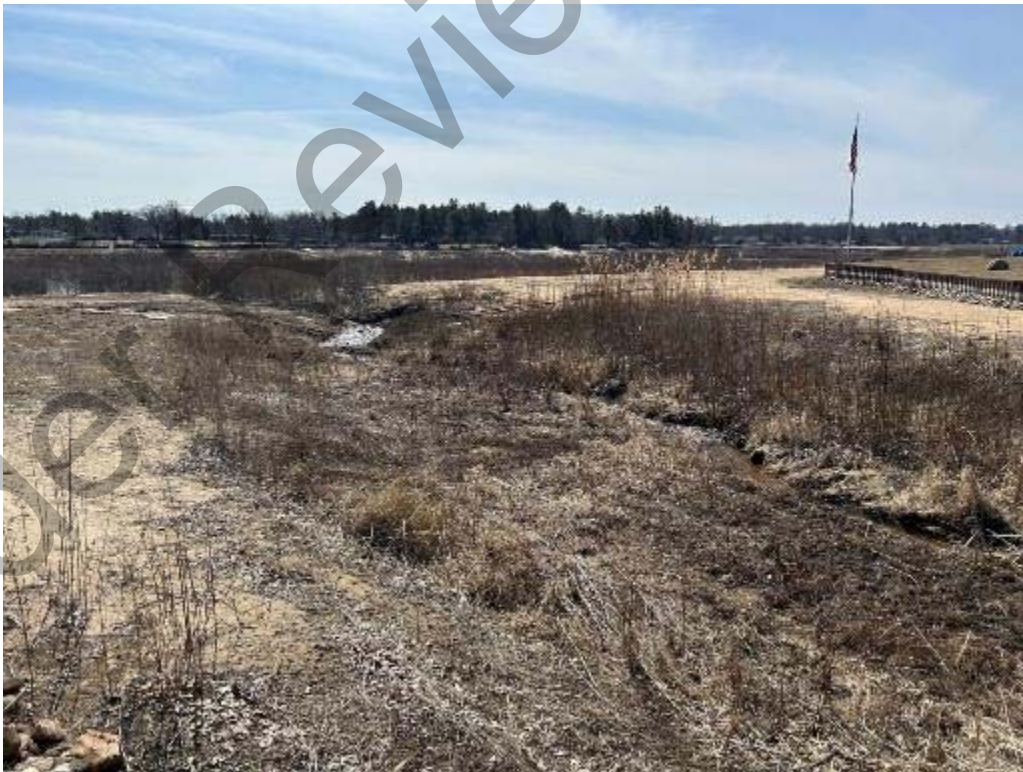
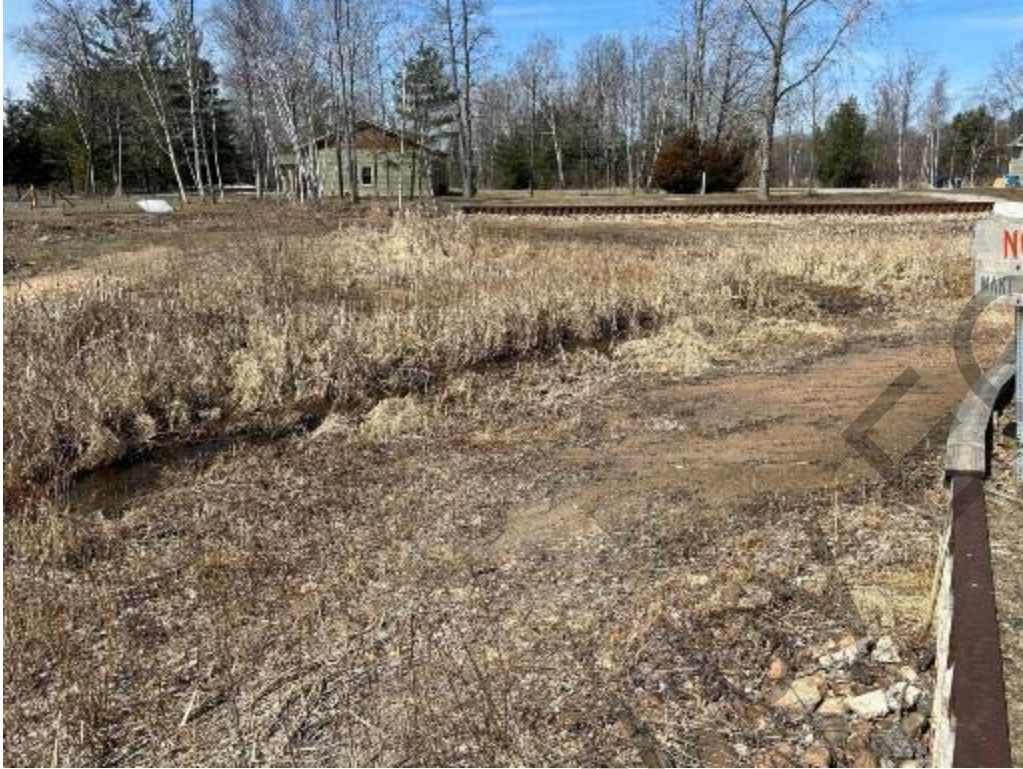
Site 8, Pary Drain, is relatively well-adjusted to the landscape, with a small stream channel surrounded by an accessible, vegetated floodplain. Sediment transport appears to be compromised, as evidenced by sand deposits with a braided channel in some areas. The stream channel itself does not reach the Tittabawassee River but, rather, flows into a large, ponded wetland area that overflows into the main river. Biological function is likely negatively impacted by the mobile sand bedload, lack of volume during dry periods and the fragmentation of habitats caused by the wetland area on the downstream end and impassable barrier at the upstream end; however, no biological survey has been completed.

- Site 8 (Pary Drain): The Pary Drain appeared to be perennial during initial inspections, though the baseflow was a trickle of water estimated to be less than one cubic feet per second (cfs). Like the Ortner Drain, the Pary Drain is an agricultural ditch upstream of Red Oak Street.

Site 8 – Looking downstream from Red Oak St.

Site 8 – Looking upstream from Red Oak St.

Site 8 – Looking downstream from Mallard Ct.

Site 8 – Looking upstream from Mallard Ct.
