**EDENVILLE DAM PERMIT APPLICATION  
- STREAM IMPACTS AND PROPOSED OFFSETTING PROJECTS -**

**APPENDIX B - IMPACTED STREAM SITE PHOTOS FOR WIXOM LAKE**

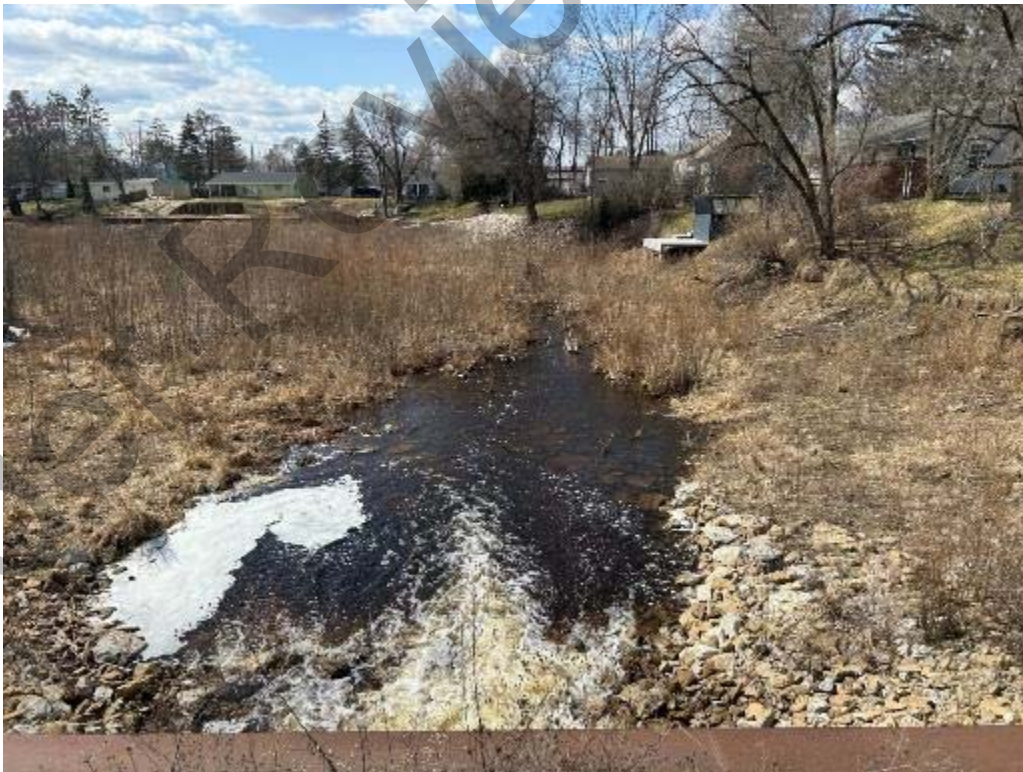
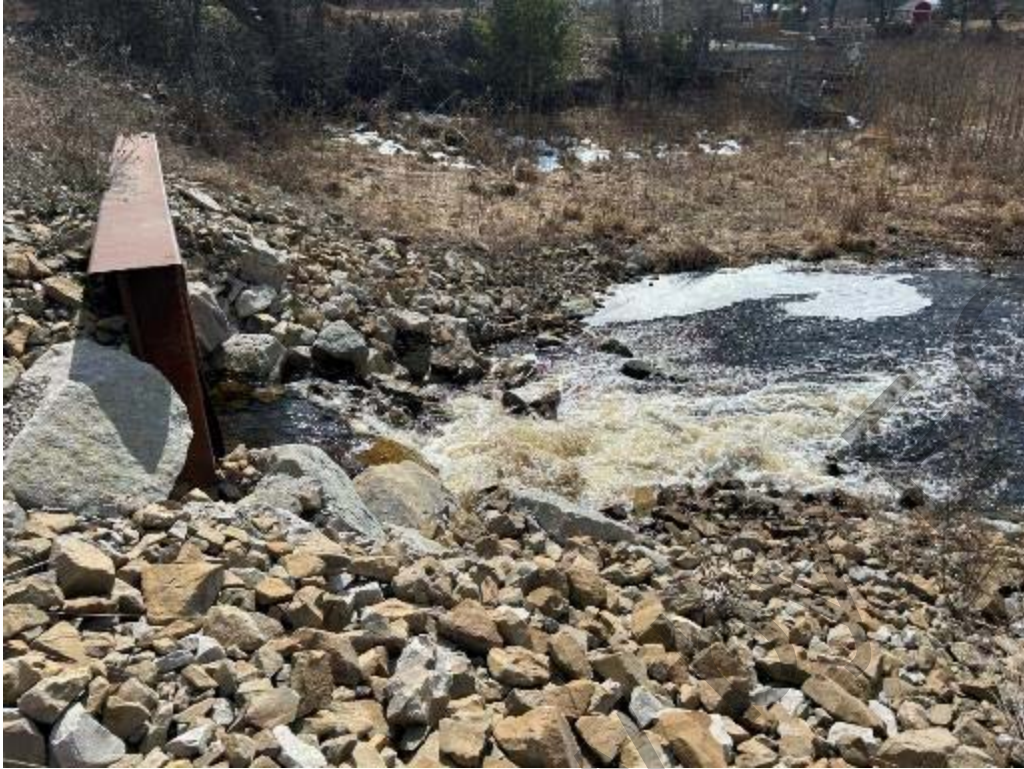
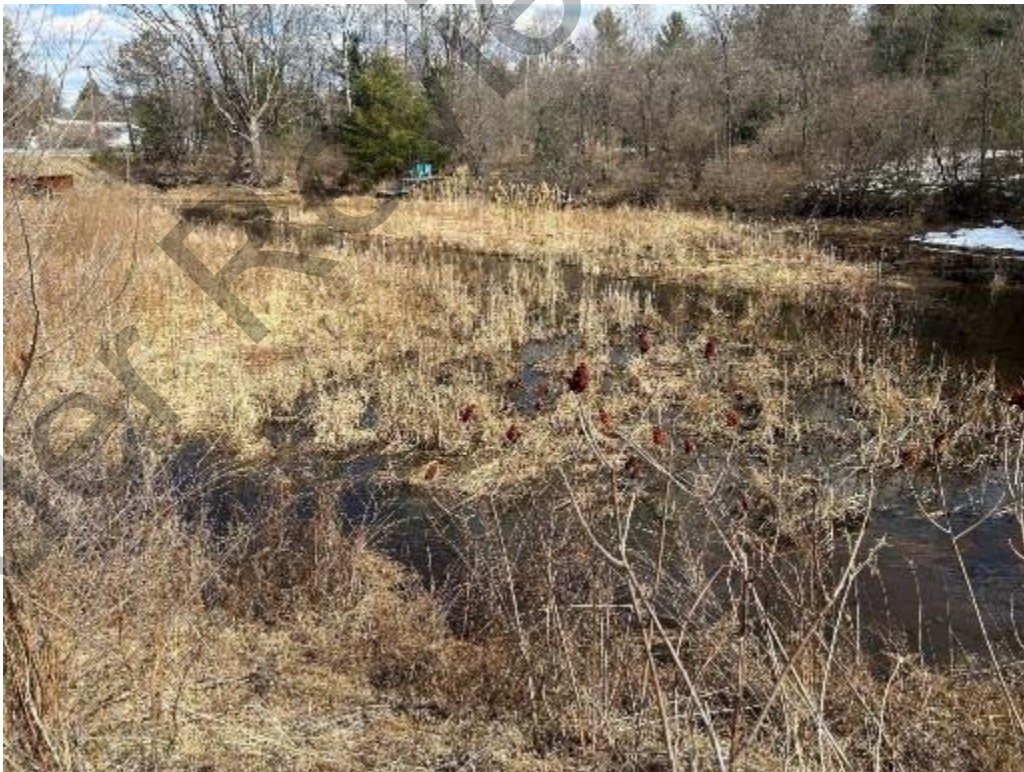
Site 9, Denton Creek, has function that is severely impacted by excessive bank and bed erosion. Beginning at the edge of the Tittabawassee River, the streambed has head cut all the way to the first upstream crossing at Dague Road, where the culvert is perched approximately two feet. The streambed has eroded down to a hard clay layer in the downstream reaches. The stream is deeply incised and signs of past and ongoing erosion of the banks are clearly evident. While northern pike have been known to travel several miles up the stream in the past, very little biological function would be expected given the existing physical condition of the stream.

- Site 9 (Denton Creek): Denton Creek is perennial but the first upstream crossing, at Bayview Drive, is severely perched. During baseflow conditions, the stream contains large, stagnant pools of standing water linked by a tiny band of flowing water.

Site 9 – Looking downstream from Denton Creek Rd.

Site 9 – Crossing under Denton Creek Rd.

Site 9 – Looking upstream from Denton Creek Rd.

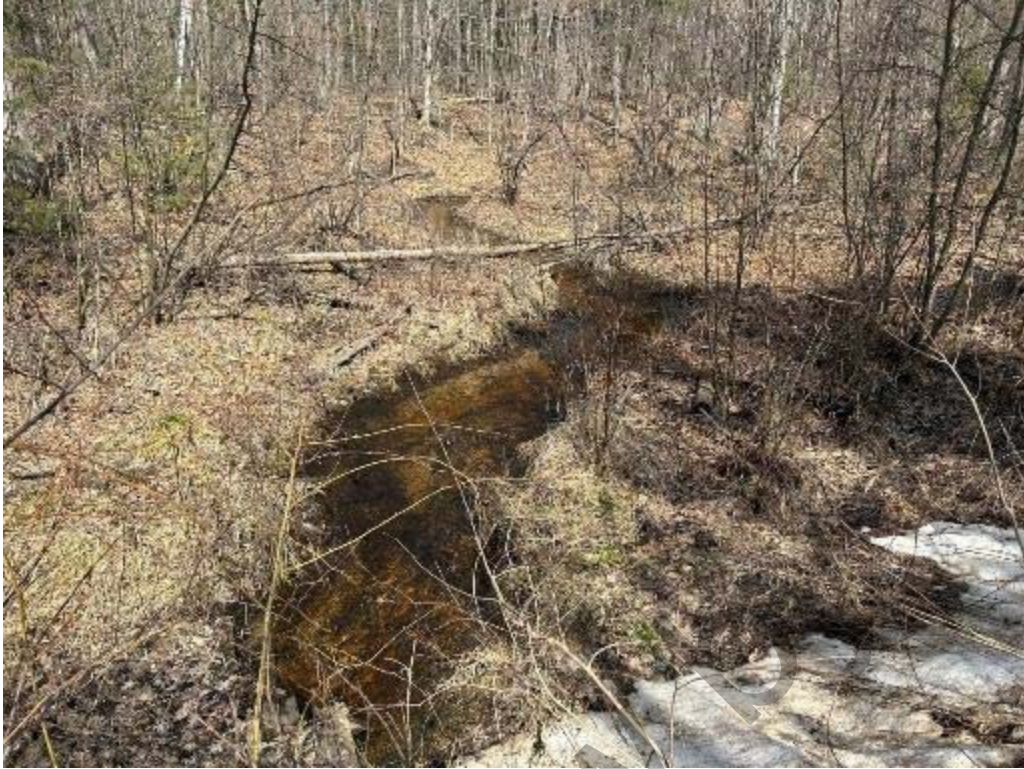
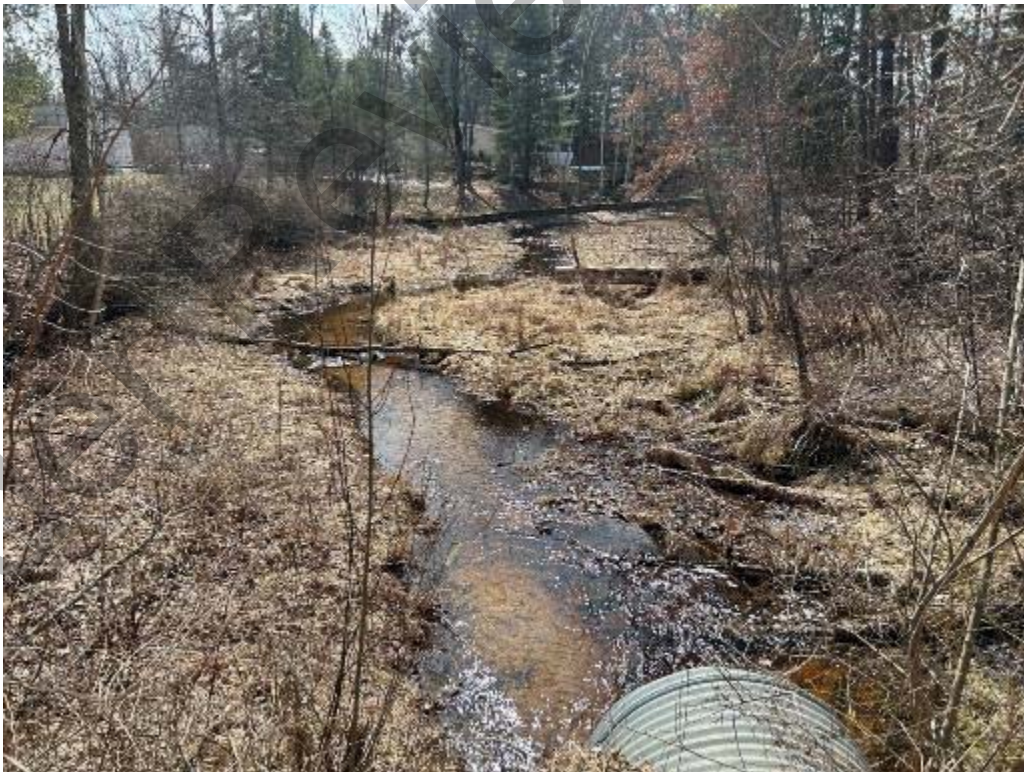
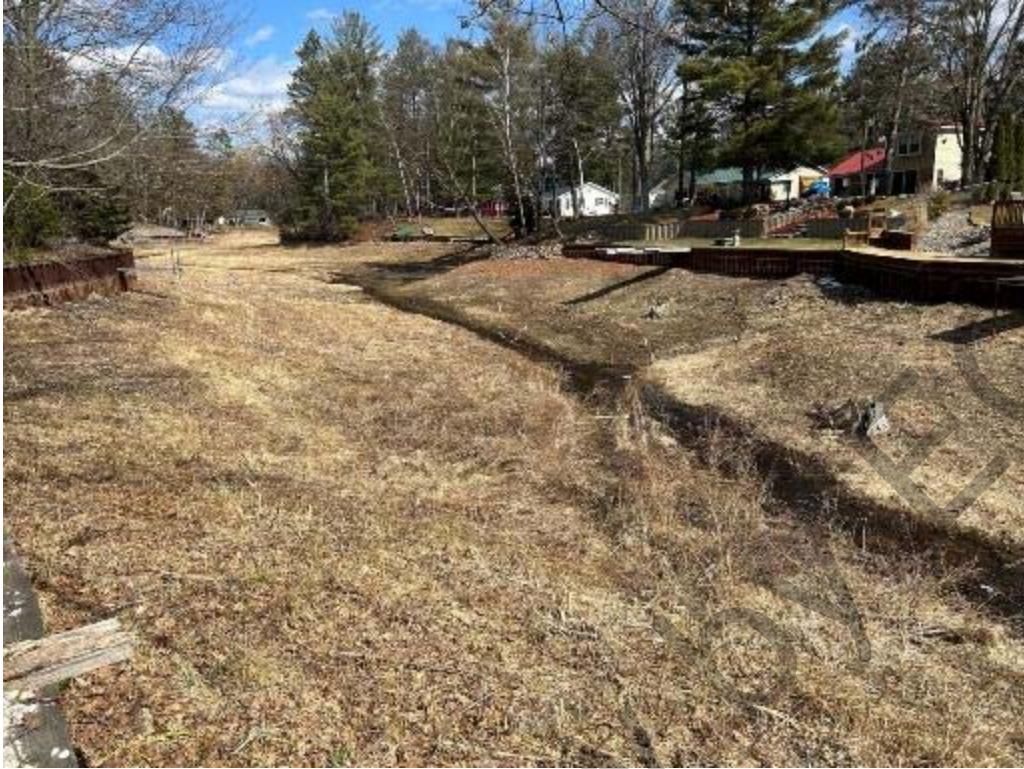
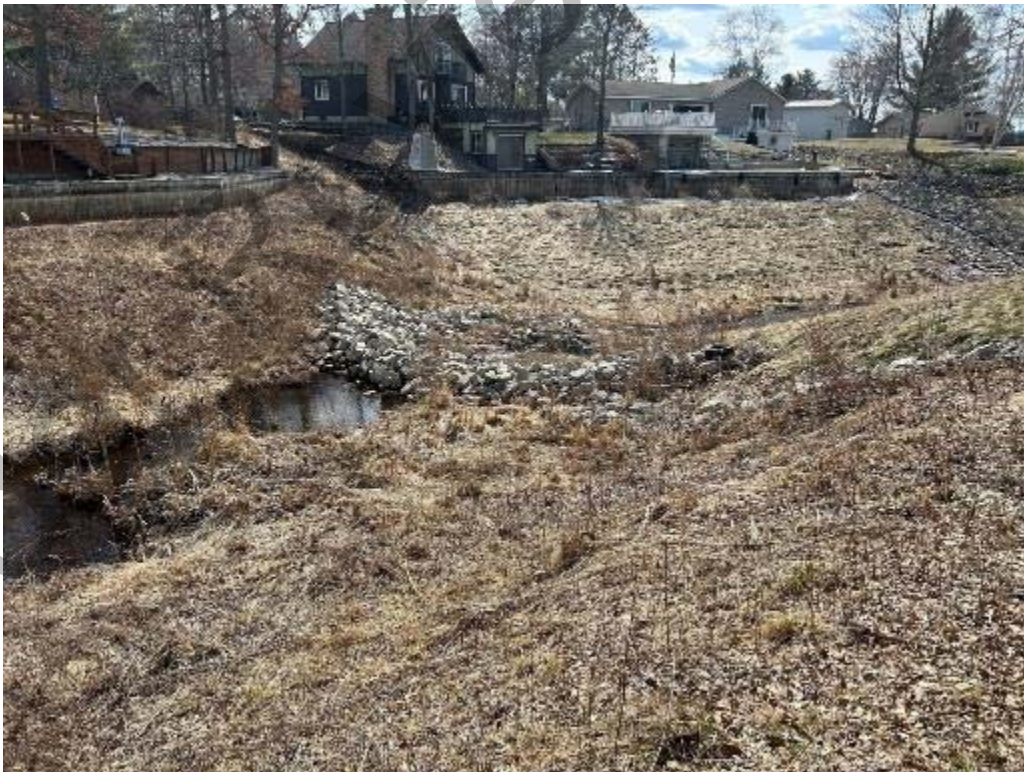
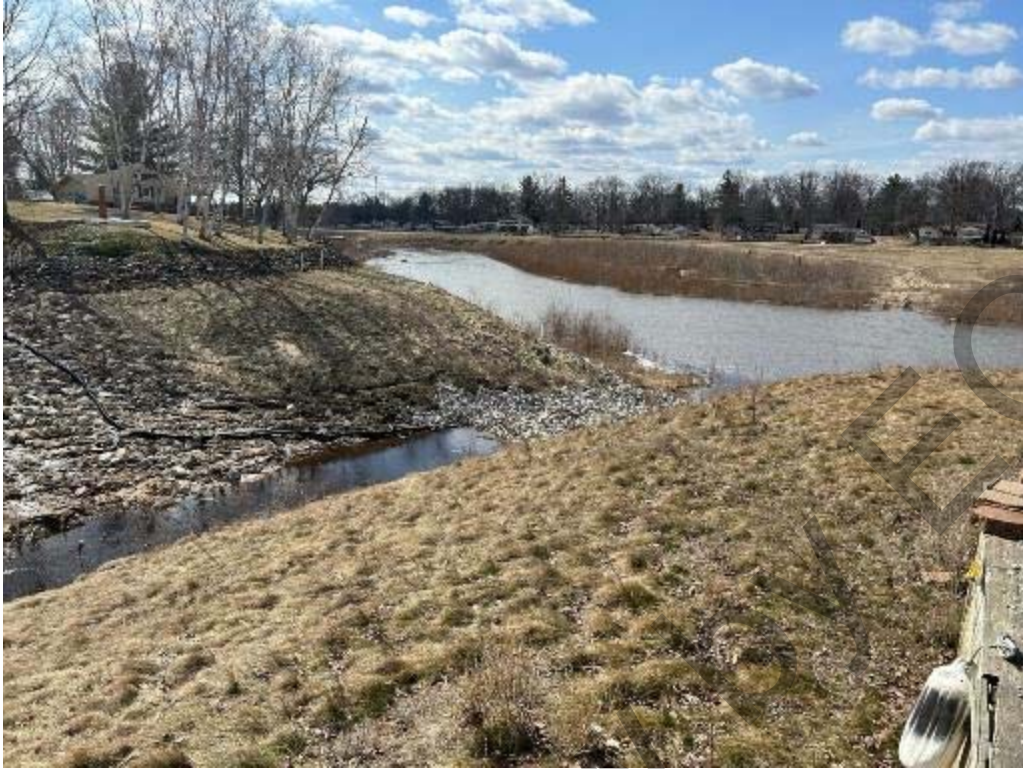
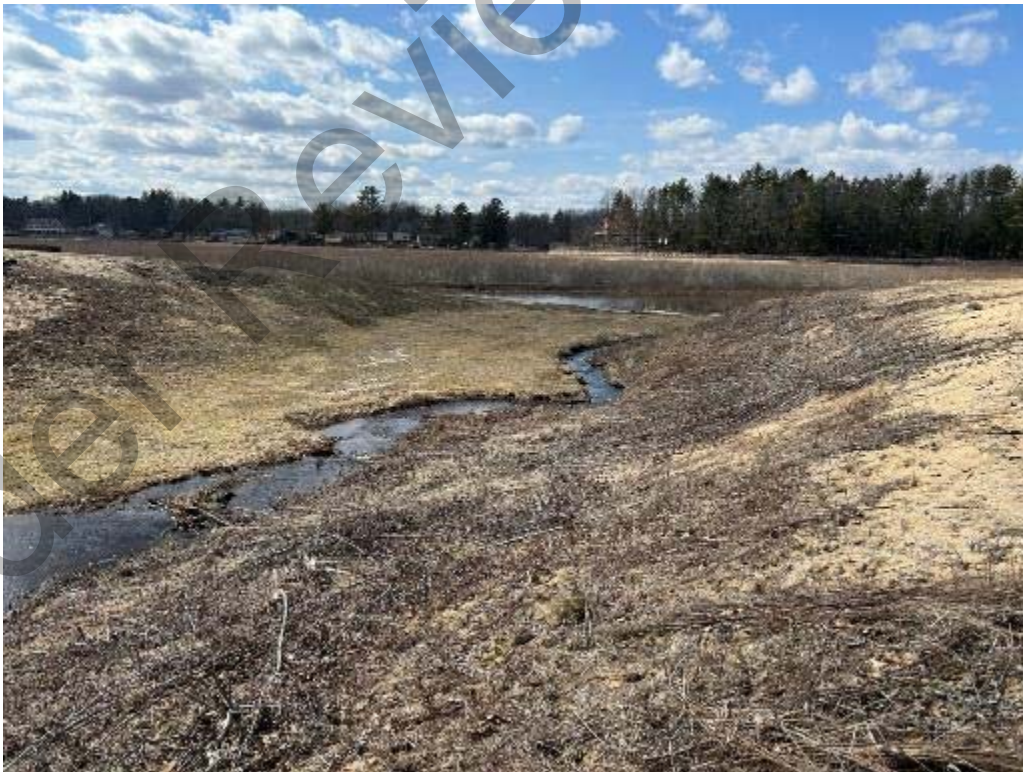
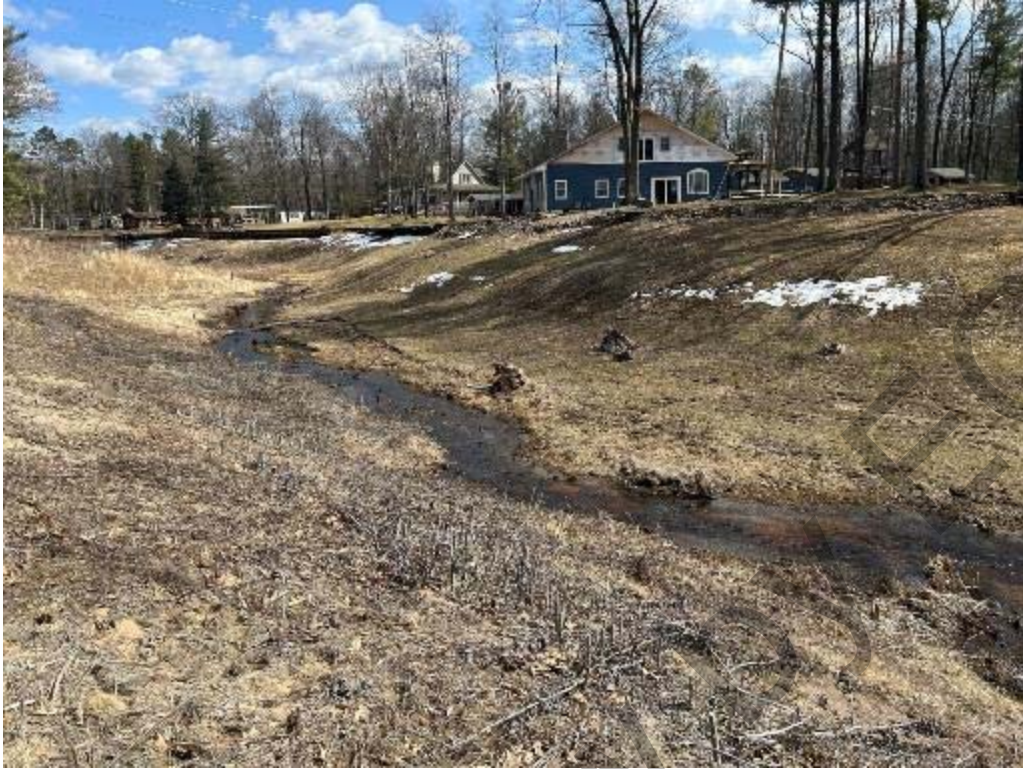
- Site 10: This is a small, intermittent stream that was eroding and headcutting until FLTF installed rock grade control structures to stabilize the channel. The culvert at Charlebois Drive is perched approximately six inches.

Site 10 – Looking downstream at rock grade control.

Site 10 – Looking downstream at rock grade control and Tittabawassee River.

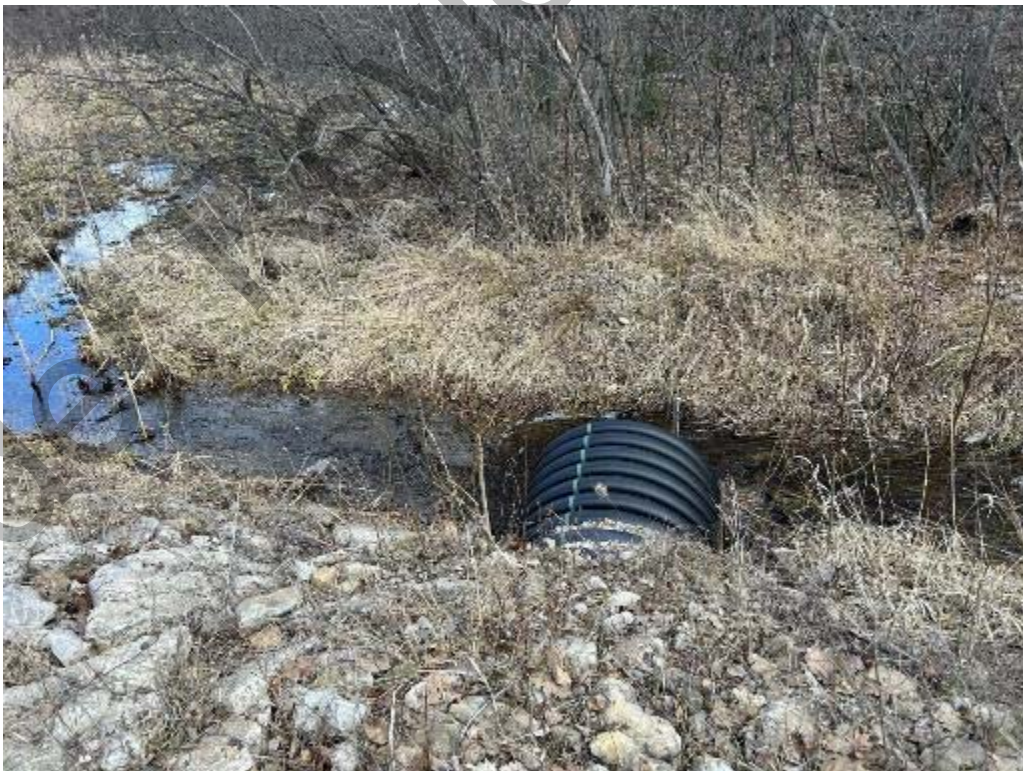
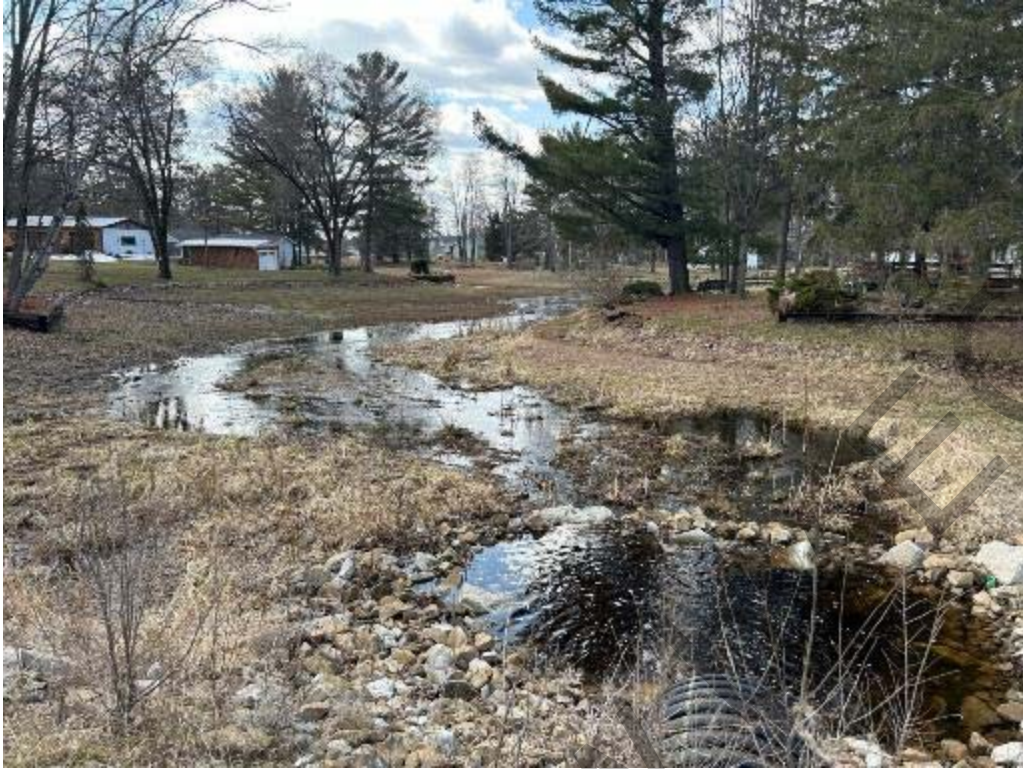
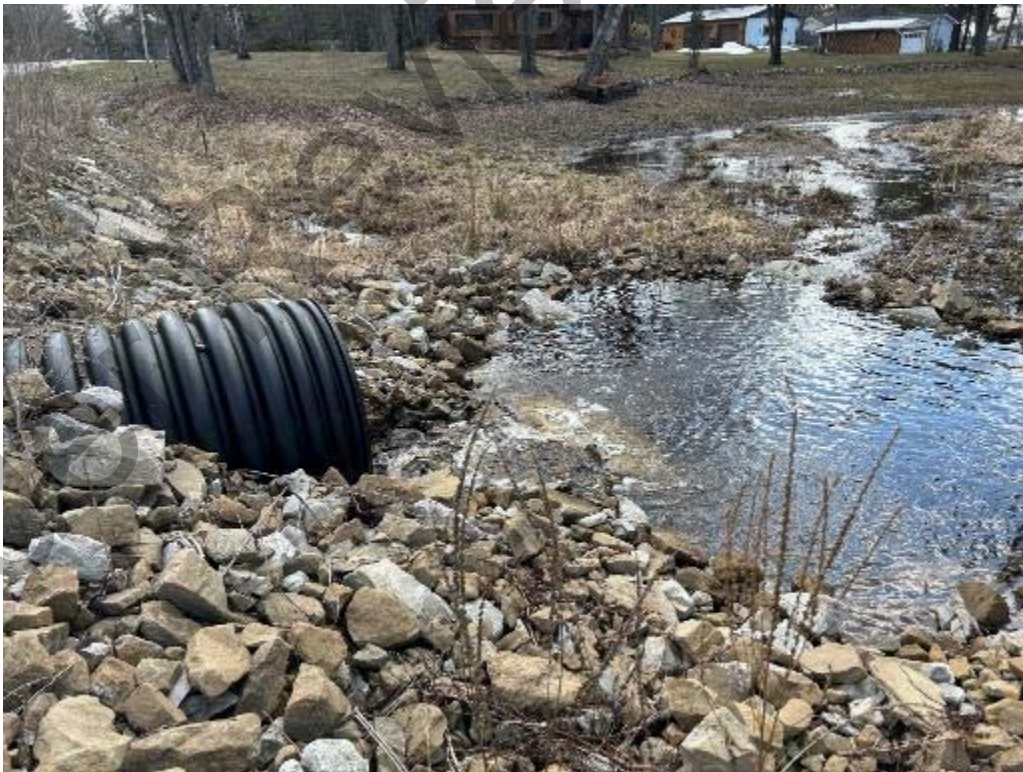
- Site 12: This is a small, intermittent stream with a perched culvert at the first upstream crossing, Poplar Drive. The channel has adjusted to the landscape but offers little ecological value.

Site 12 – Upstream end of culvert under Poplar Dr.

Site 12 – Downstream end of culvert beneath Poplar Dr.

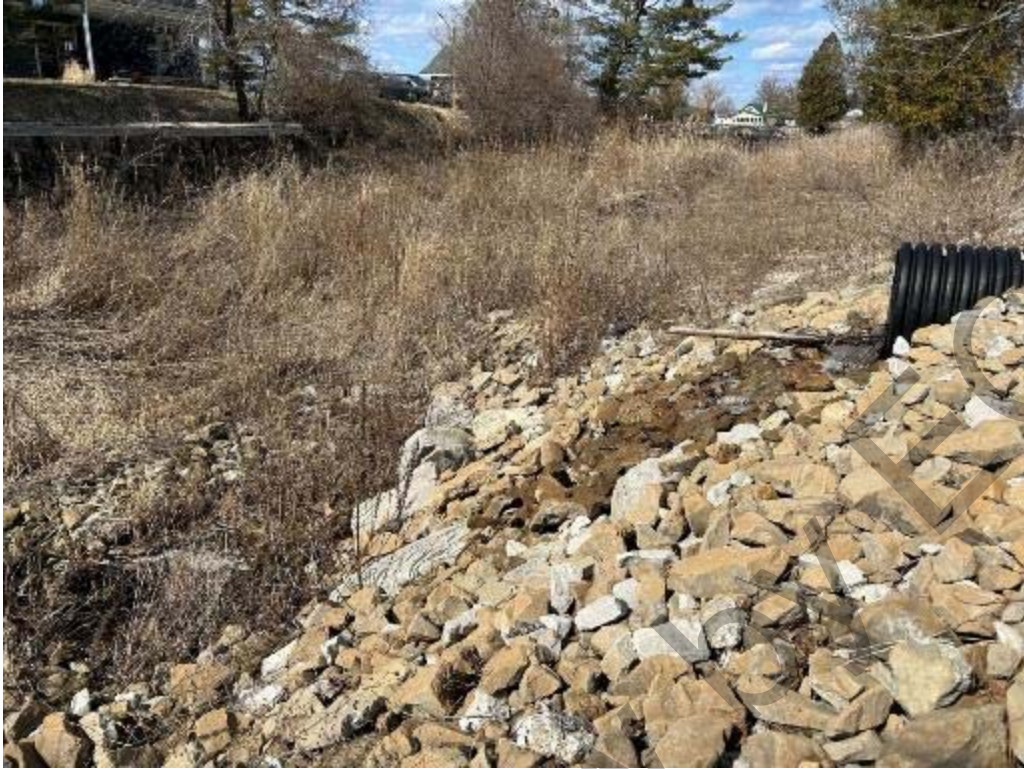
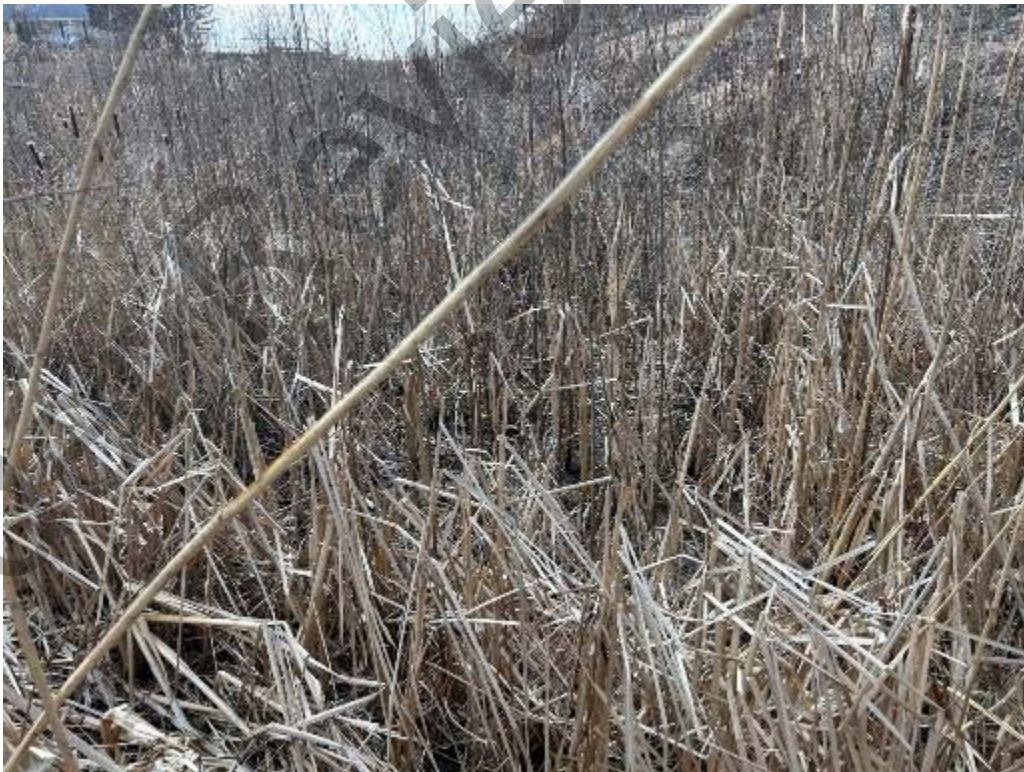
- Site 13: This small, intermittent stream passes between wetland areas. The culvert at Middle Road is perched about one foot; Middle Road acts as a dam and backs up a small pond measuring about 2.5 acres in surface area.

Site 13 – Downstream end of culvert beneath Middle Rd.

Site 13 – Stream channel disappears into wetland.

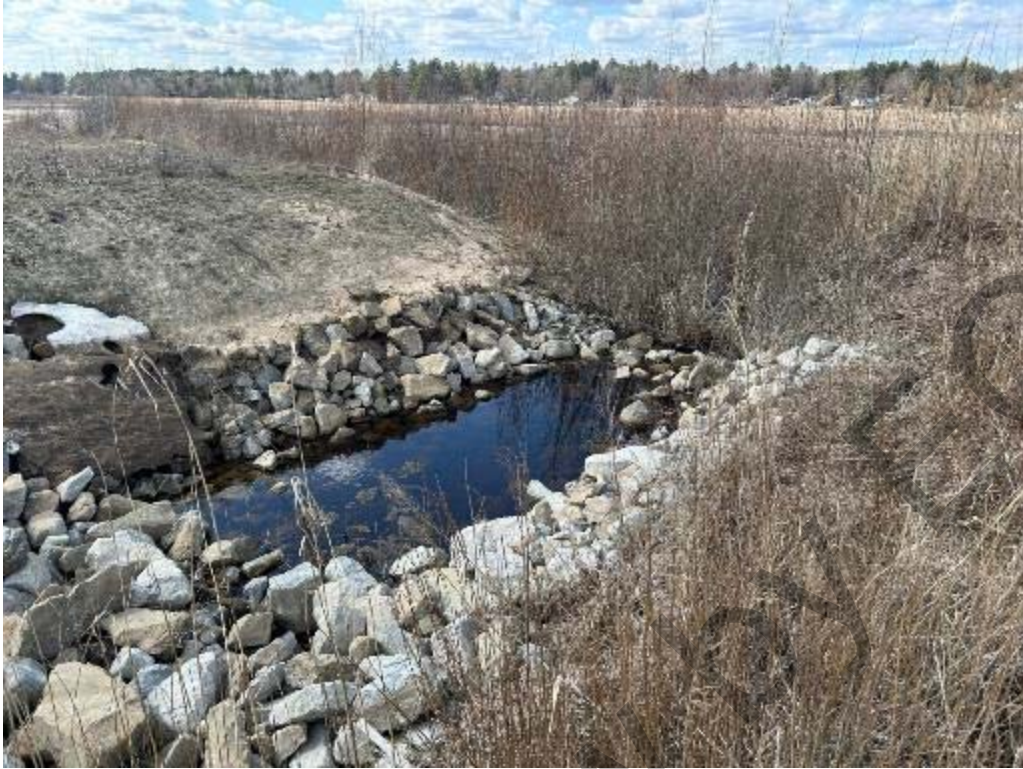
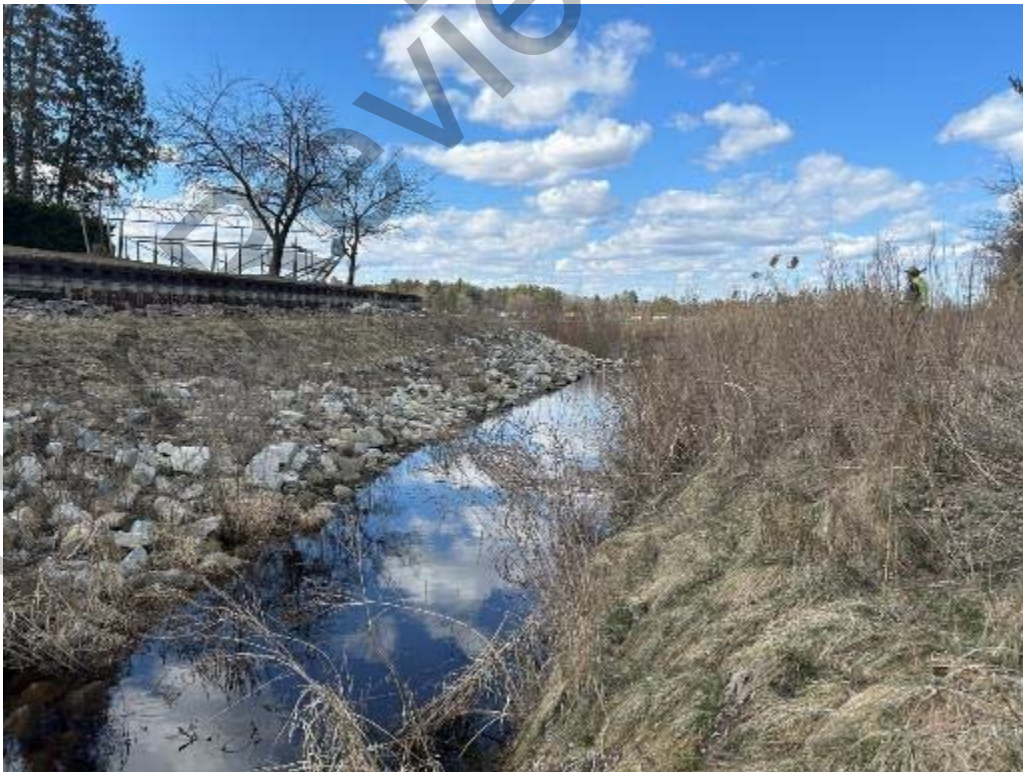
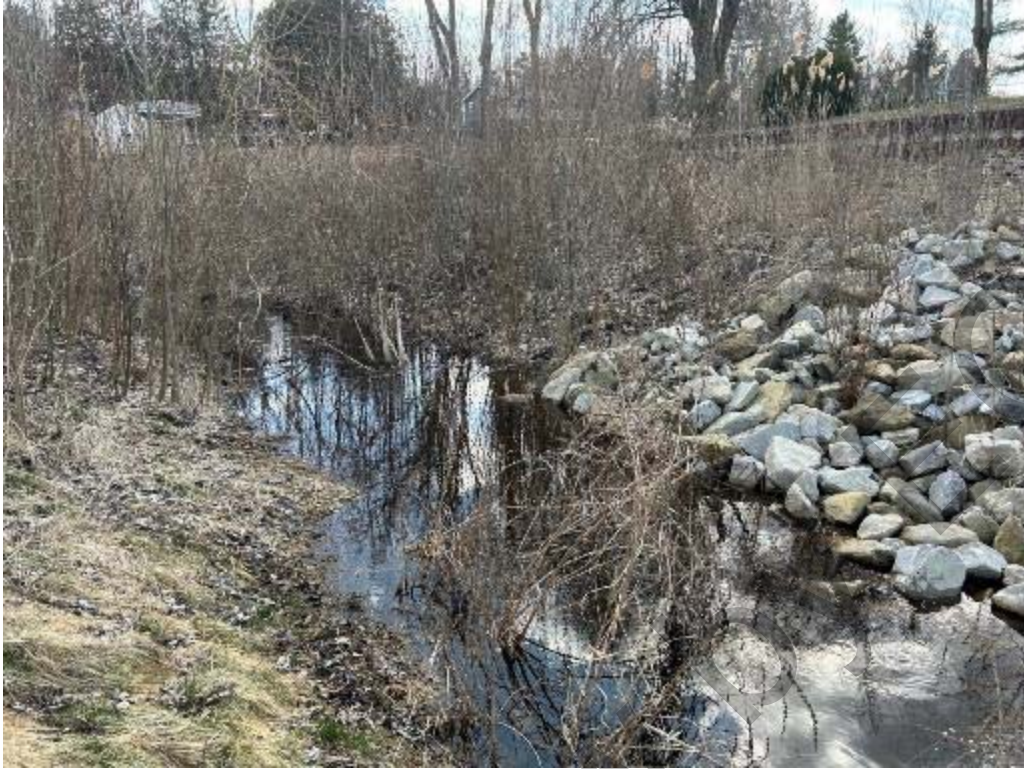
- Site 14: This is an intermittent channel with a completely dry streambed during the summer inspection. The channel was flowing near bankfull in March of 2023. A rock grade control structure was constructed by FLTF to reduce the amount of erosion that was occurring during high flows.

Site 14 – Looking downstream toward Tittabawassee River.

Site 14 – Looking downstream toward grade control.

Site 14 – Looking upstream from grade control.

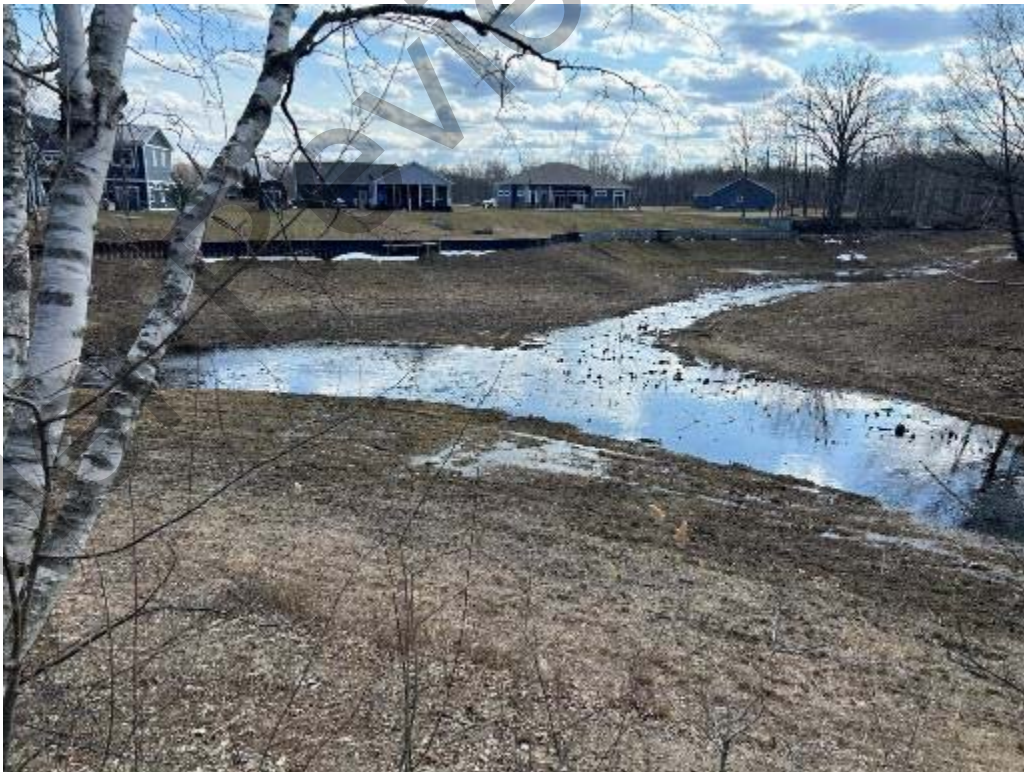
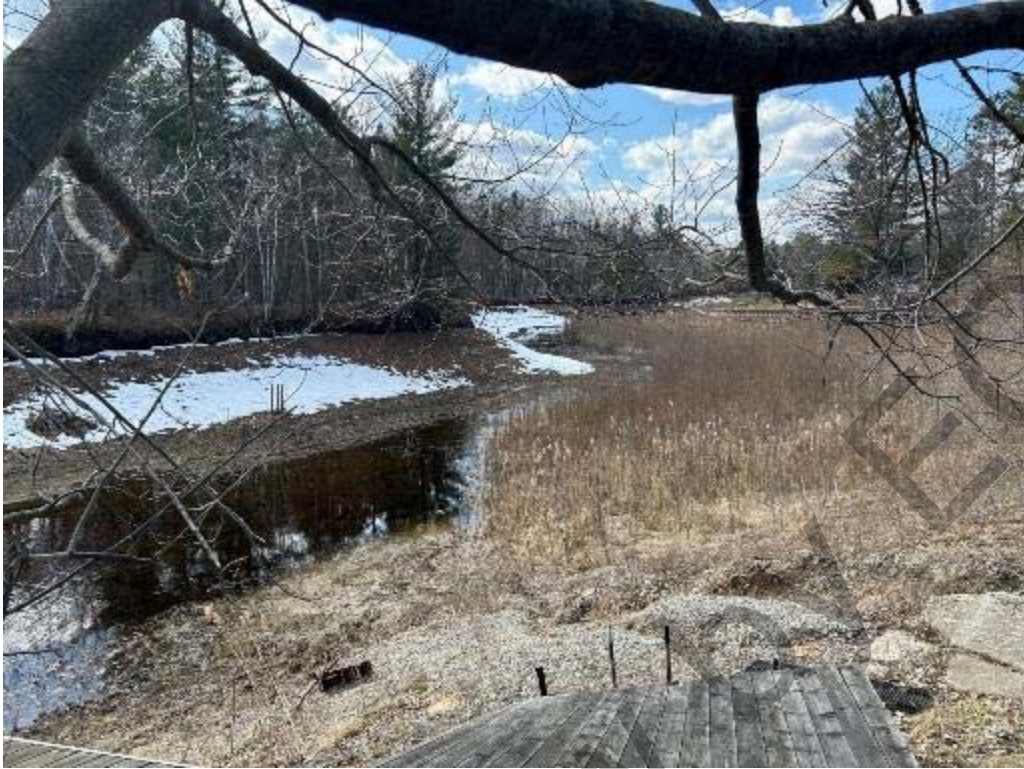
- Site 15: This site consists of an intermittent main channel fed by three smaller, intermittent tributaries that merge near Narraganet Drive. The channel alternates between reaches that are narrow and deep and others that are wide and shallow; adjustment is still ongoing. The streambed was almost completely dry during summer inspections but the plunge pool beneath the perched culvert at Middle Road contained painted and common musk turtles and a blue heron (presumably hunting fish).

Site 15 – View upstream from Oswegathie Lane.

Site 15 – Looking downstream from Oswegathie Lane.

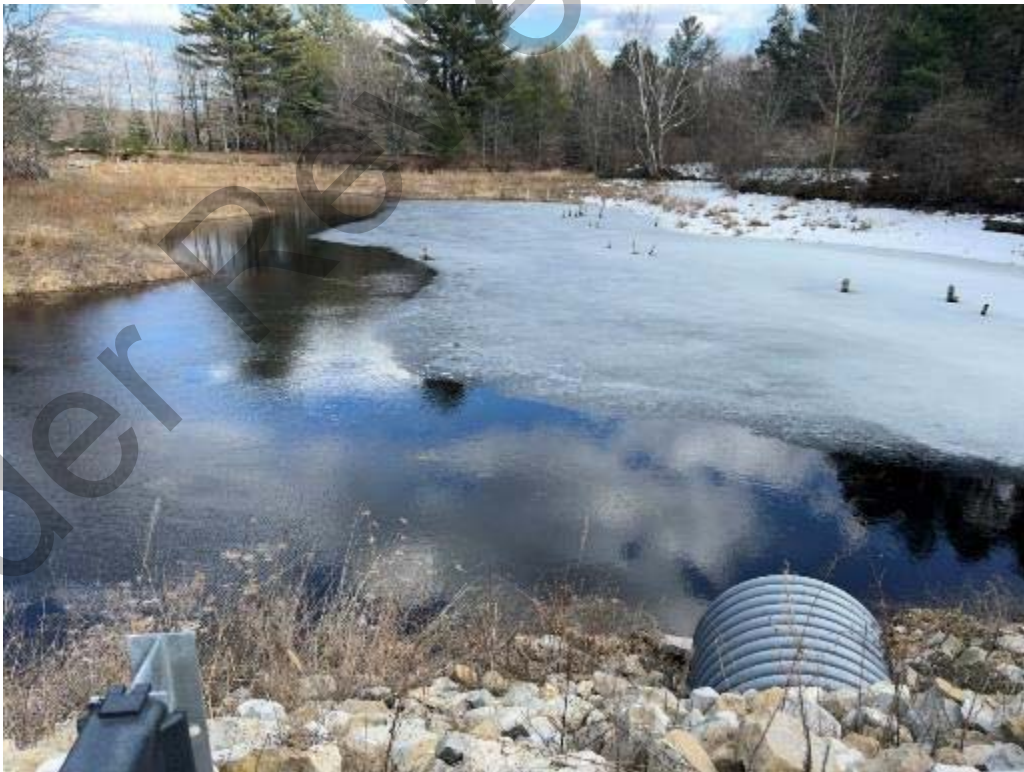
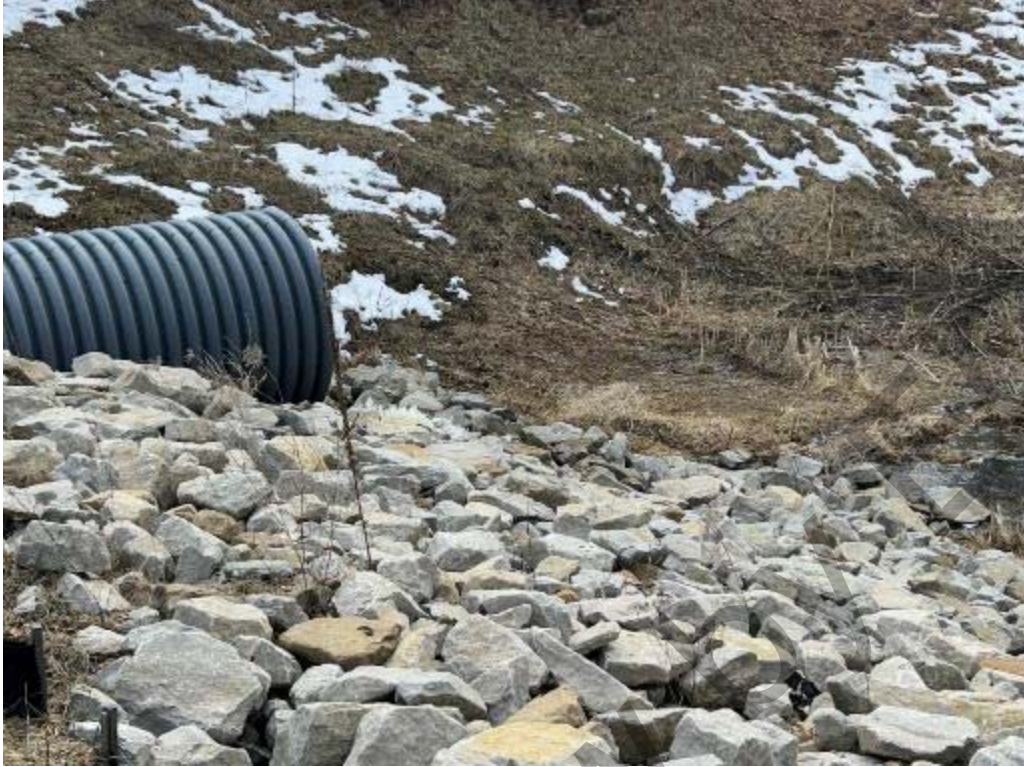
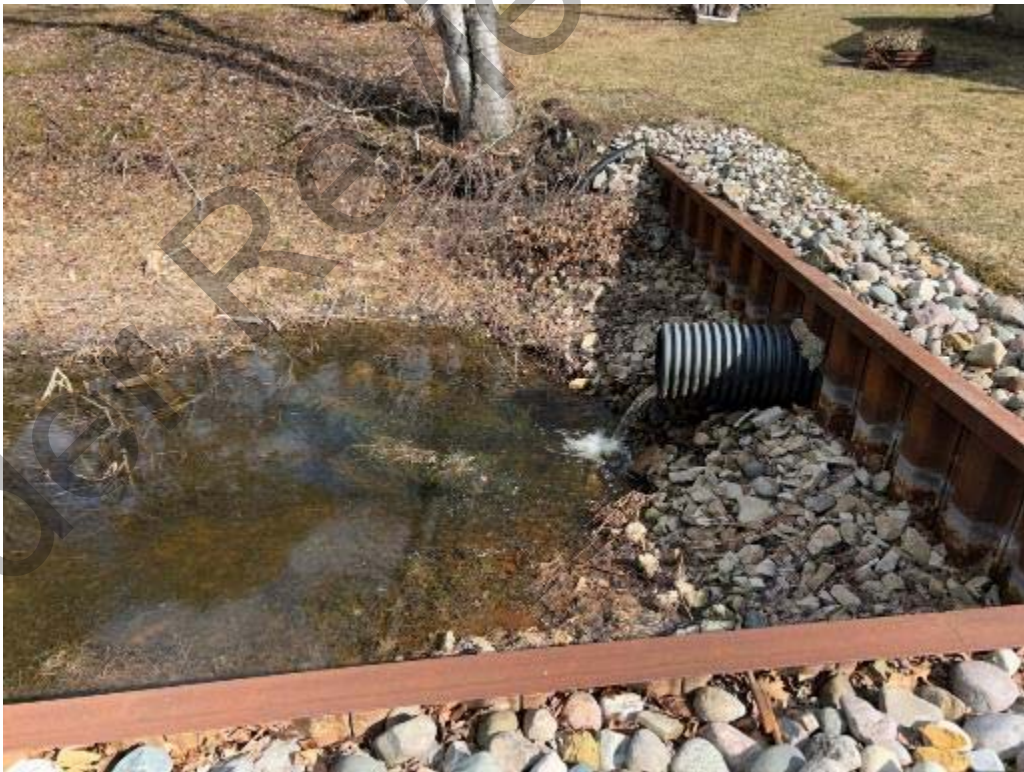
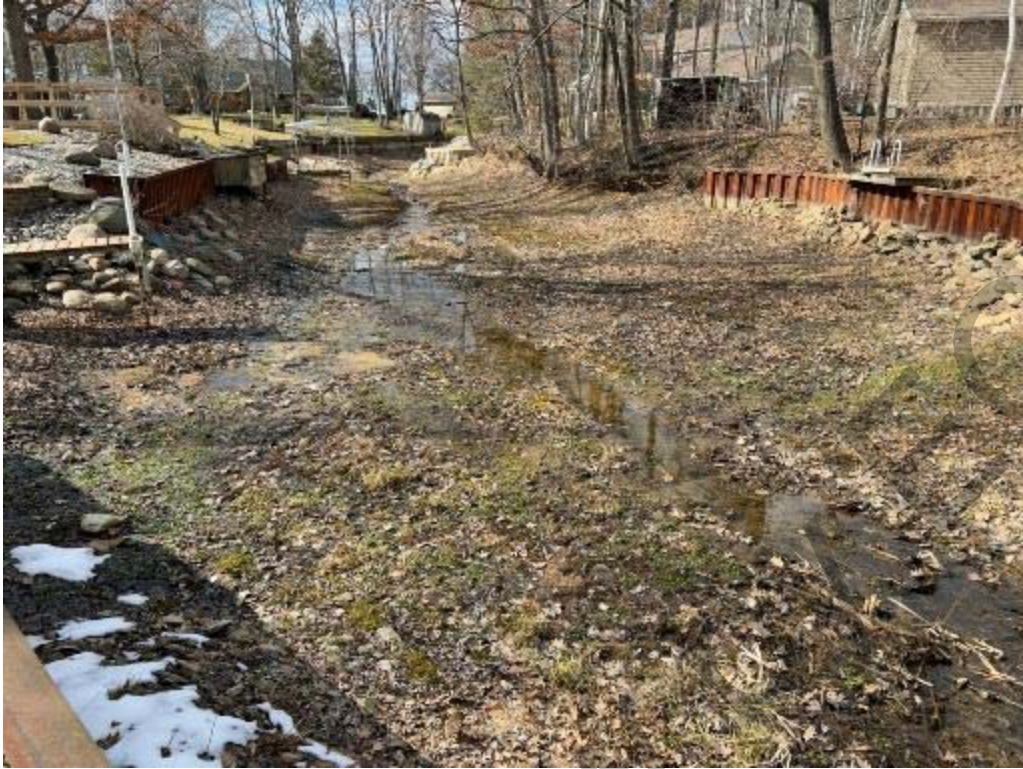
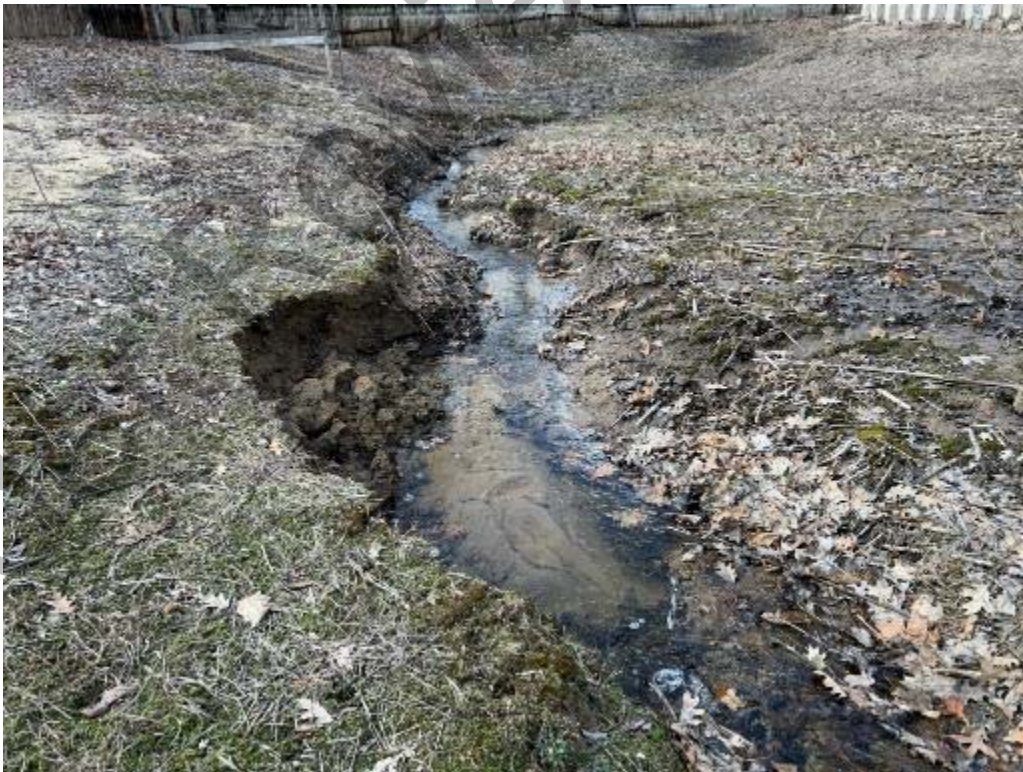
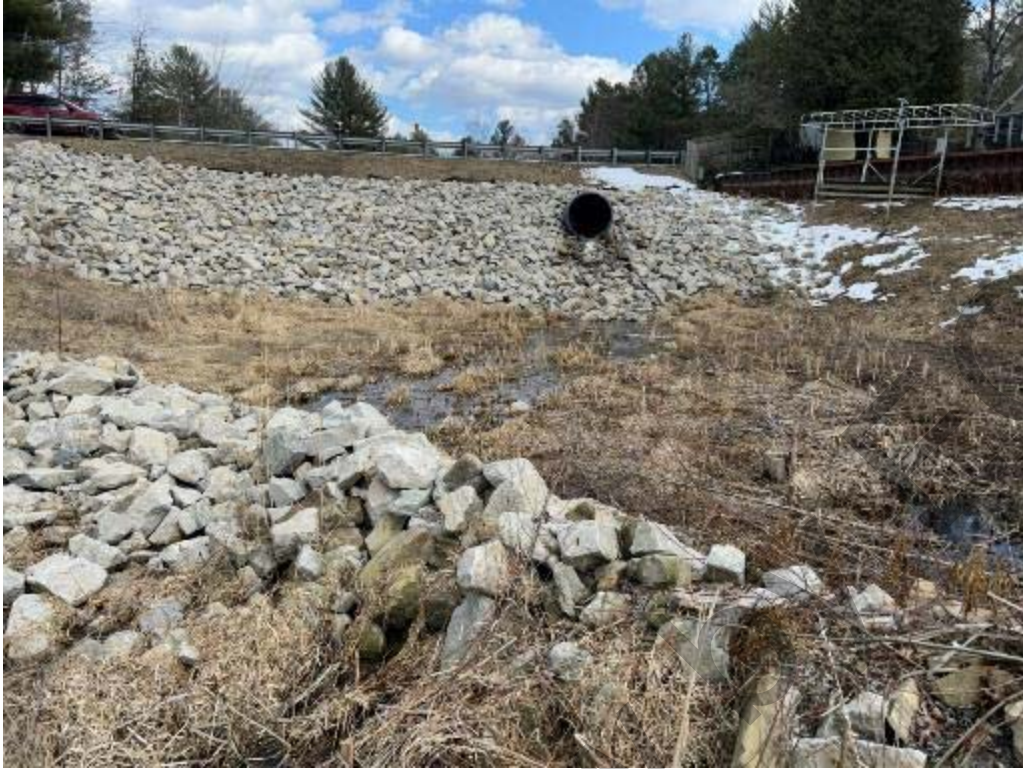
- Site 16 (Fowley Drain): The Fowley Drain is intermittent and the reach downstream of E. Lakeshore Drive was completely dry during the summer inspection. The culvert is perched and impounds a small pond on the upstream side. At full pool, the pond would be separated from the lake by the culvert, but aquatic organisms would pass freely through the culvert. On the upstream end of the pond, additional stream channel was exposed after the dam failure.

Site 16 – Culvert on downstream side of E. Lakeshore Dr.

Site 16 – Southern culvert on E. Lakeshore Dr.

Site 16 – Bank erosion.

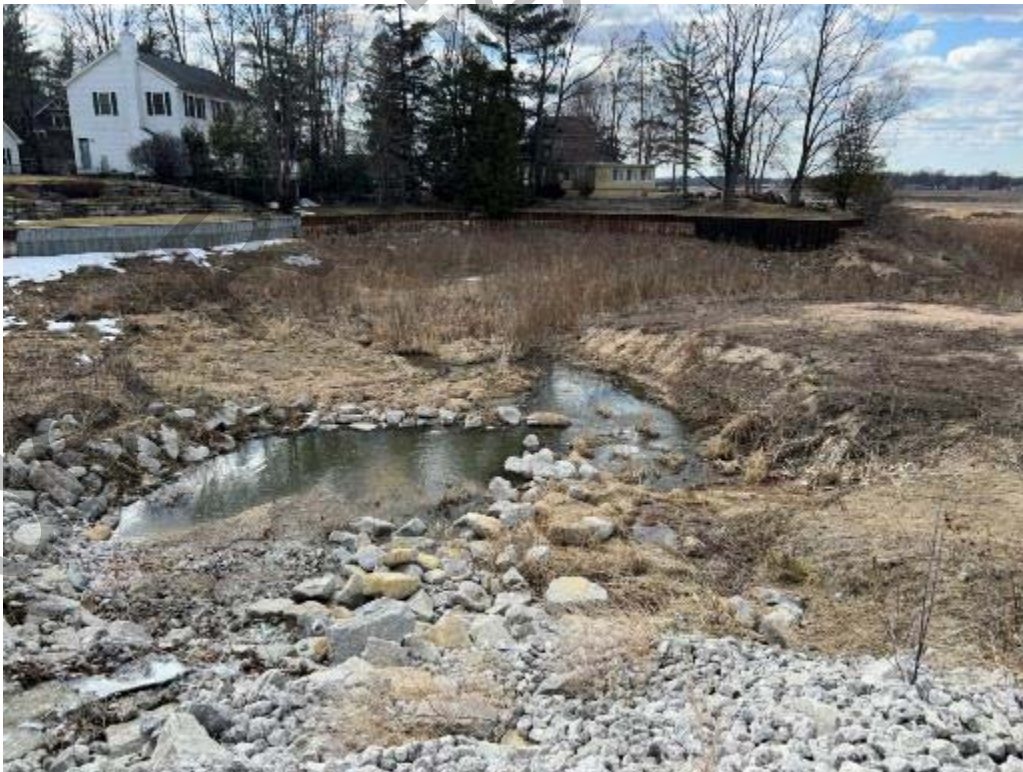
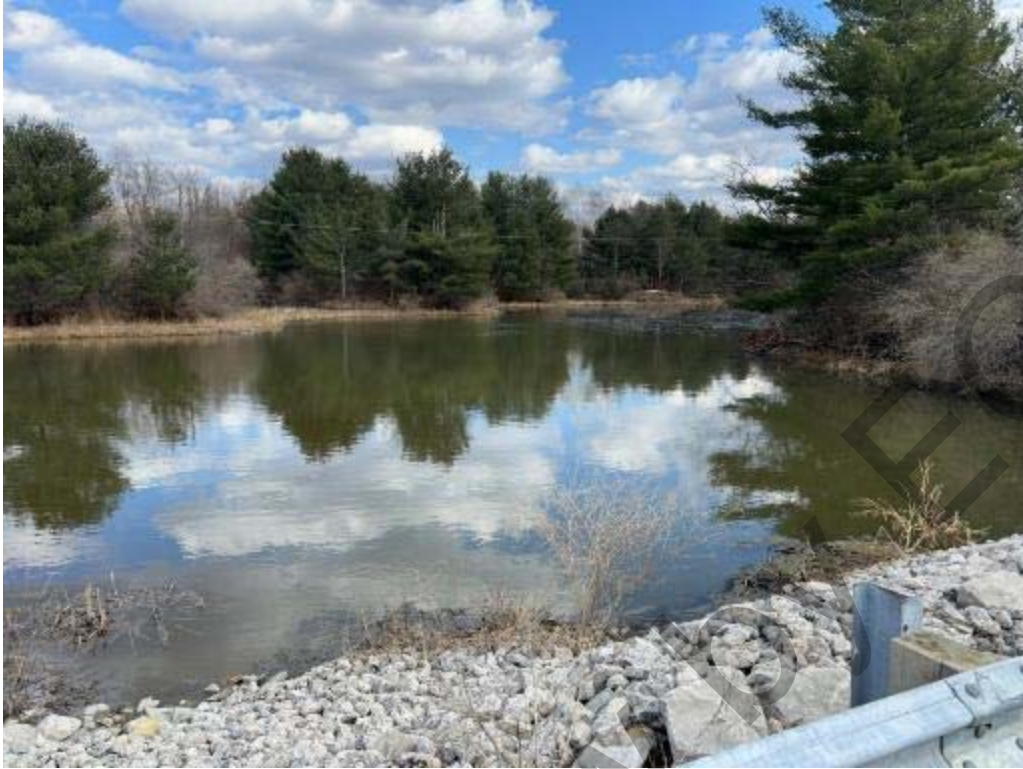
- Site 17: Similar to Site 16, the stream reach downstream of the road (N. Meridian) is dry and intermittent, while the road creates a pond on the upstream side of the crossing. This site has a culvert that is perched about ten feet.

Site 17 – Looking downstream from N. Meridian Rd.

Site 17 – Looking upstream from N. Meridian Rd.
