**EDENVILLE DAM PERMIT APPLICATION  
- STREAM IMPACTS AND PROPOSED OFFSETTING PROJECTS -**

**APPENDIX B - IMPACTED STREAM SITE PHOTOS FOR WIXOM LAKE**

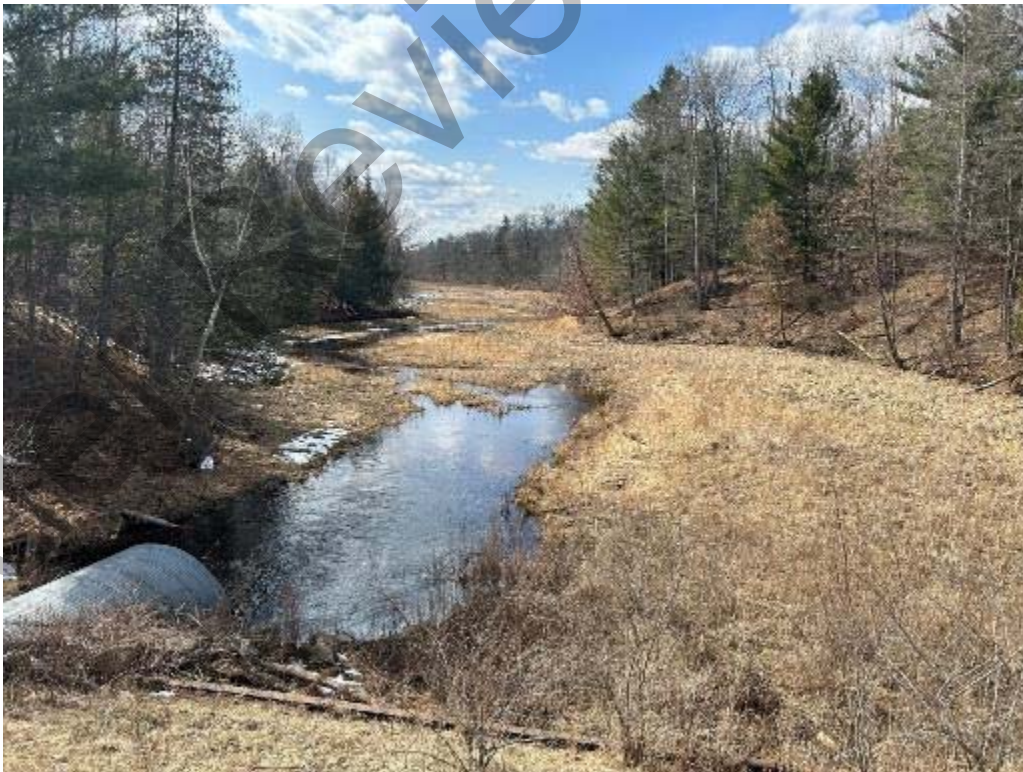
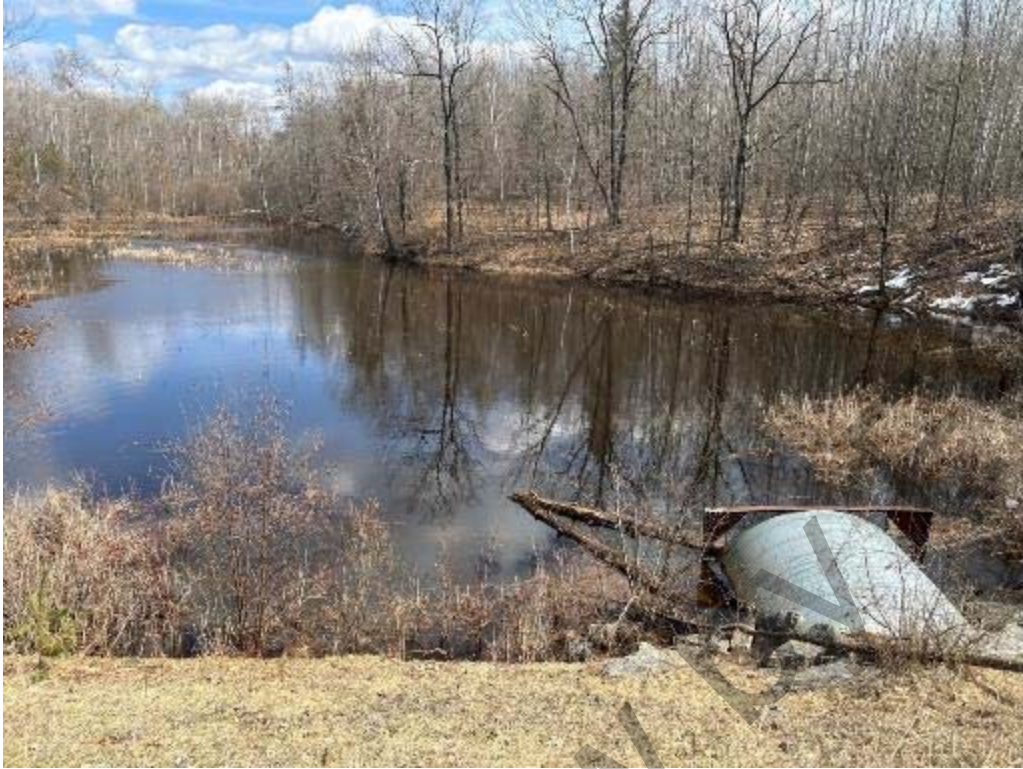
- Site 18 (Guernsey Creek): Guernsey Creek is only about one foot wide, with a dry, intermittent channel bisecting a floodplain during summer inspection. Common carp were stranded in a plunge pool beneath the culvert at Whitney Beach Road.

Site 18 – Looking downstream from Jones Rd.

Site 18 – Looking upstream from Jones Rd.

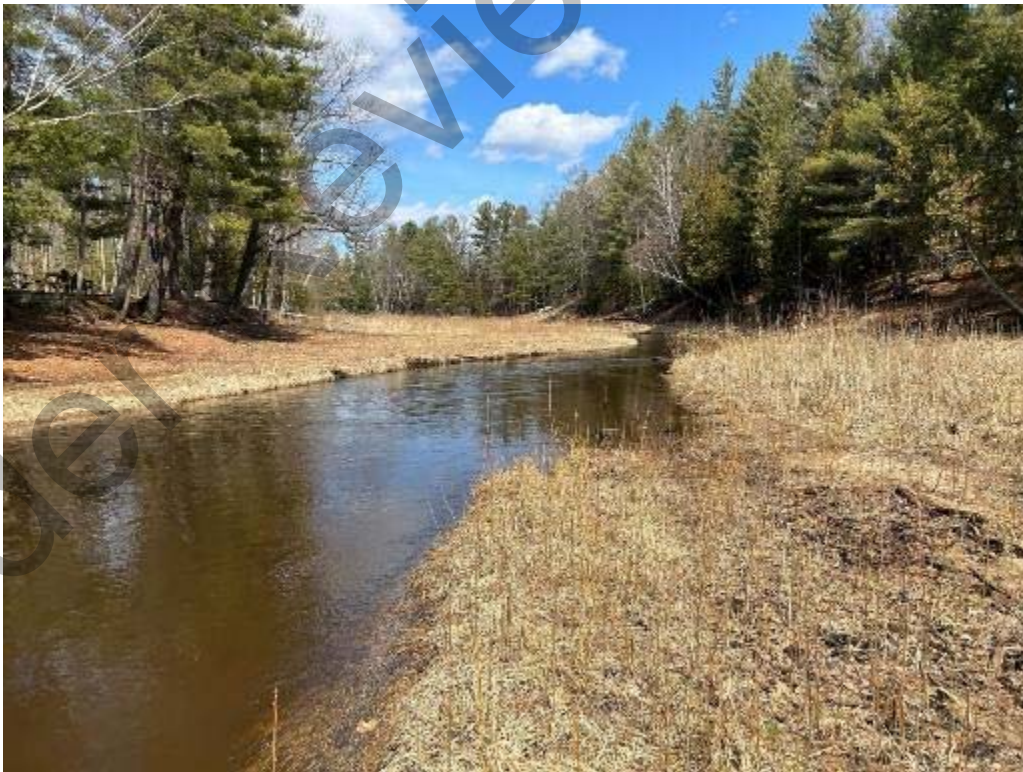
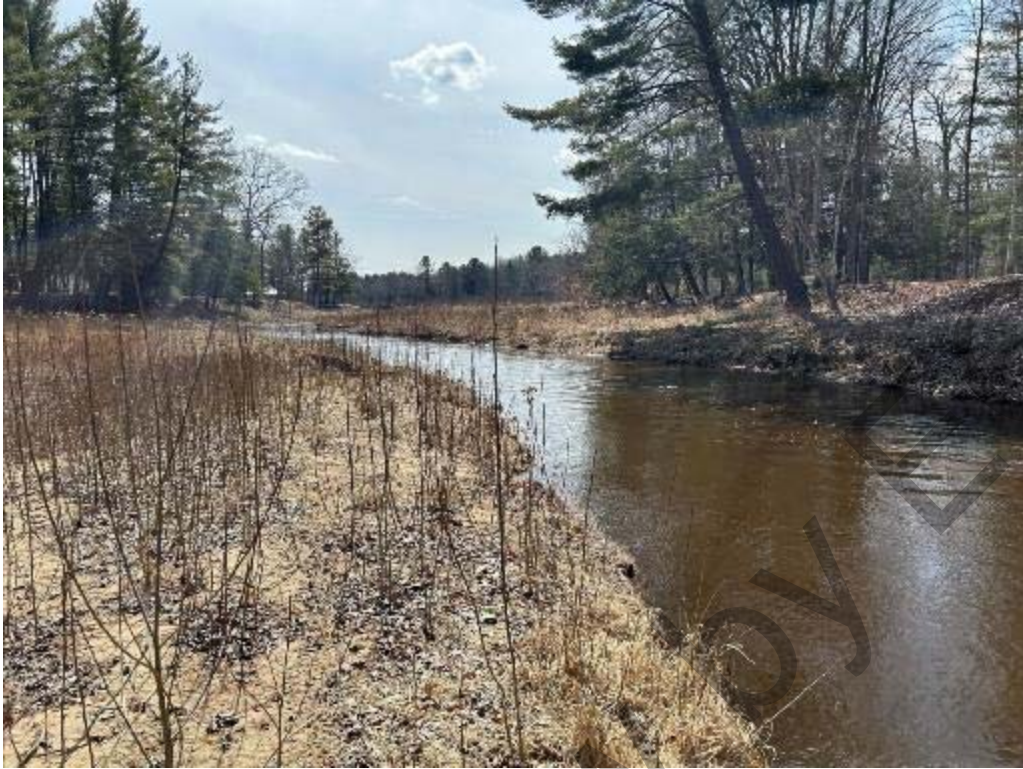
Site 19, Molasses River, is the most substantial tributary to Wixom Lake, in terms of volume of flow and stream function. Presently, the bed is dominated by shifting sand and the water depth is mostly uniform with no natural riffle, run, or pool sequencing. However, the channel has mostly adjusted to the new landscape, no headcuts or incision were observed, and the floodplain appears to relate approximately to the bankfull discharge. The floodplain has become well-vegetated. Minnows and one live native freshwater mussel were observed during miscellaneous visits to the site.

- Site 19 (Molasses River): As discussed previously, the Molasses River is probably the highest quality tributary to Wixom Lake; it has what appears to be a stable perennial flow, is well-adjusted to the floodplain and has some ecological value within the impacted reach. However, the streambed consists of shifting sand that has not allowed formation of bed features.

Site 19 – Looking upstream.

Site 19 – Looking downstream.

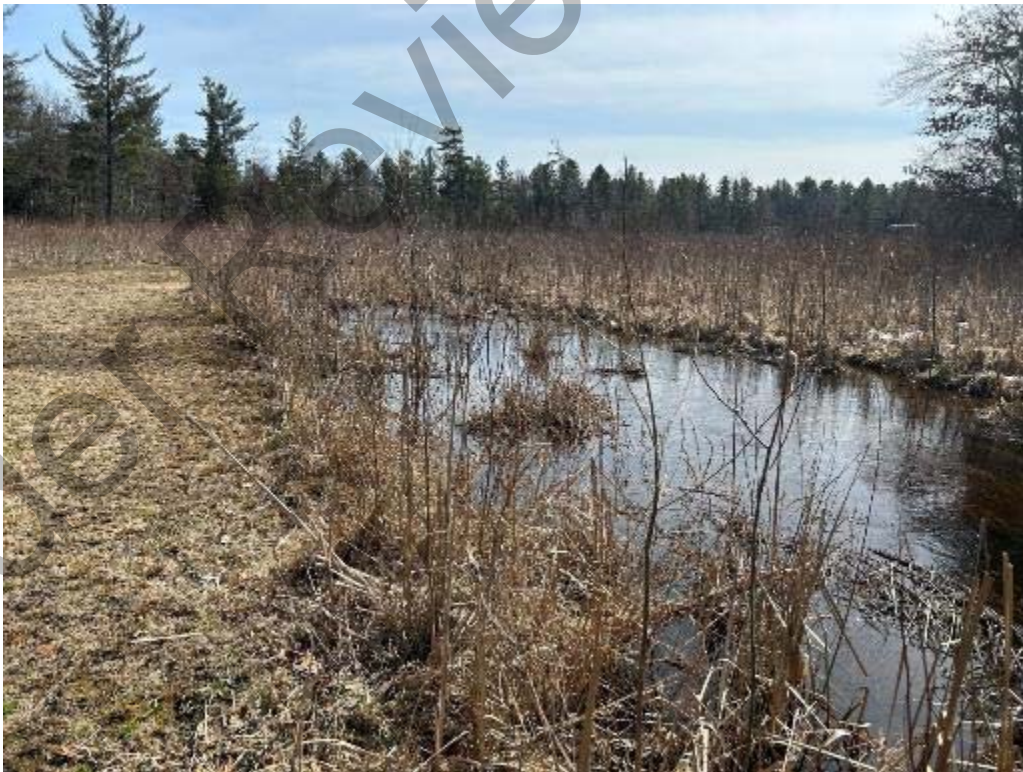
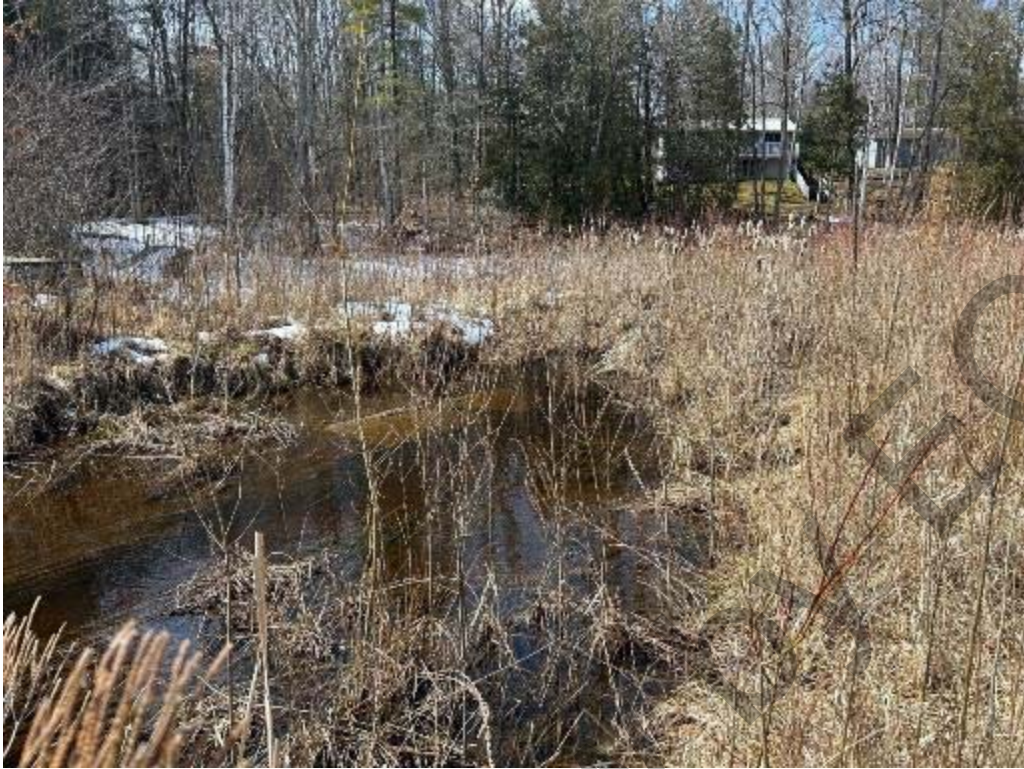
- Site 20 (Robbins Drain): The Robbins Drain is intermittent and contained a completely dry bed (four feet wide and six inches deep) during summer inspection. At high flow, the stream channel is interrupted by wetland areas in which the channel disappears.

Site 20 – Looking downstream near Hay Rd.

Site 20 – Looking upstream near Hay Rd.

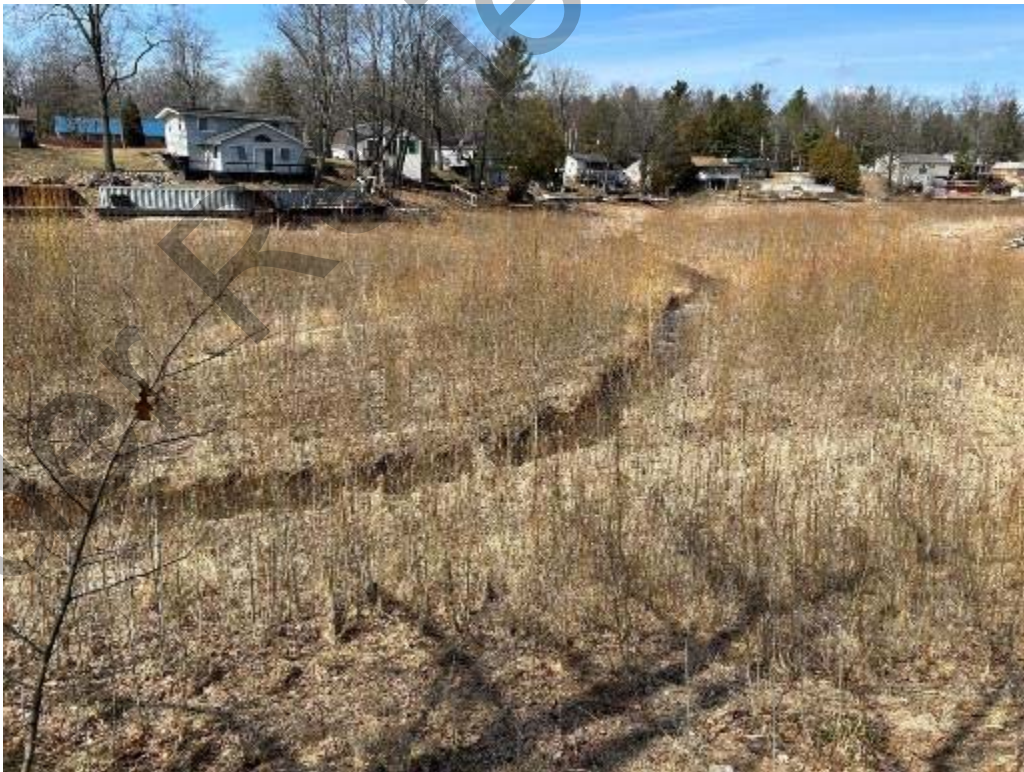
Site 21, Larabee Creek, is a small (5-6 foot wide with discharge estimated to be 2-3 cfs at baseflow) stream that winds through a vegetated floodplain. The stream channel has become well-adjusted to the landscape, though head-cutting is still present in several locations. Common carp and numbers of minnows were observed in the plunge pool on the downstream side of E. Pointe Drive.

- Site 21 (Larabee Creek): Larabee Creek is perennial, with an estimated baseflow of two-three cfs. Upstream of E. Pointe Drive, the channel is stable and aesthetically appealing. Common carp and minnows were observed in the stream.

Site 21 – View from E. Pointe Dr.

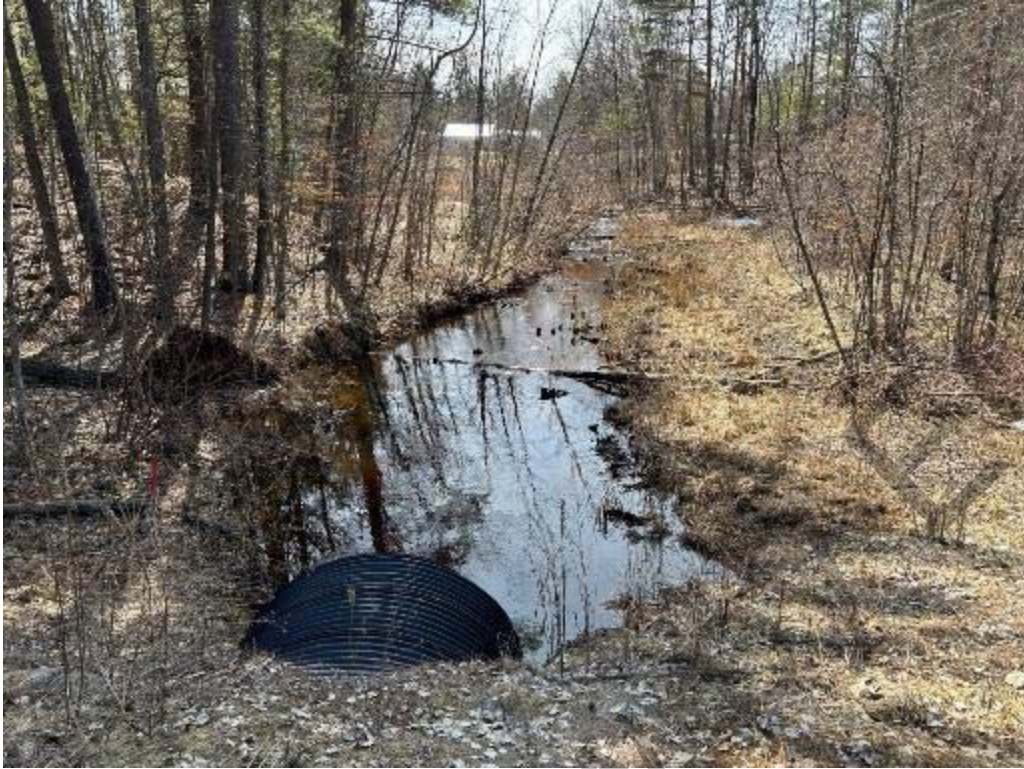
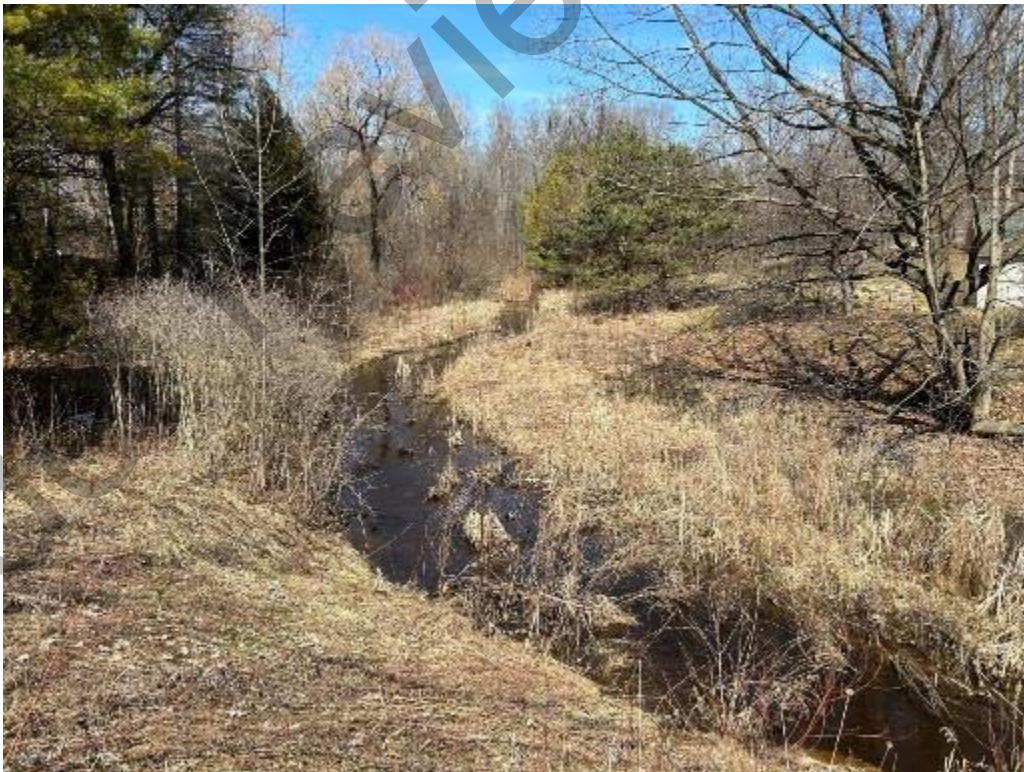
- Site 22: This is an intermittent stream that contained standing pools of water during summer inspection. The adjacent landowner suggested, anecdotally, that a large volume of sediment washed down the valley and significantly changed the function of the stream. There is no doubt that the function is severely compromised.

Site 22 – Looking downstream from Burling Rd.

Site 22 – Looking upstream from Burling Rd.
