Technical Memorandum

Introduction and Project Background

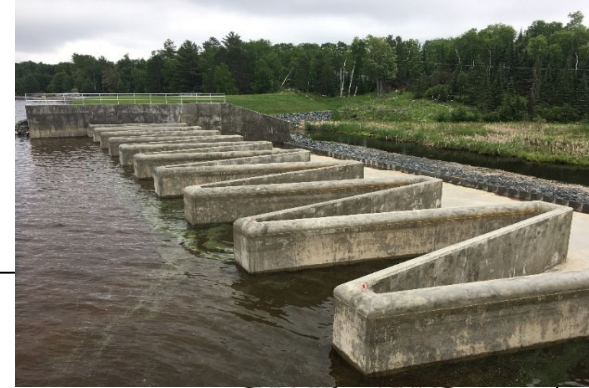
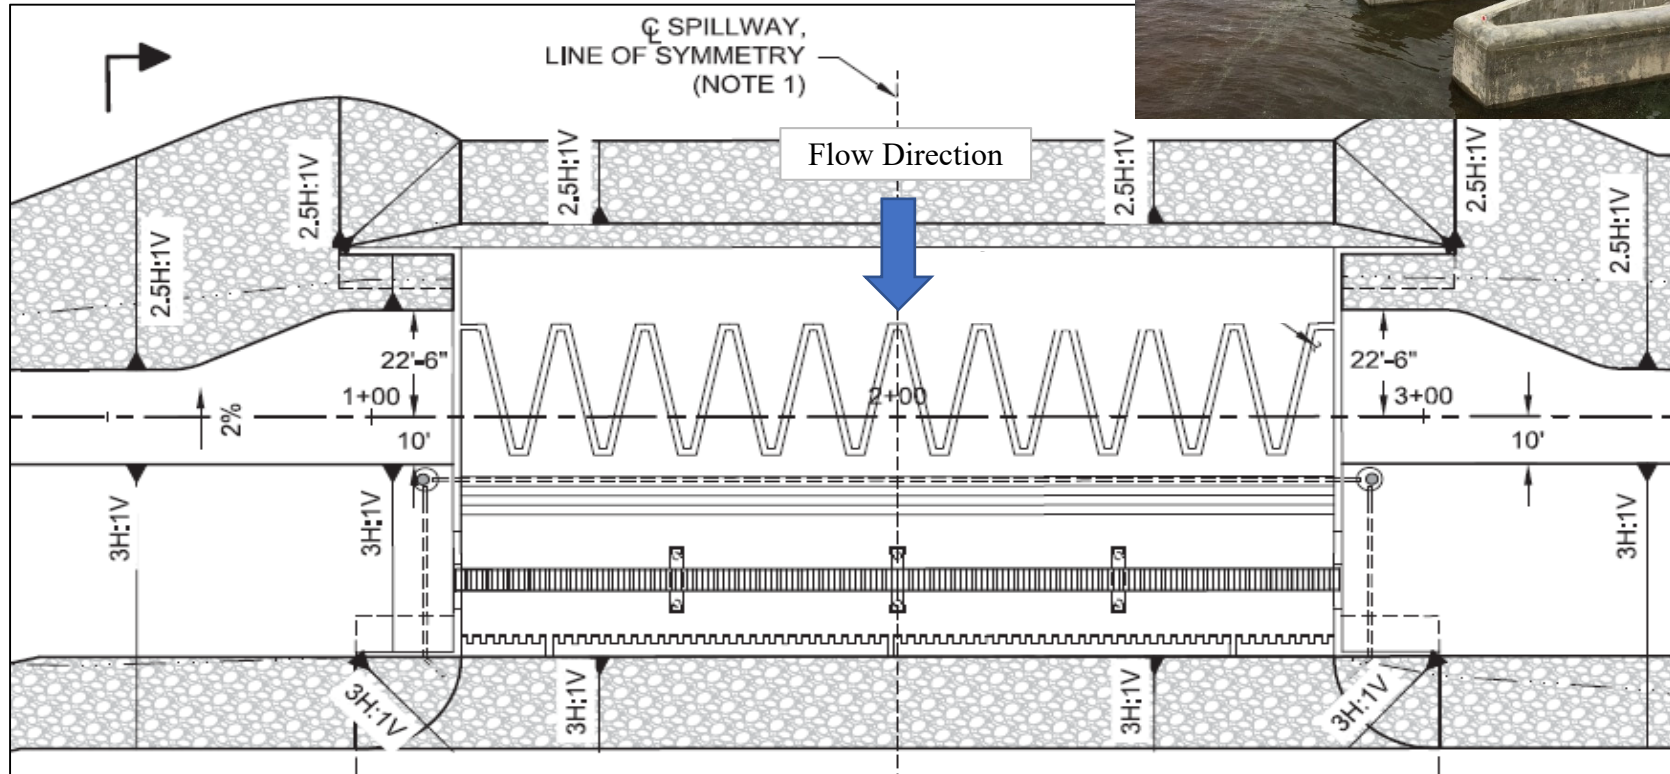
Post Failure Reconstruction Cost Analysis
 Client: Four Lake Task Force (FLTF)
 Location: Midland, Michigan

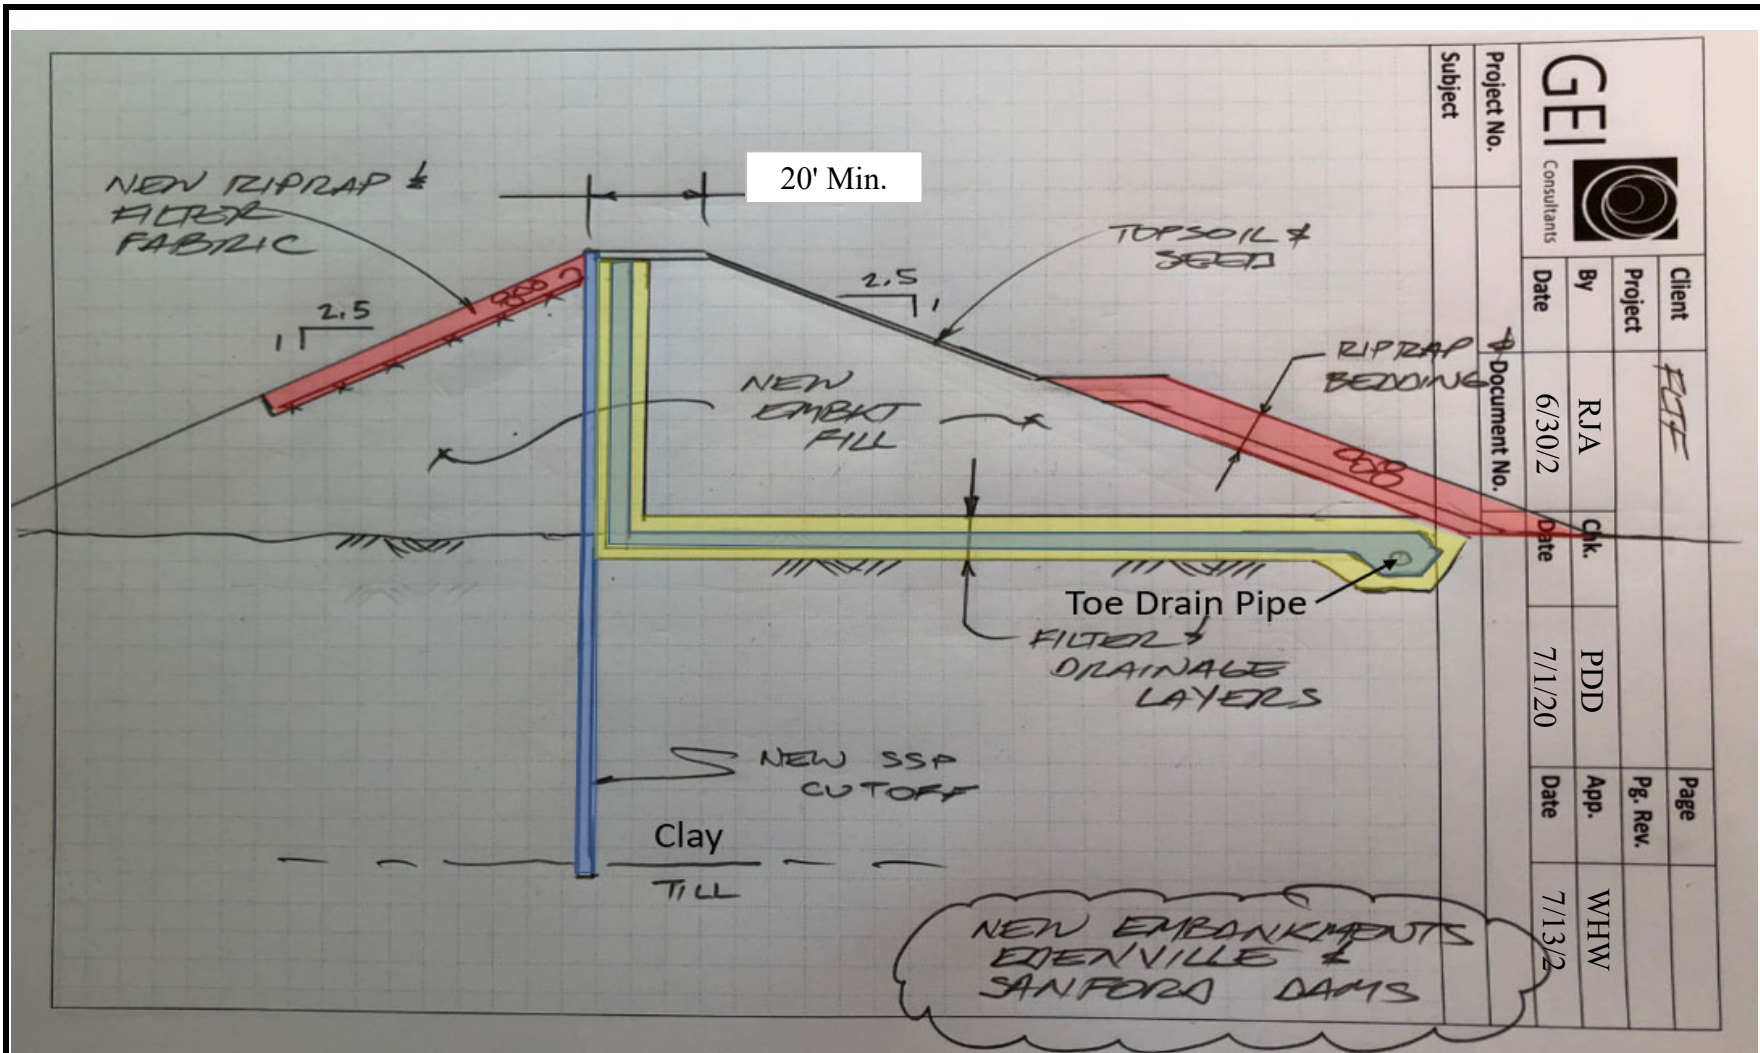
Post Failure Reconstruction Cost Analysis
 Client: Four Lake Task Force (FLTF)
 Location: Midland, Michigan

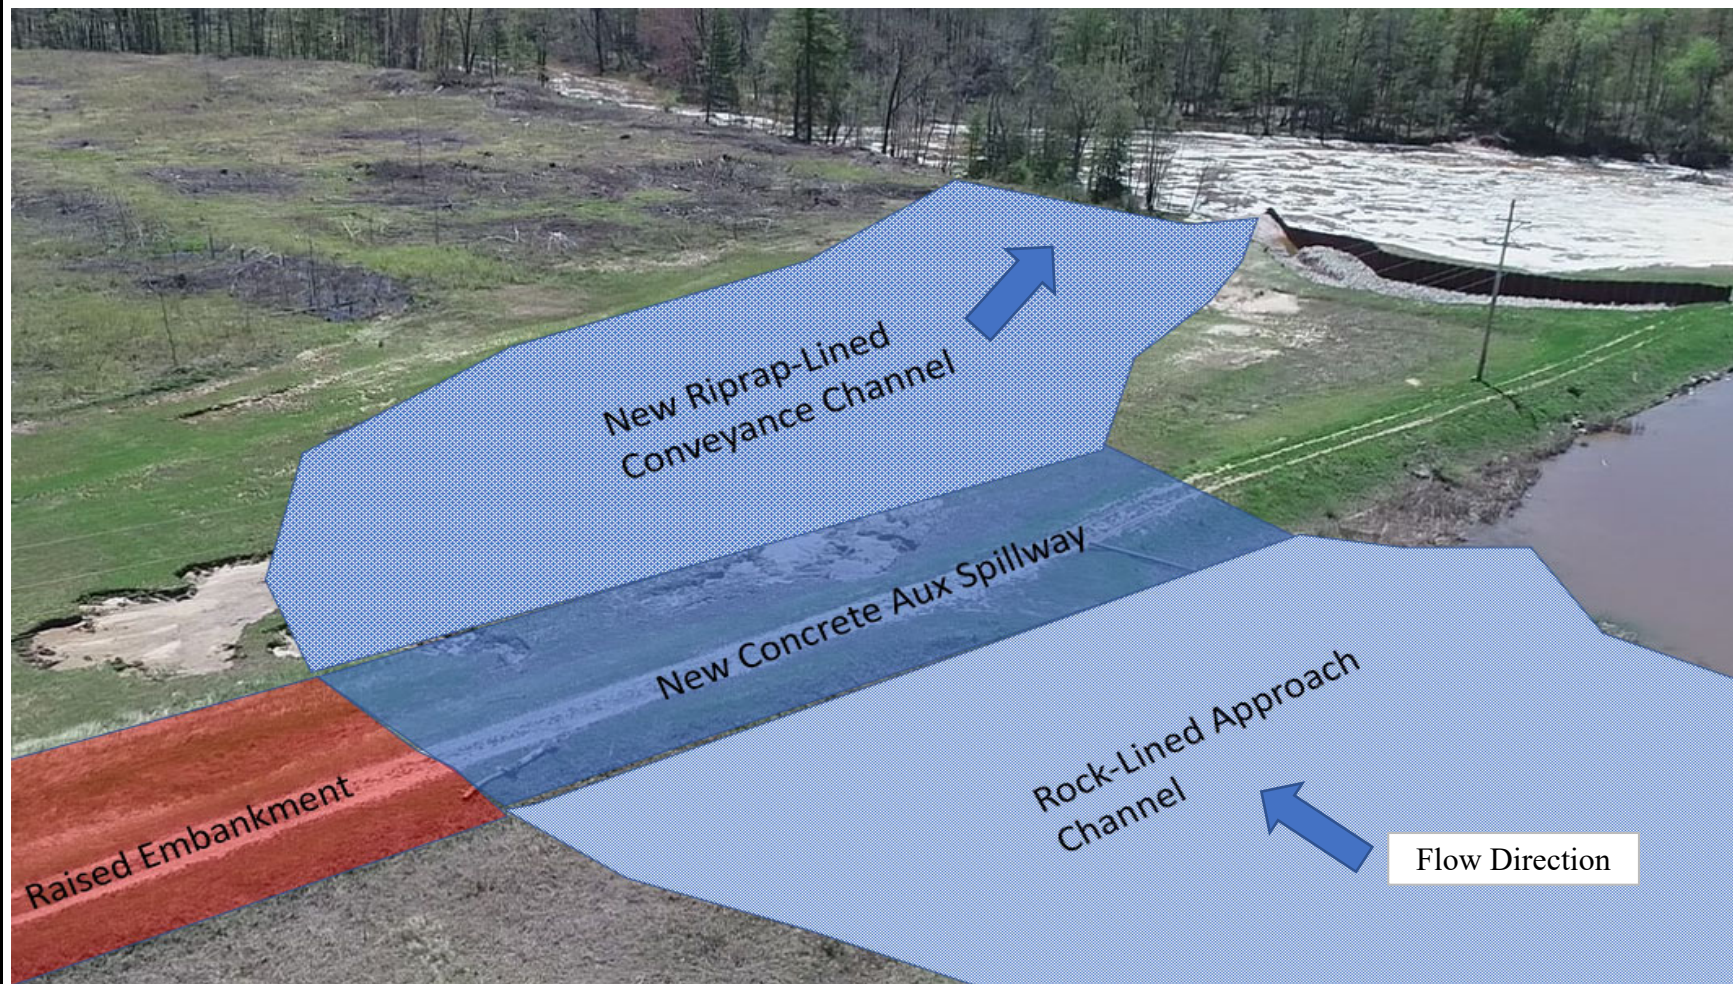
Post Failure Reconstruction Cost Analysis
 Client: Four Lake Task Force (FLTF)
 Location: Midland, Michigan

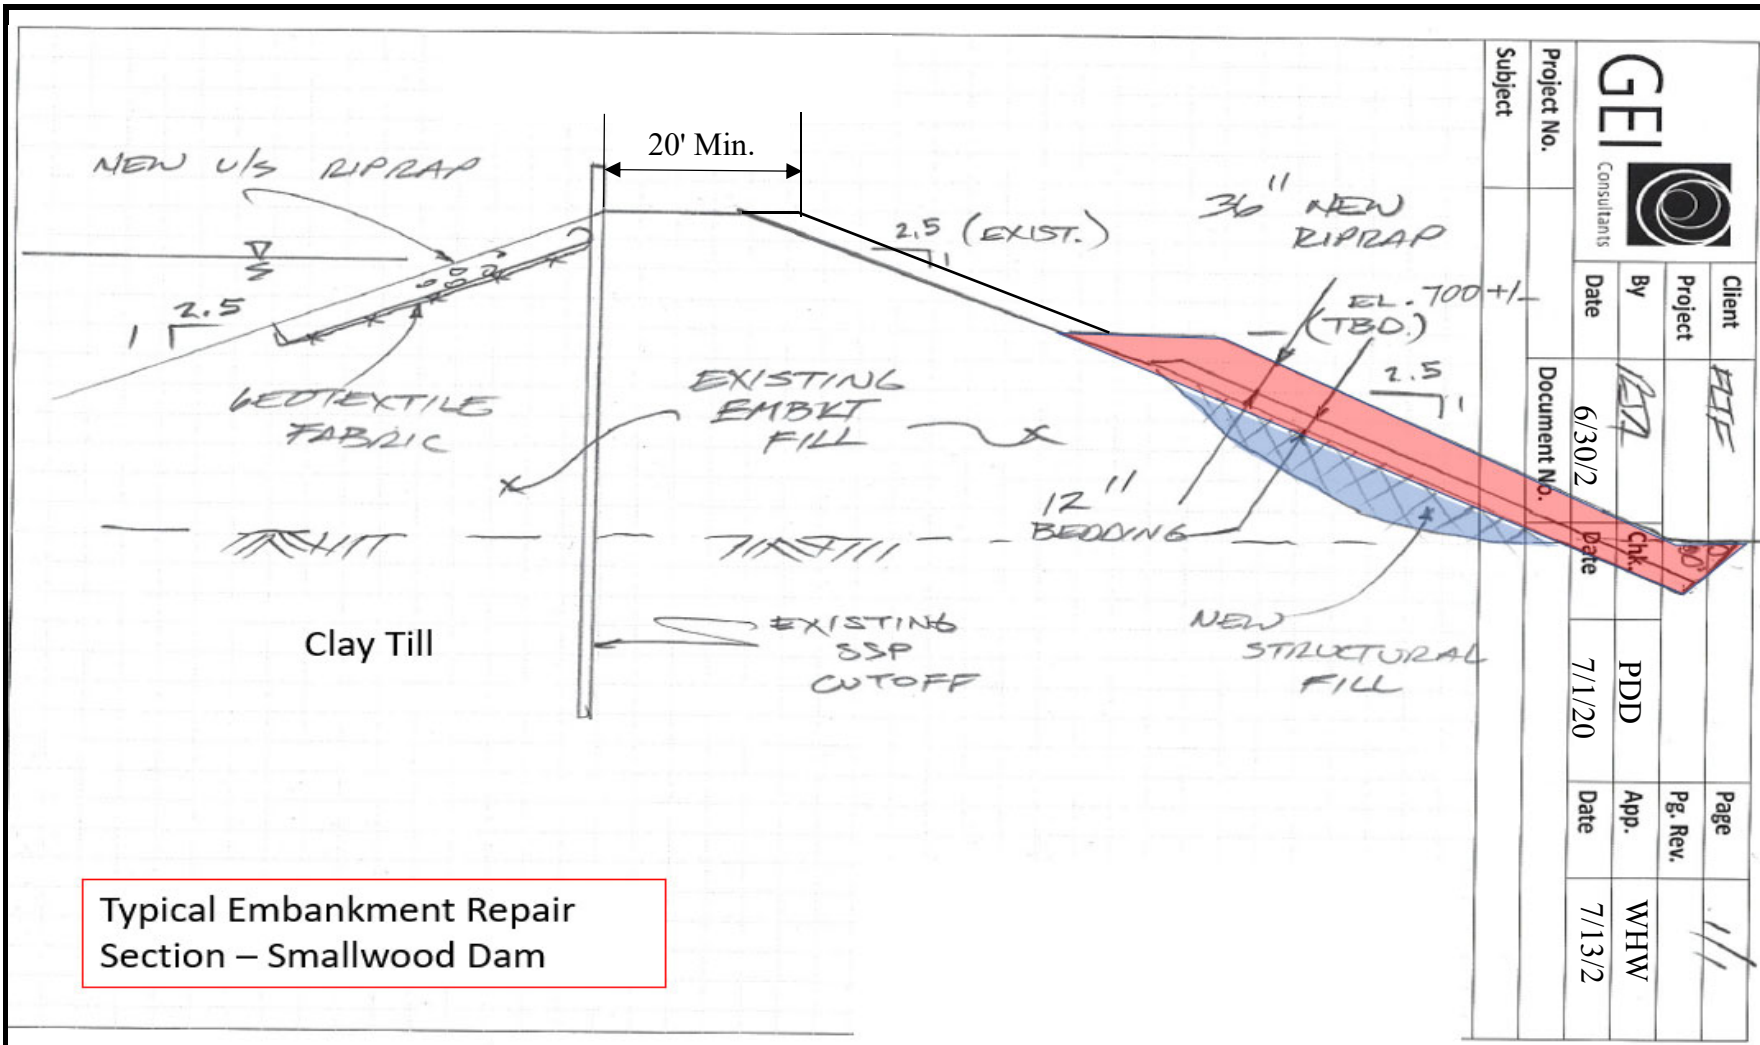
Typical Embankment Repair Section – Smallwood Dam

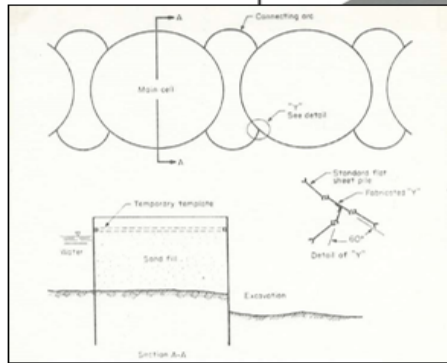
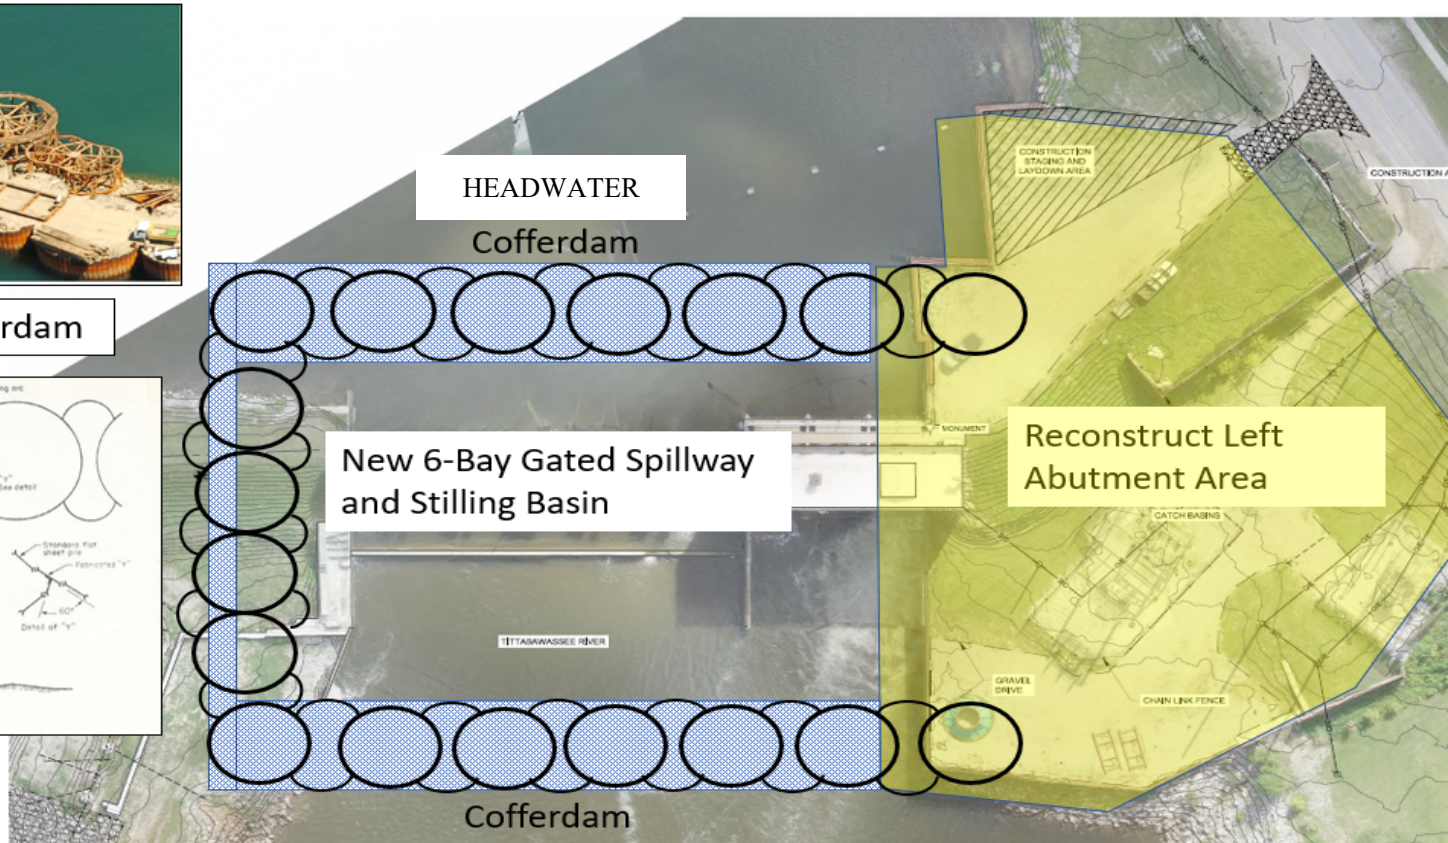
Post Failure Reconstruction Cost Analysis
Client: Four Lake Task Force (FLTF)
Location: Midland, Michigan

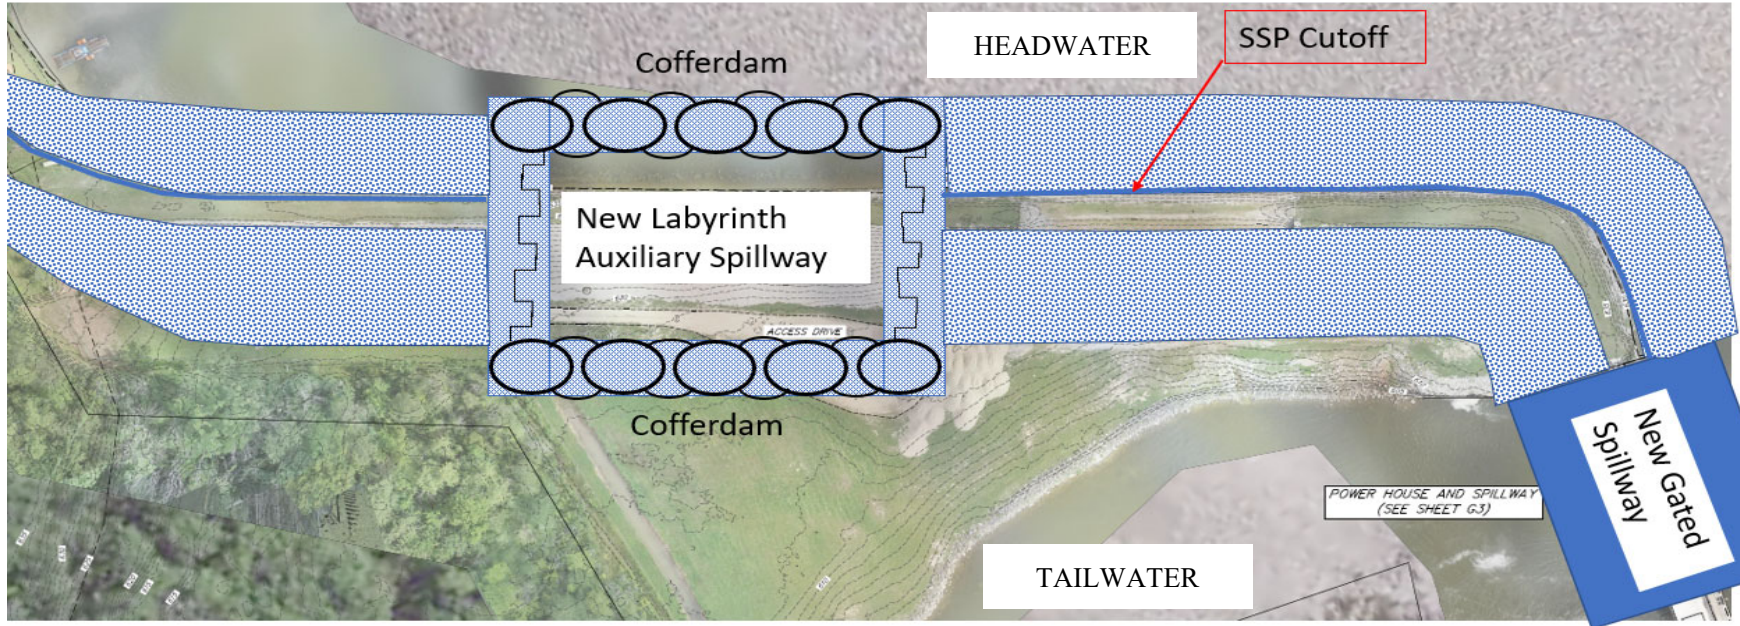
Post Failure Reconstruction Cost Analysis
 Client: Four Lake Task Force (FLTF)
 Location: Midland, Michigan

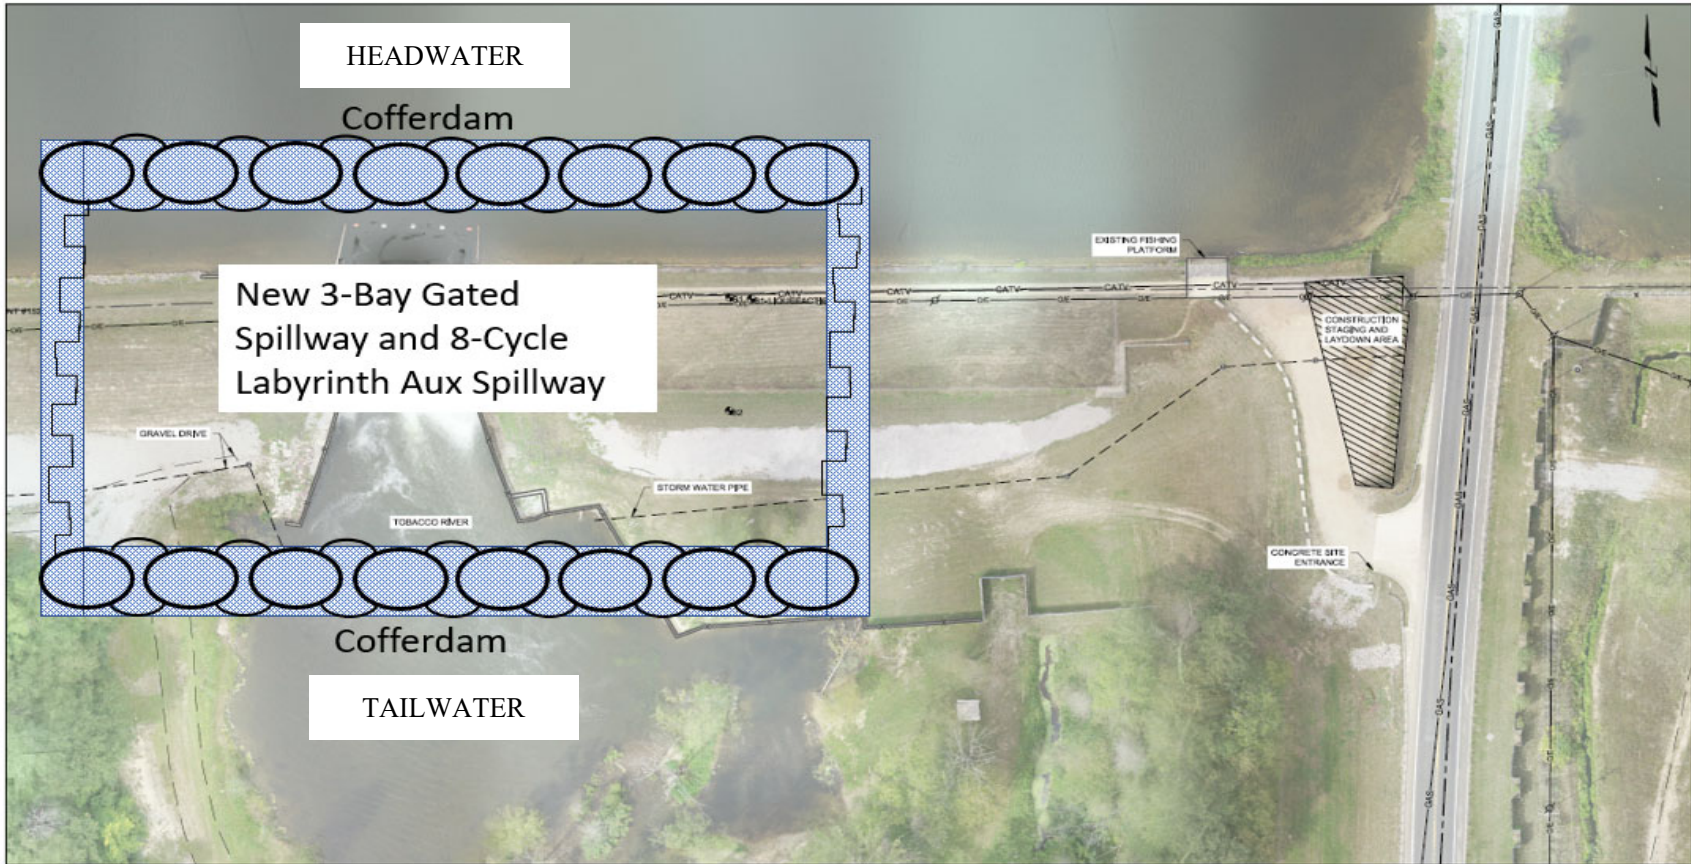
Post Failure Reconstruction Cost Analysis
Client: Four Lake Task Force (FLTF)
Location: Midland, Michigan

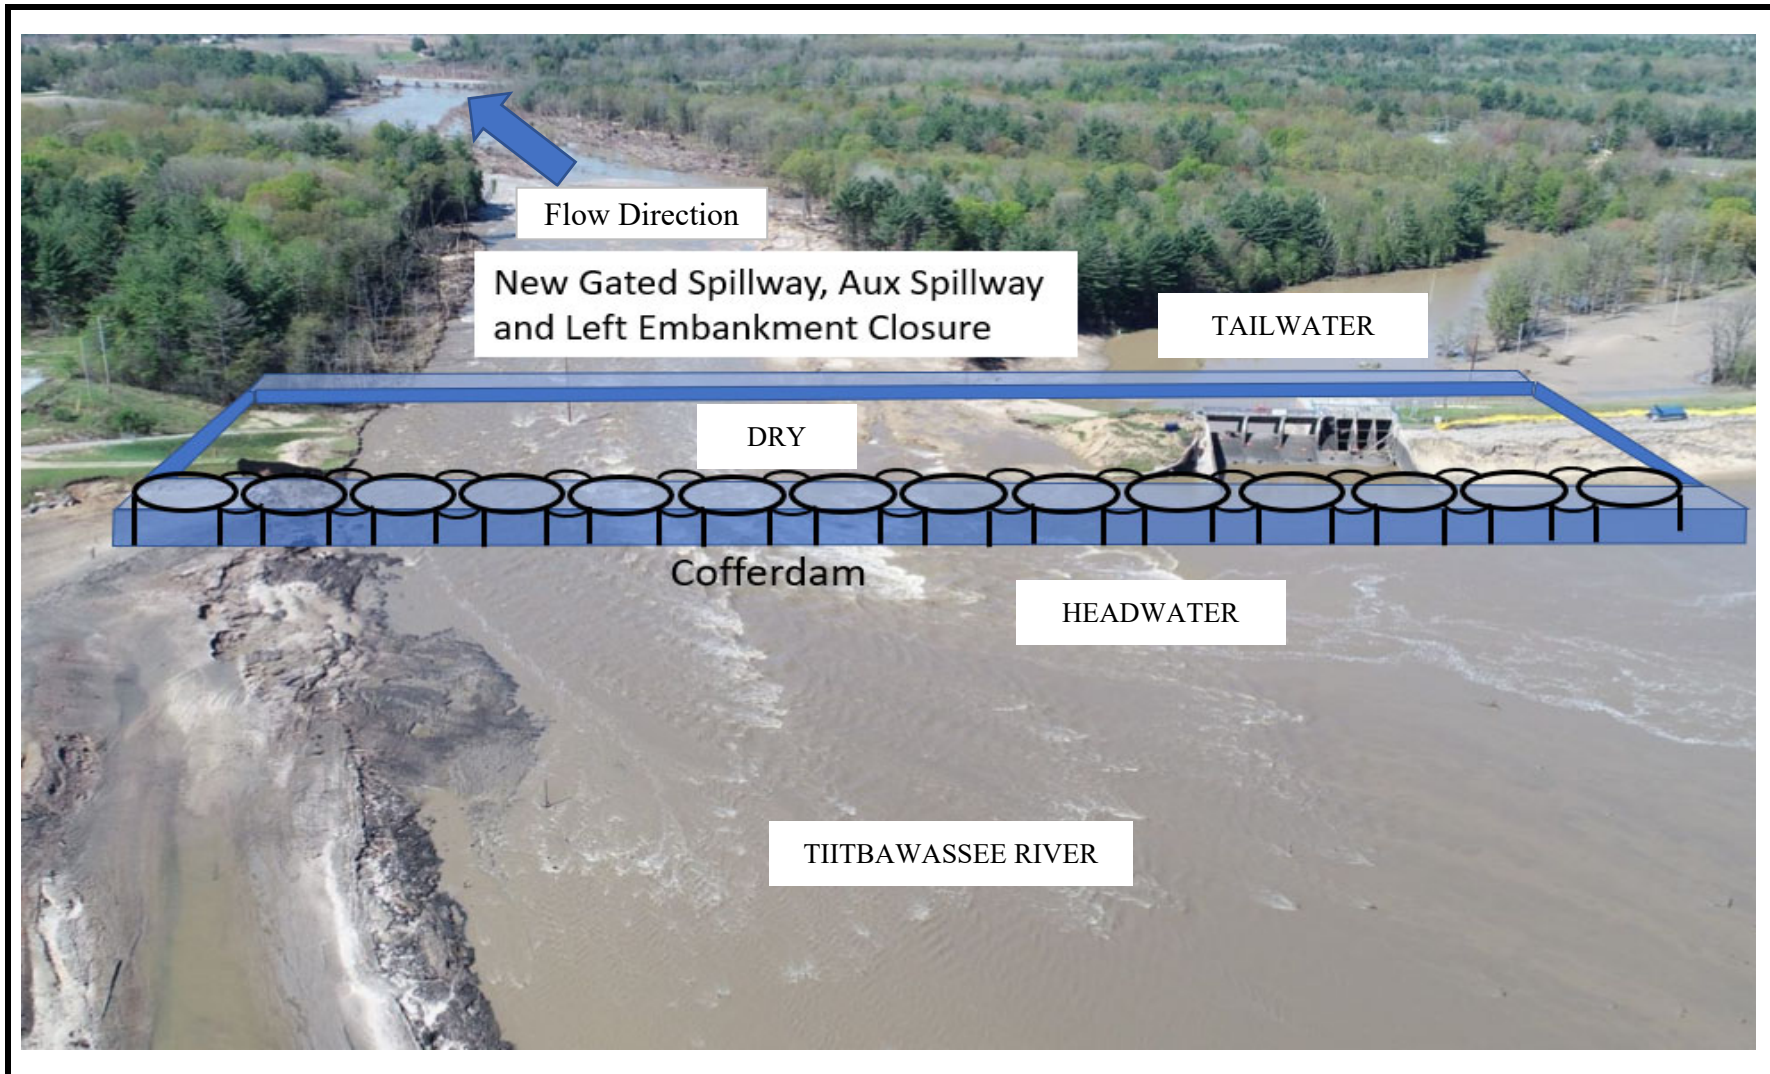
Post Failure Reconstruction Cost Analysis
 Client: Four Lake Task Force (FLTF)
 Location: Midland, Michigan

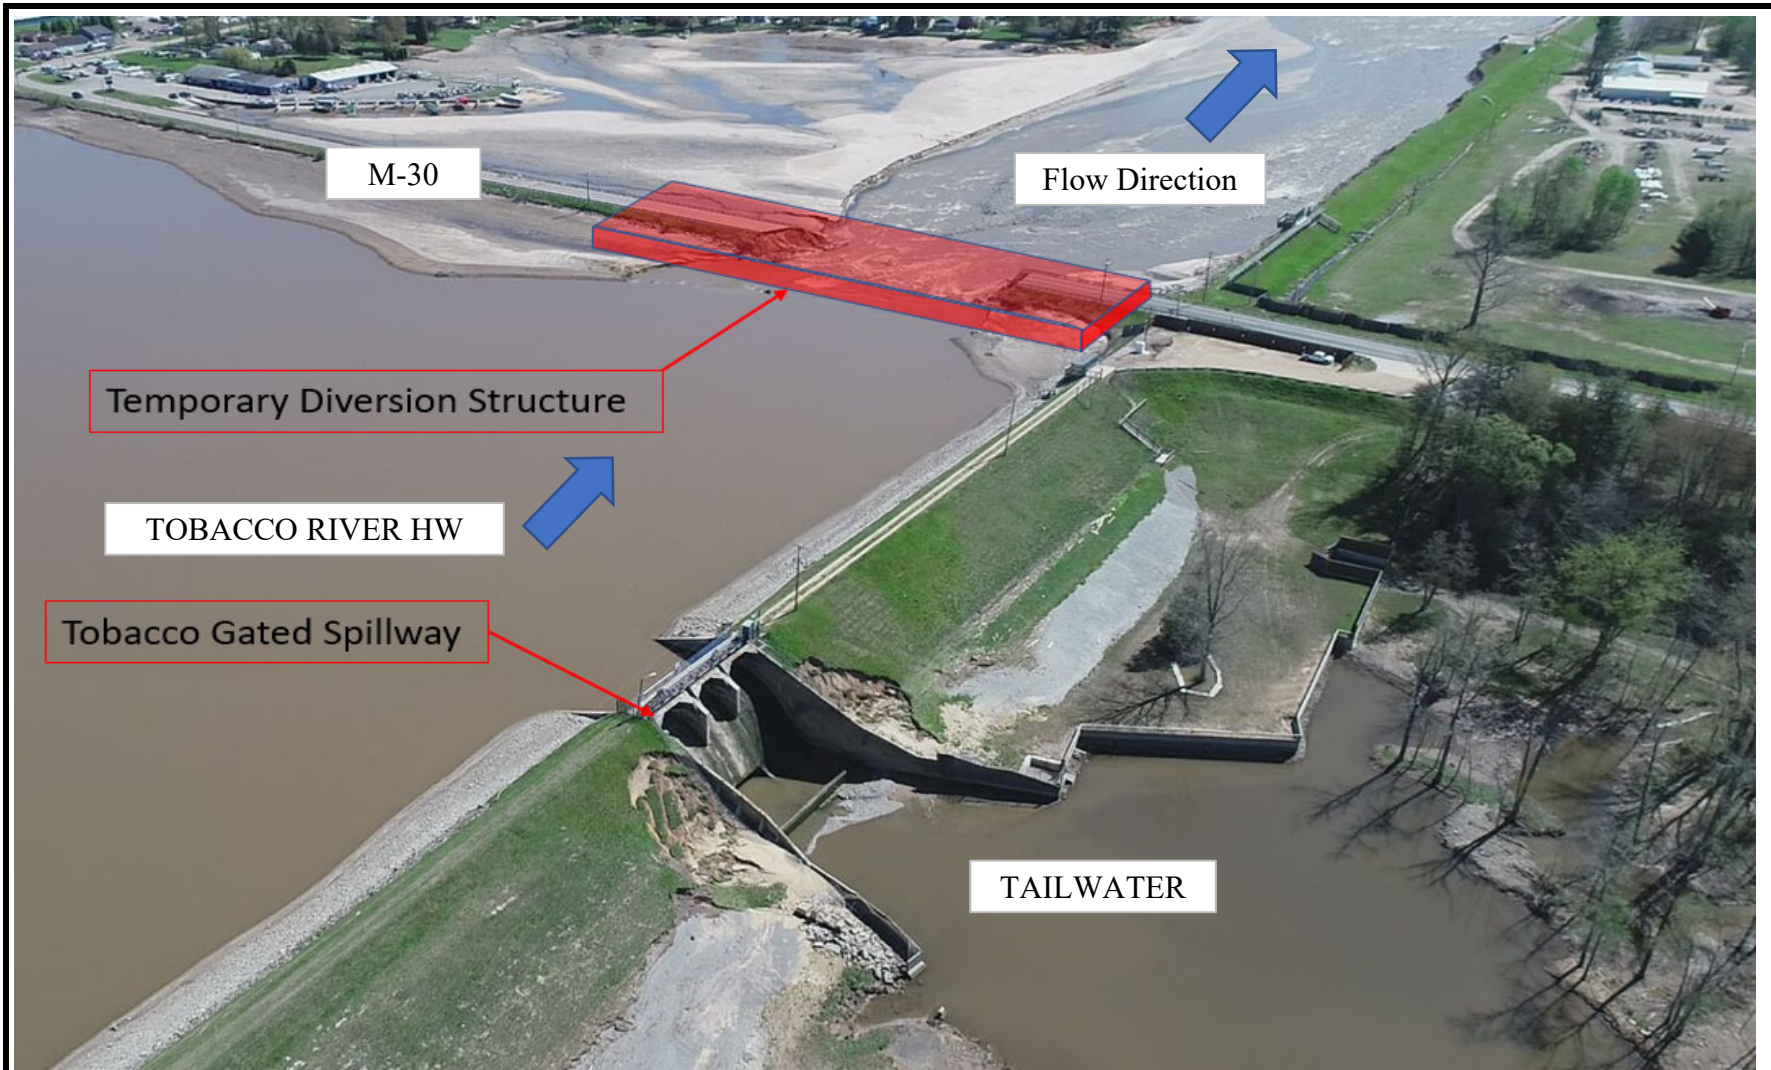
Post Failure Reconstruction Cost Analysis
 Client: Four Lake Task Force (FLTF)
 Location: Midland, Michigan

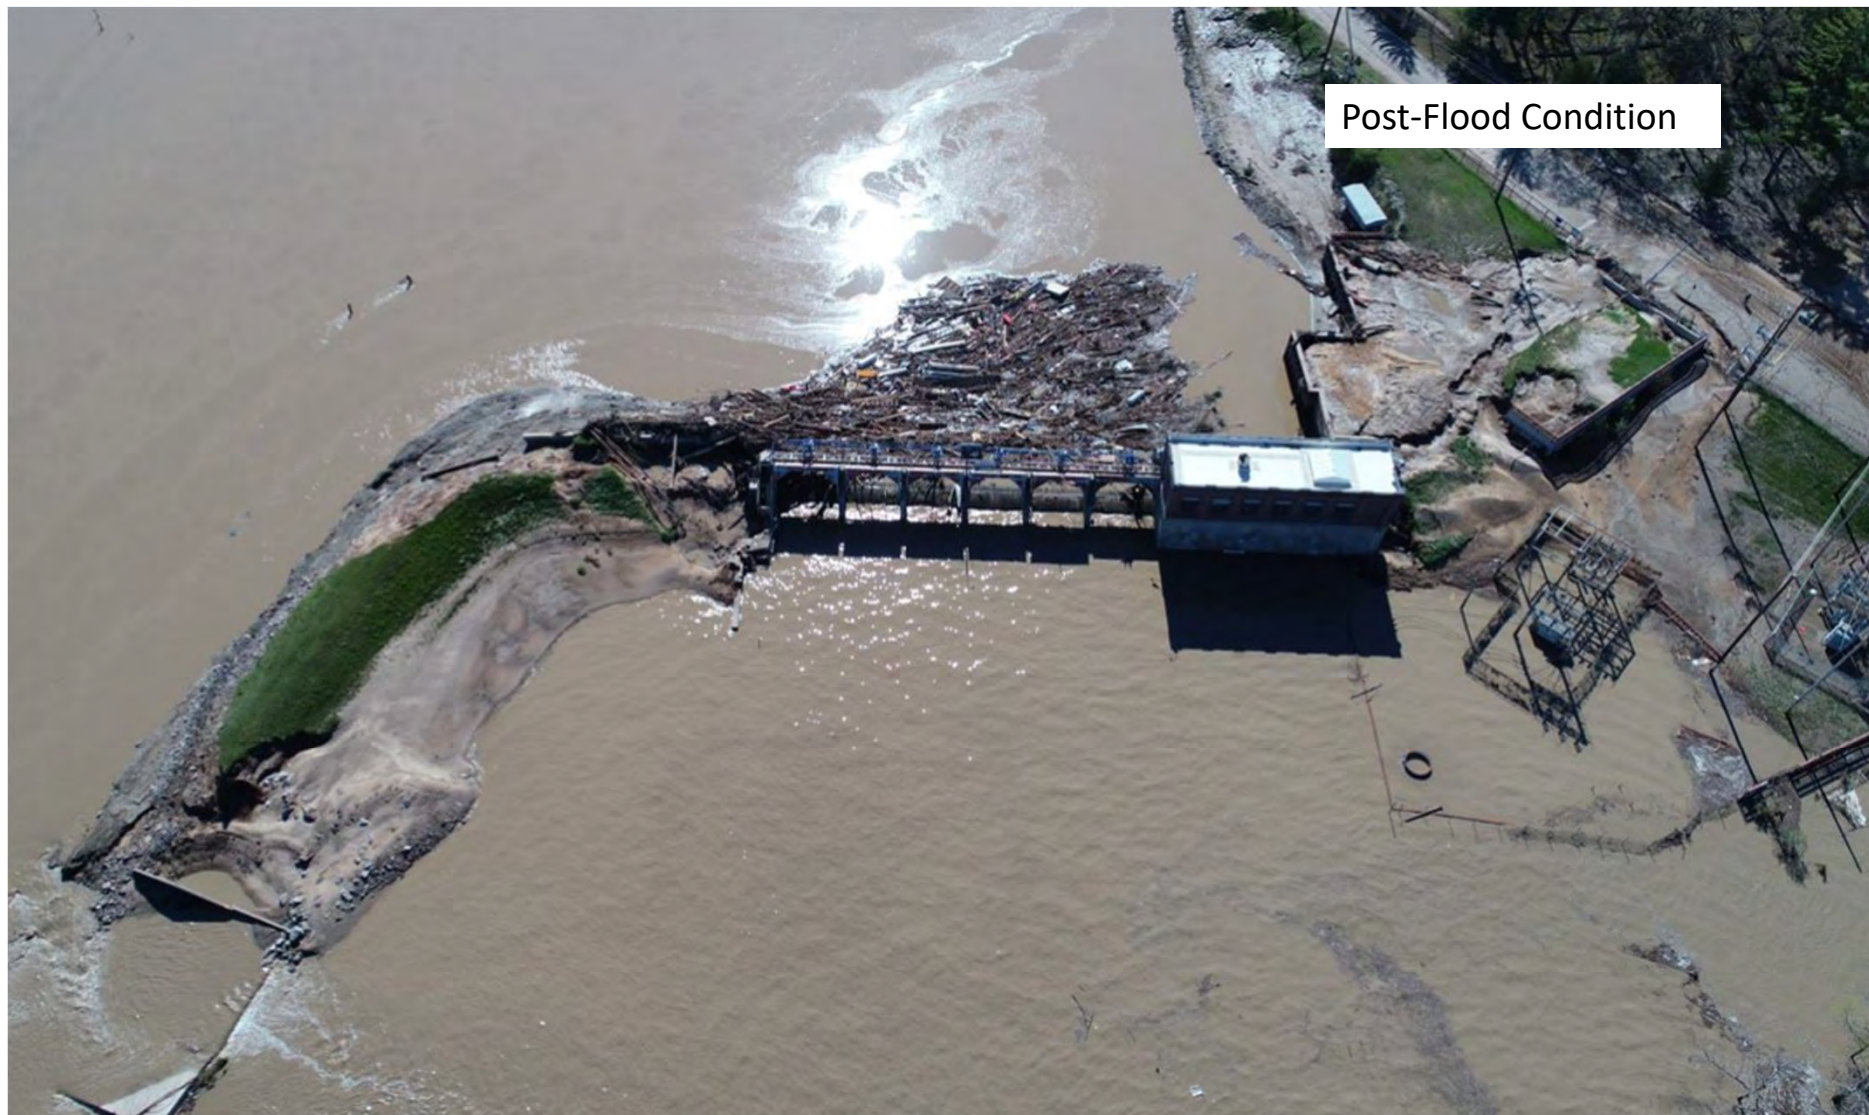
Edenville Dam - Tobacco Spillway

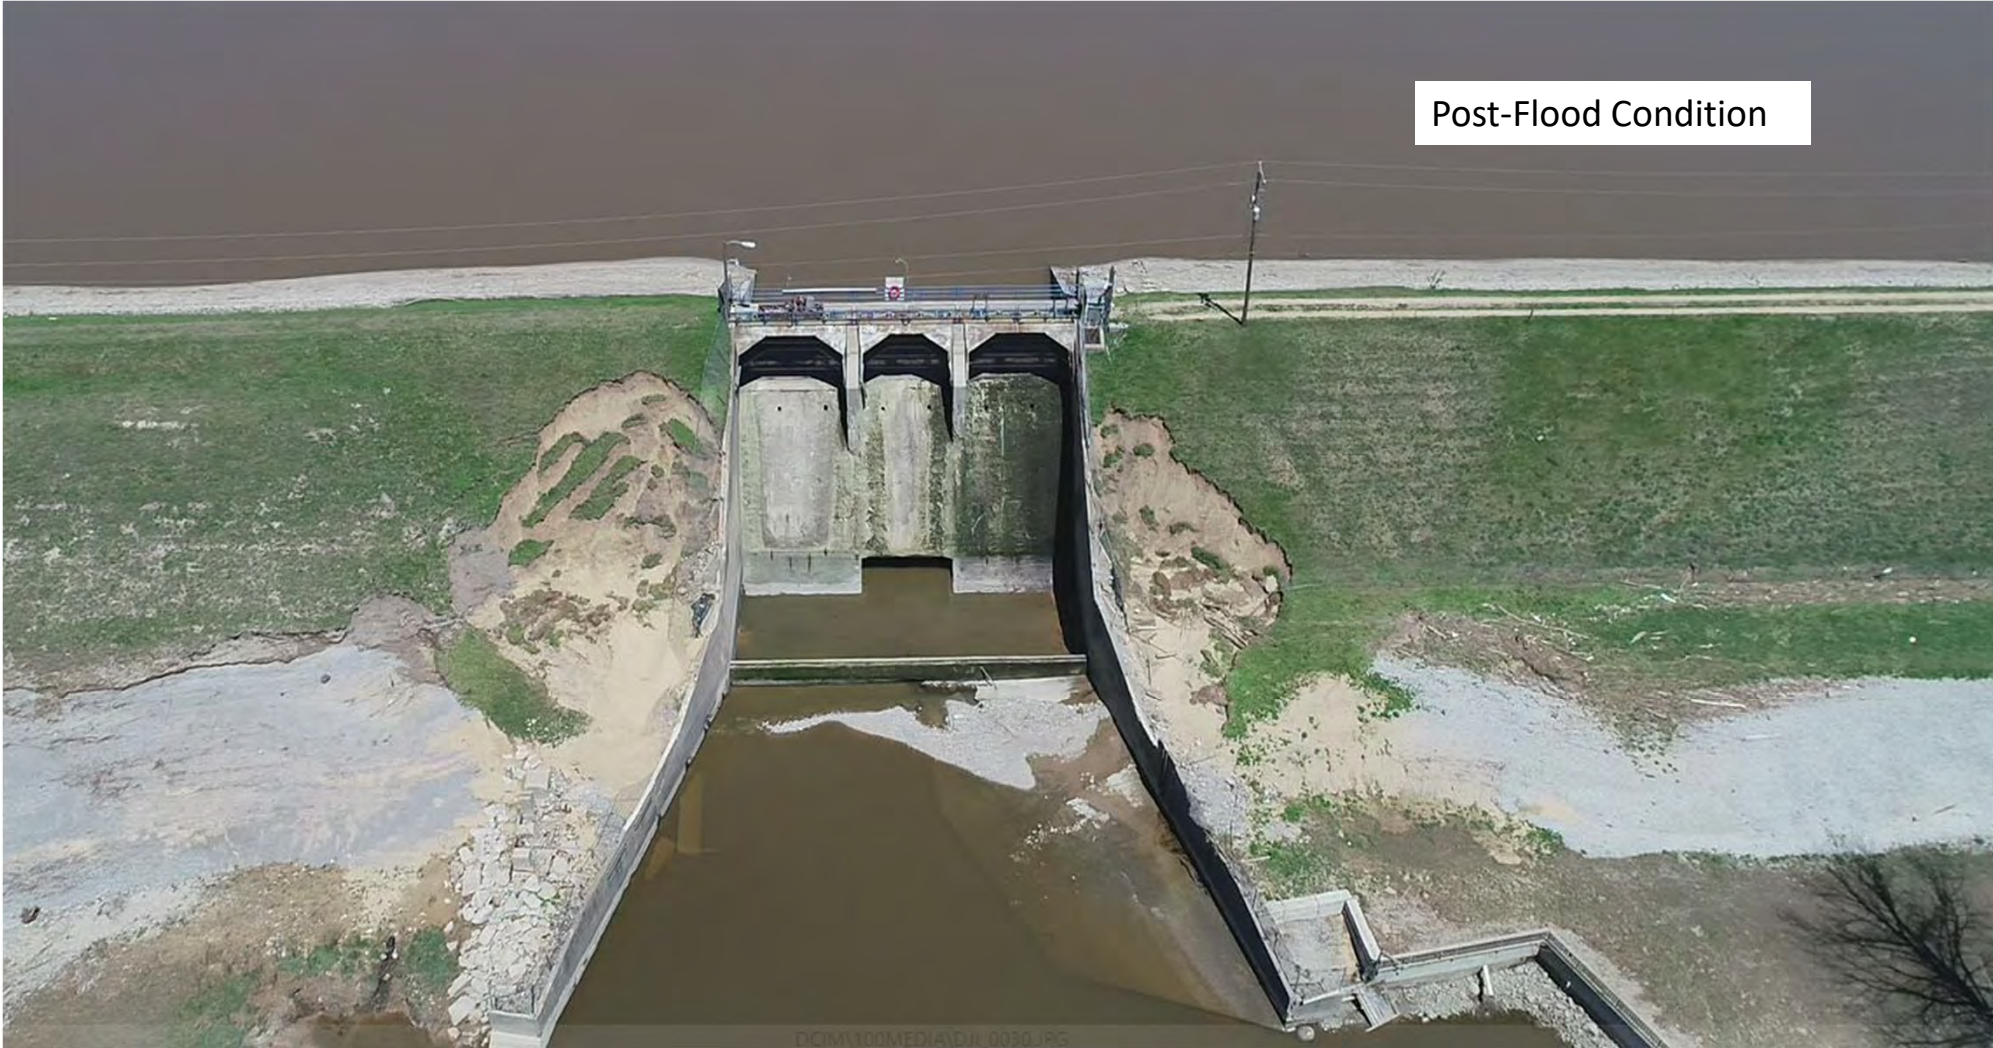
Edenville Dam - Tobacco Spillway

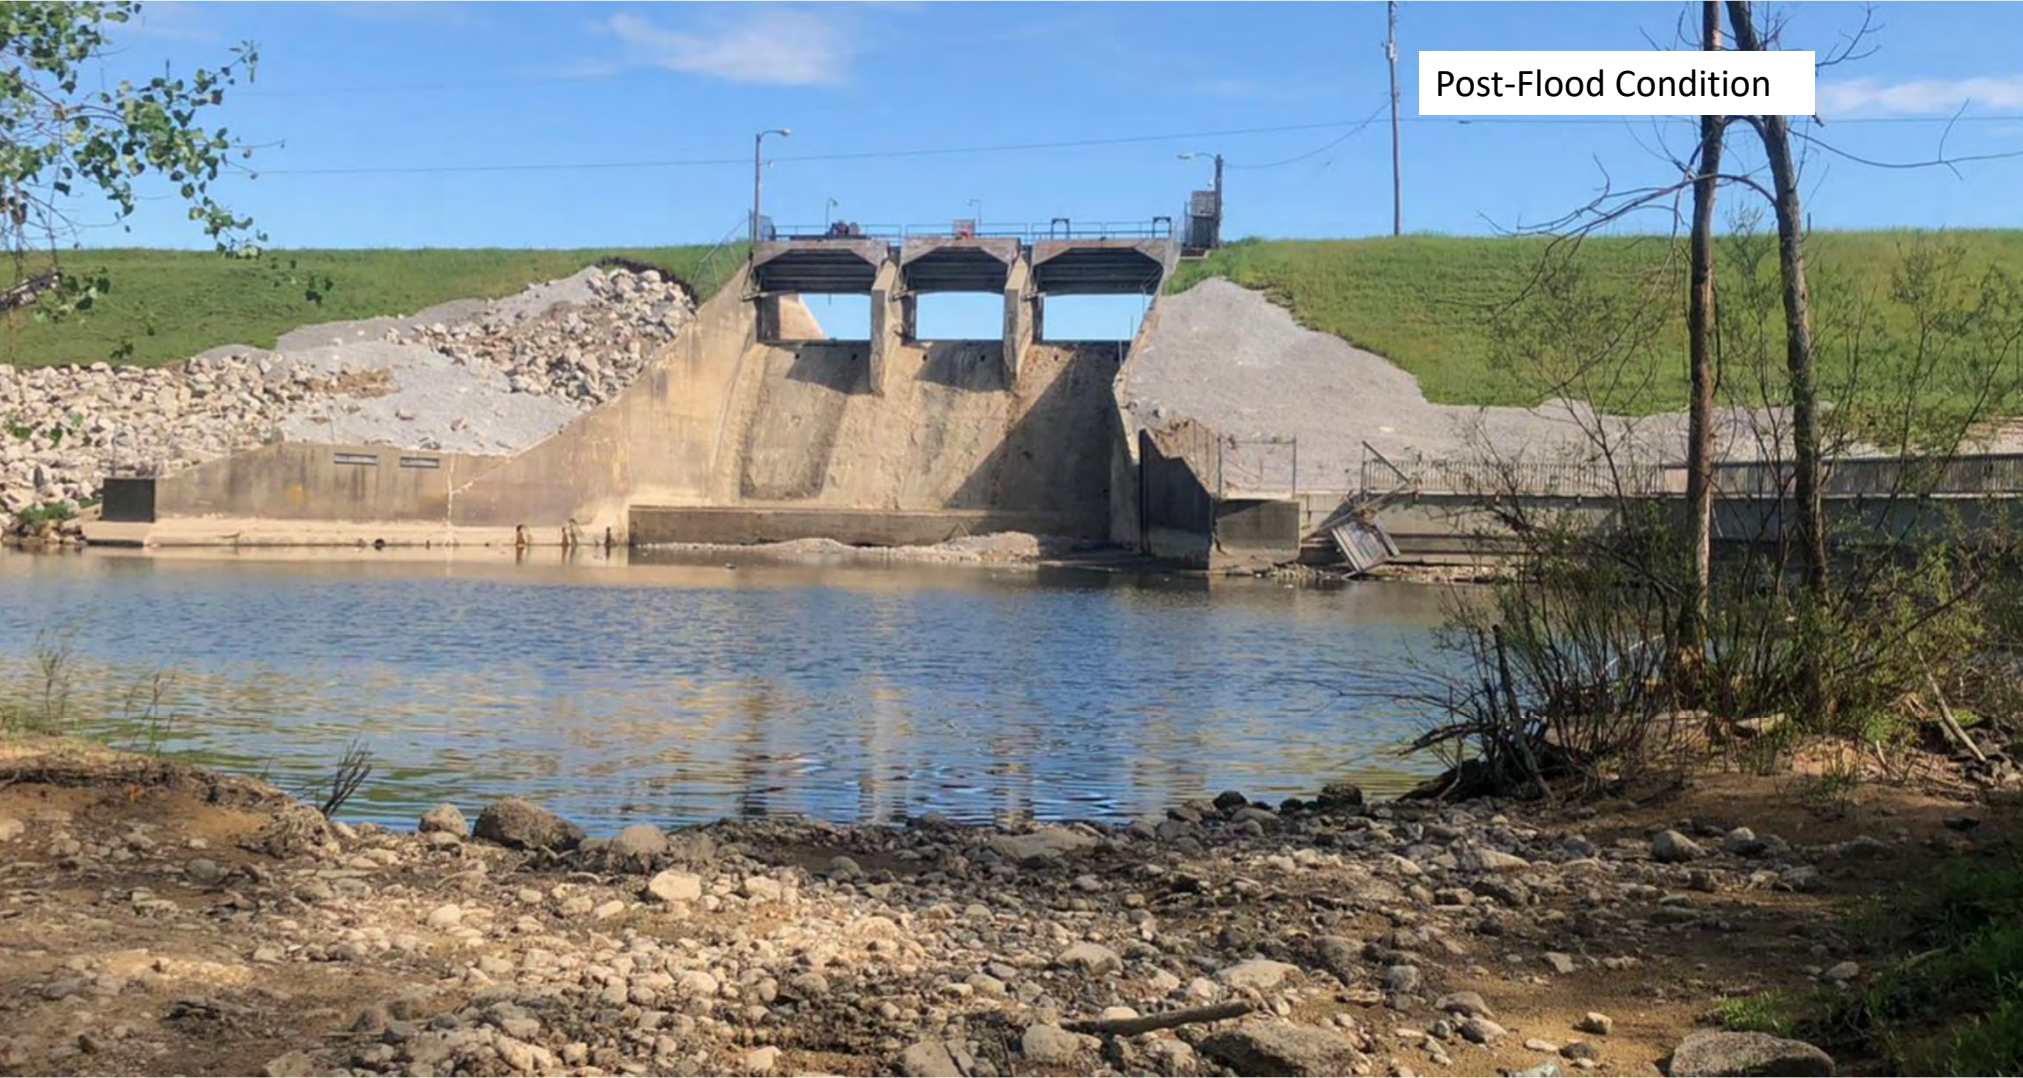
Edenville Dam - Tobacco Spillway

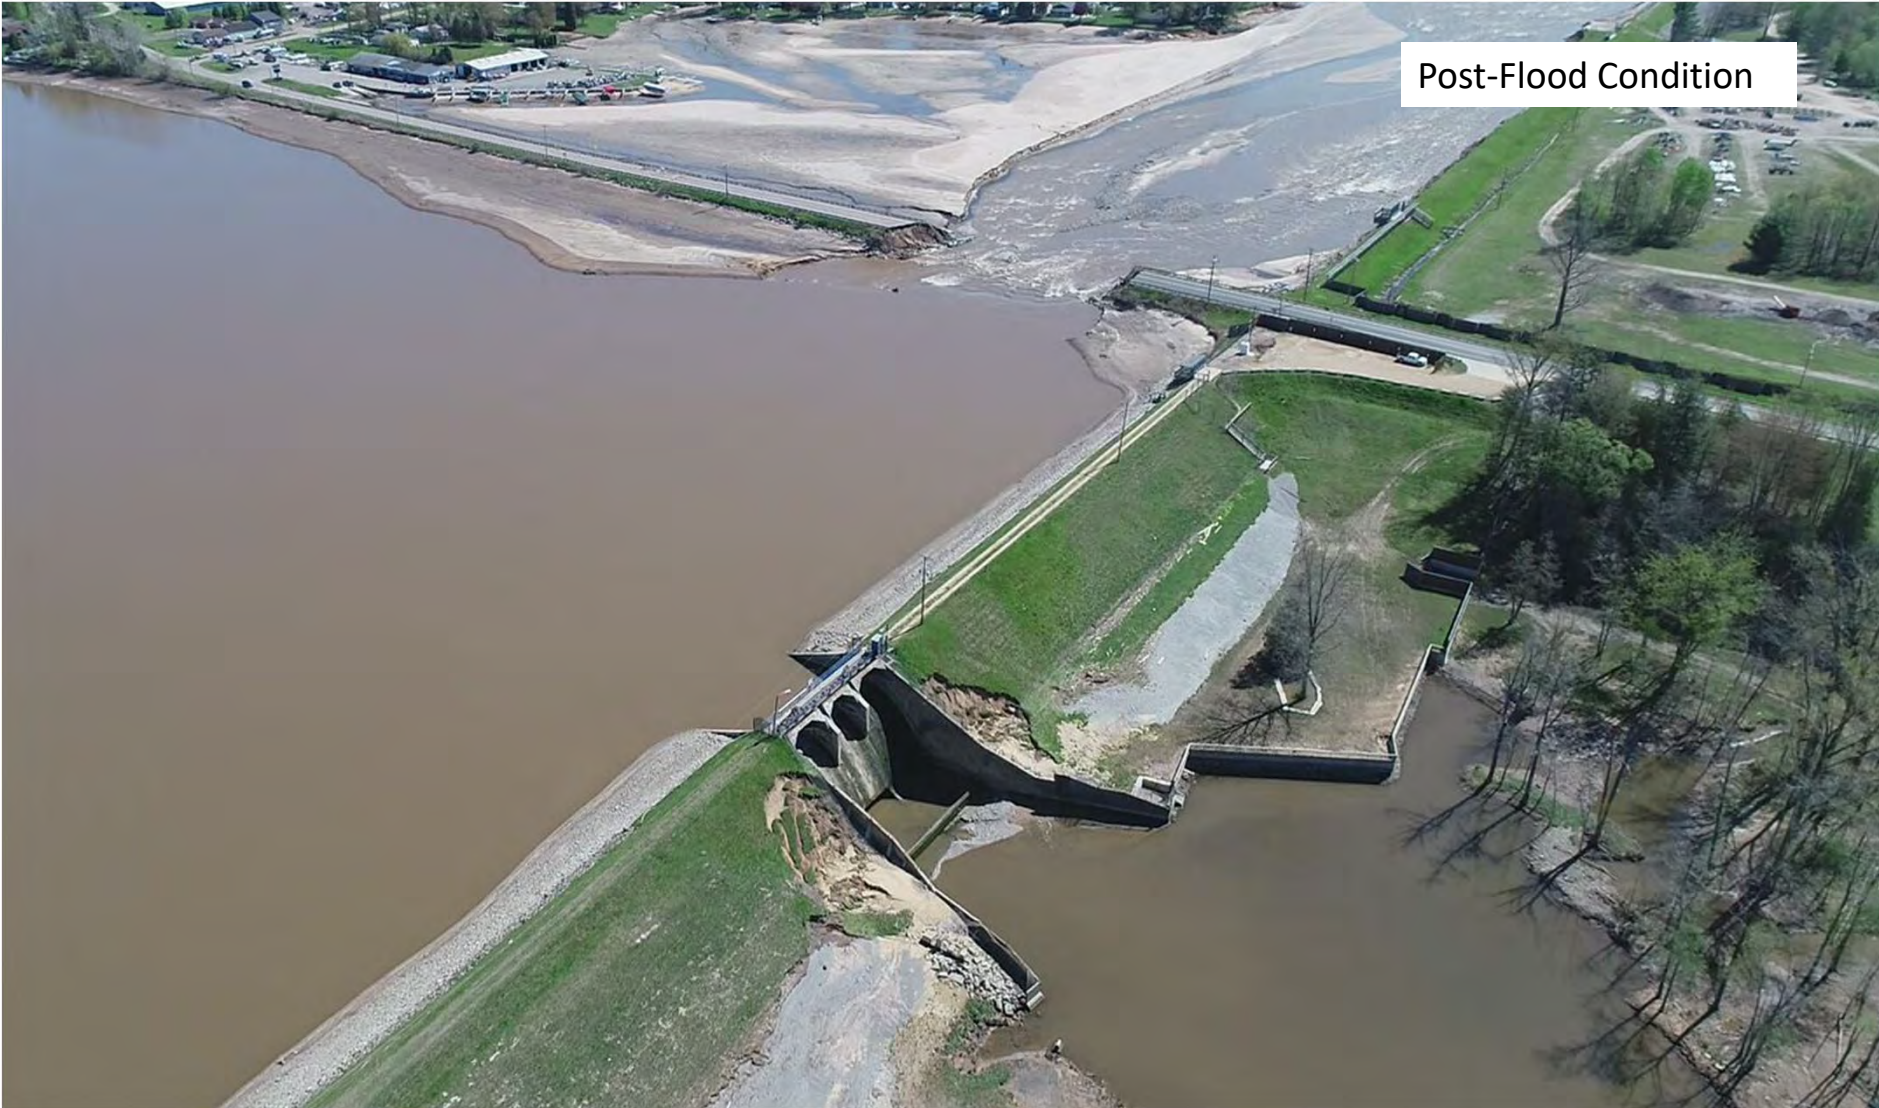
Post-Flood Condition
