Technical Memorandum

Introduction and Project Background

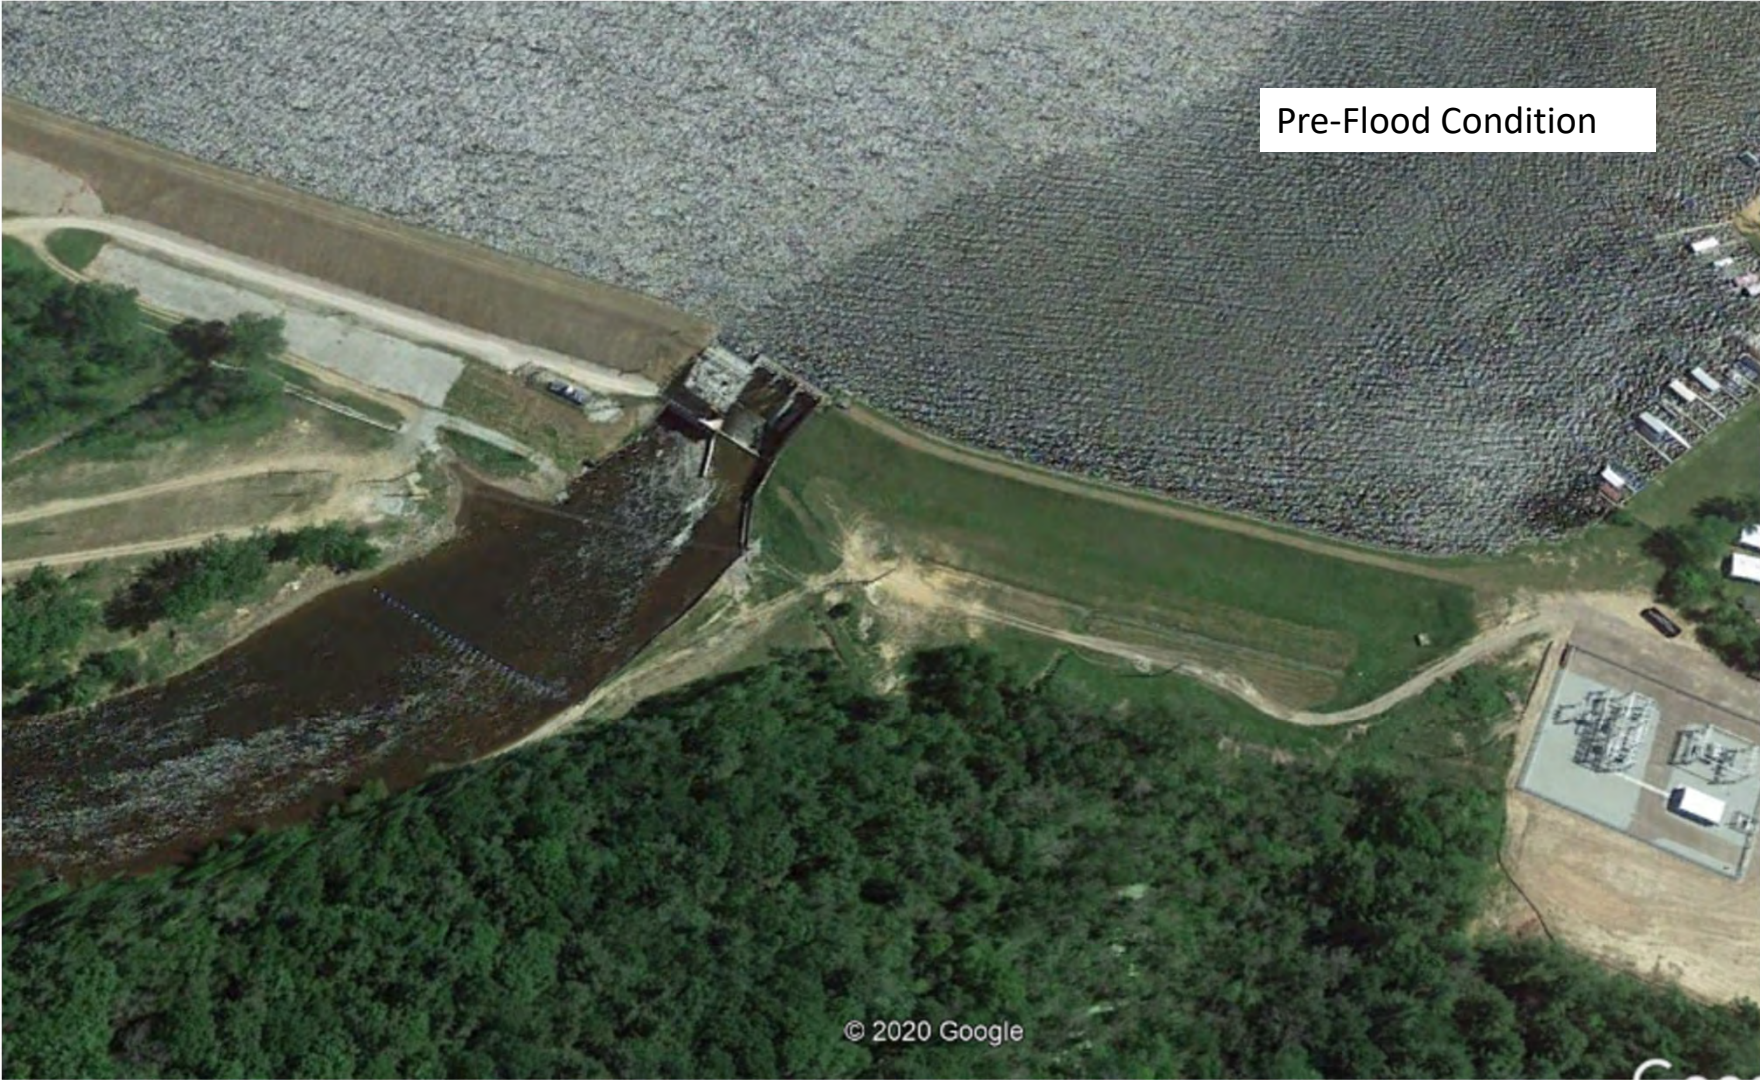
Edenville Dam - Edenville Spillway

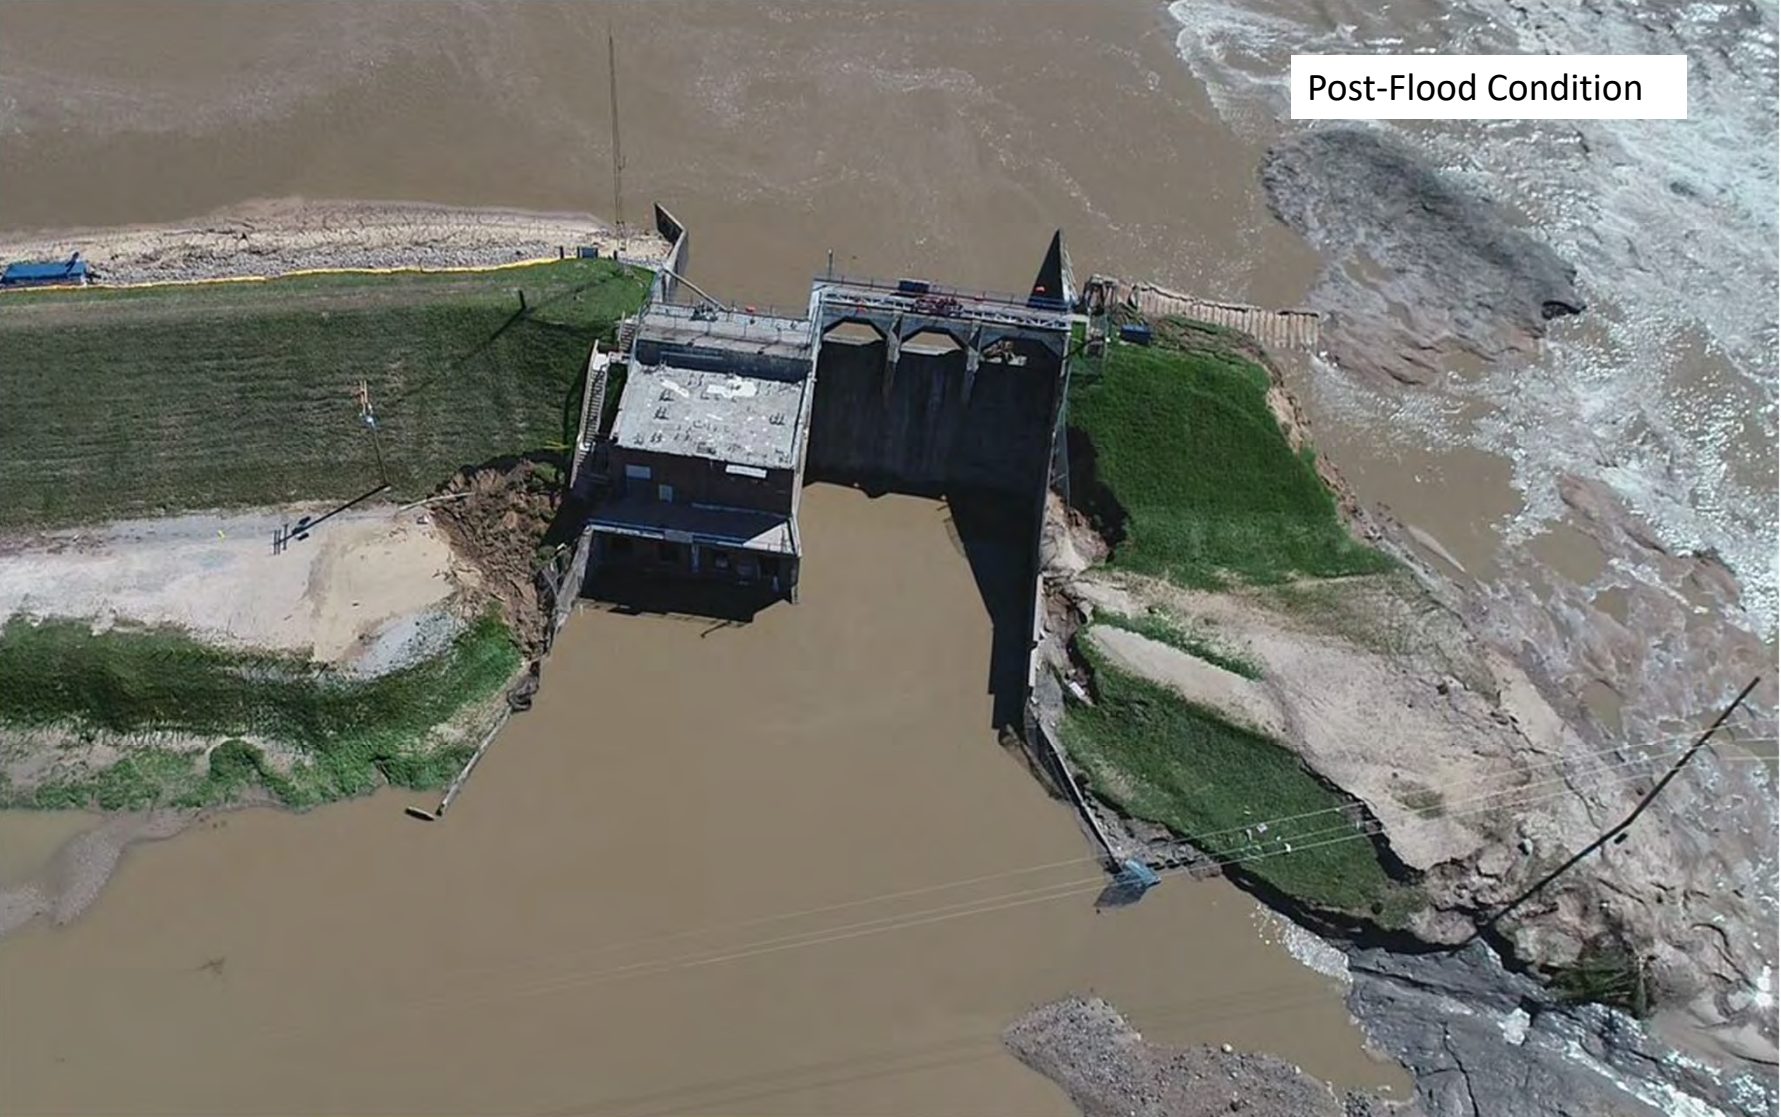
Edenville Dam - Edenville Spillway

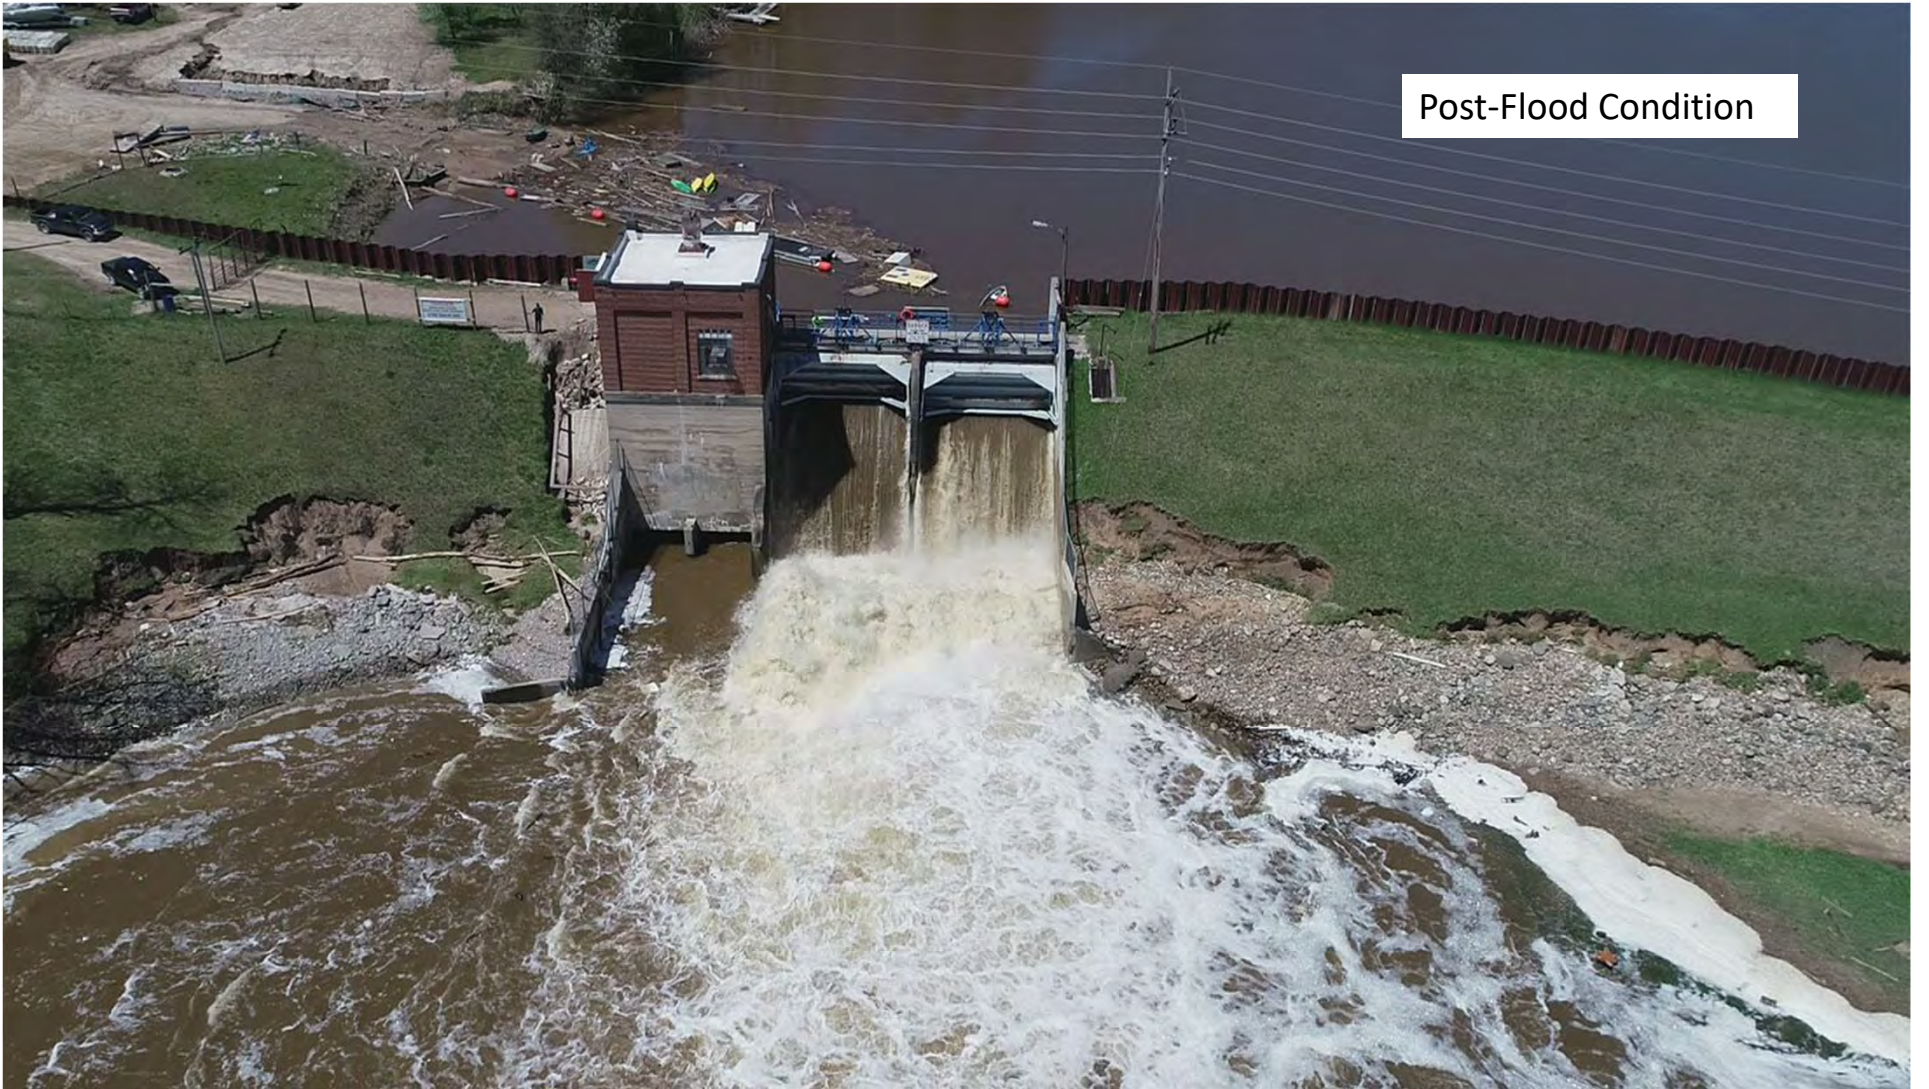
Post-Flood Condition

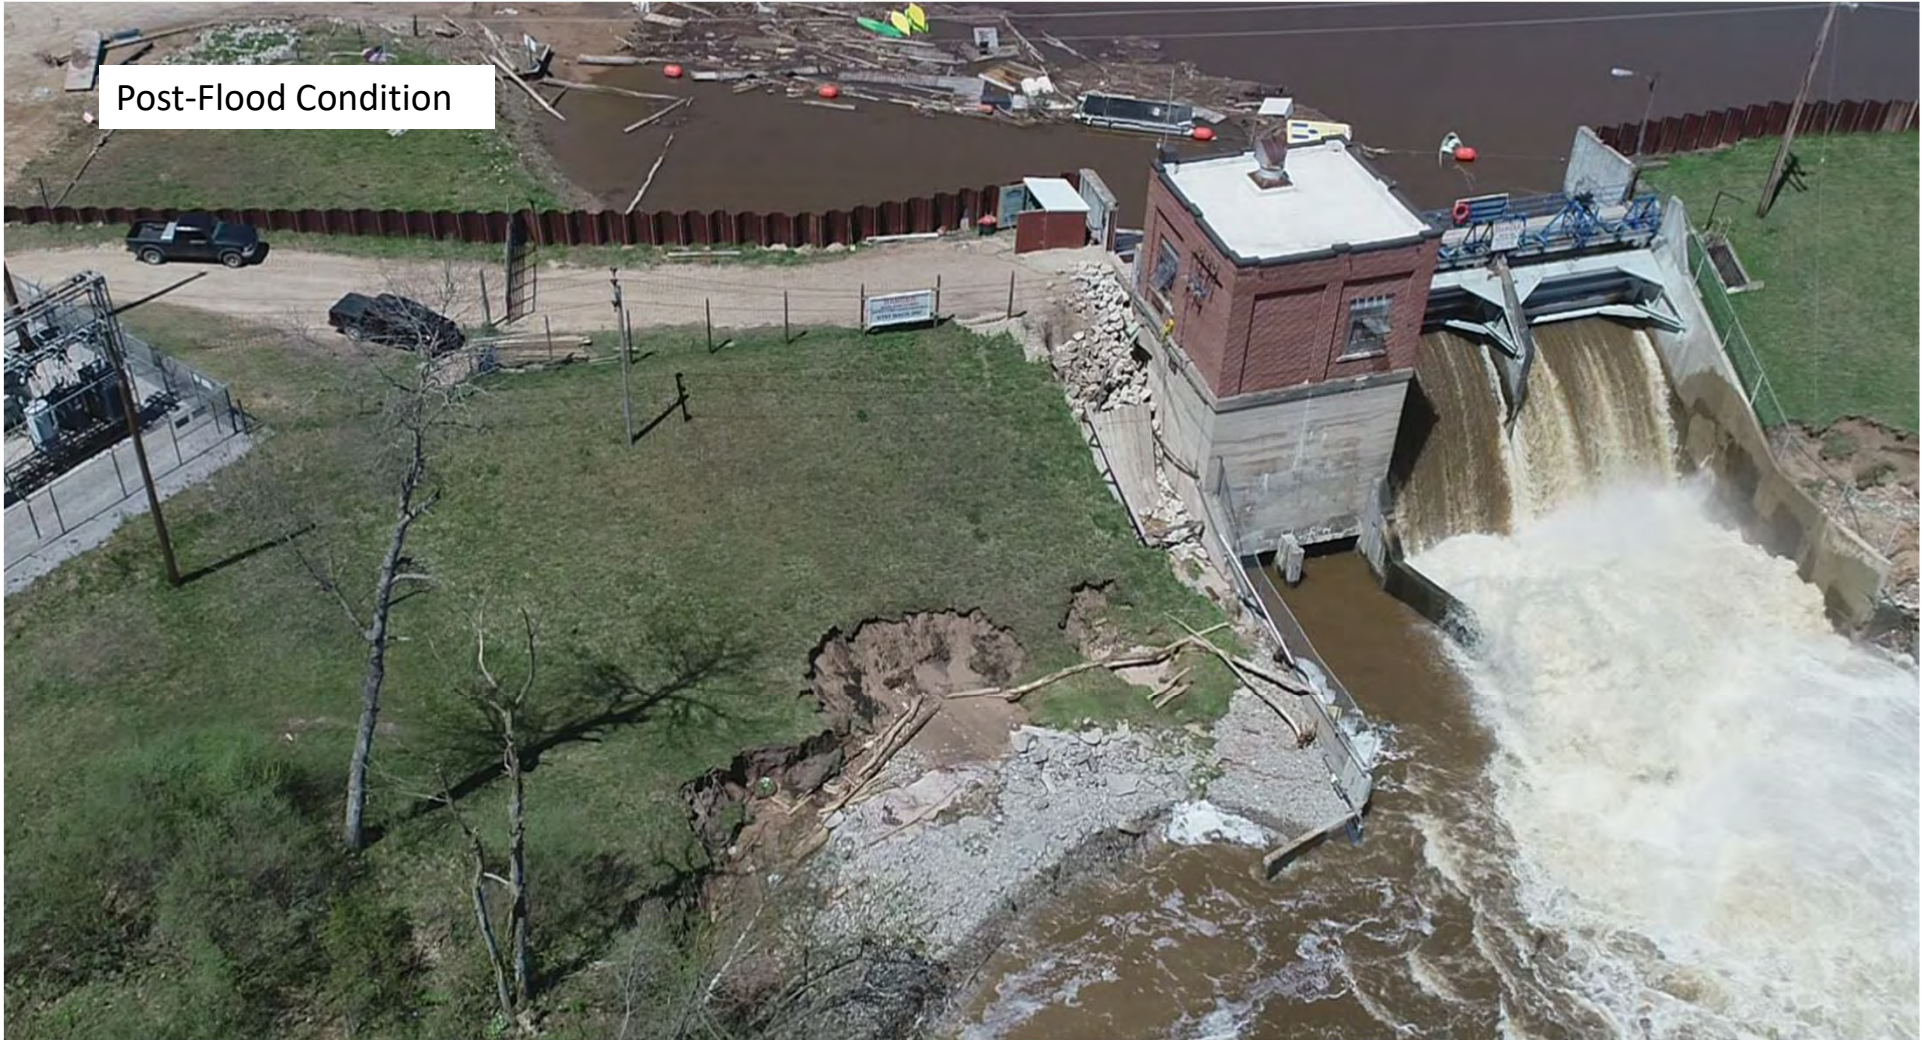
Post-Flood Condition

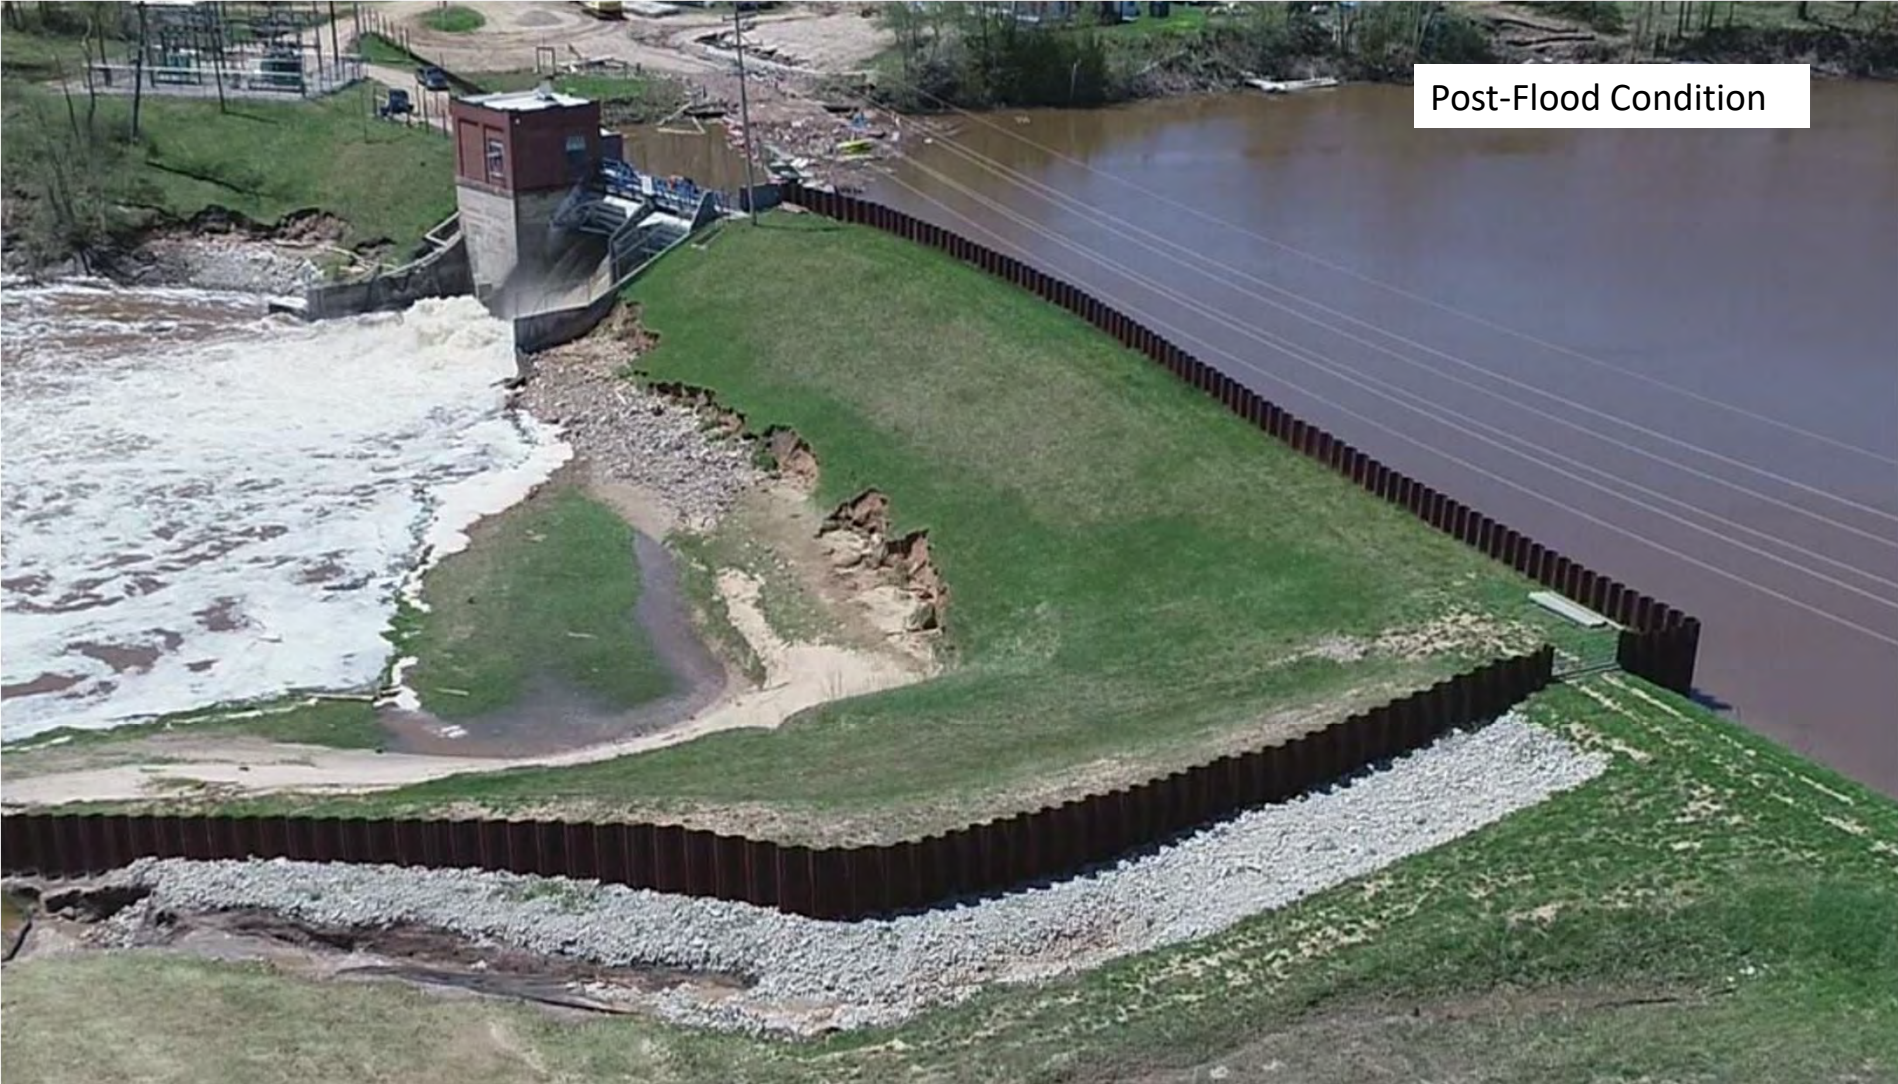
Post-Flood Condition

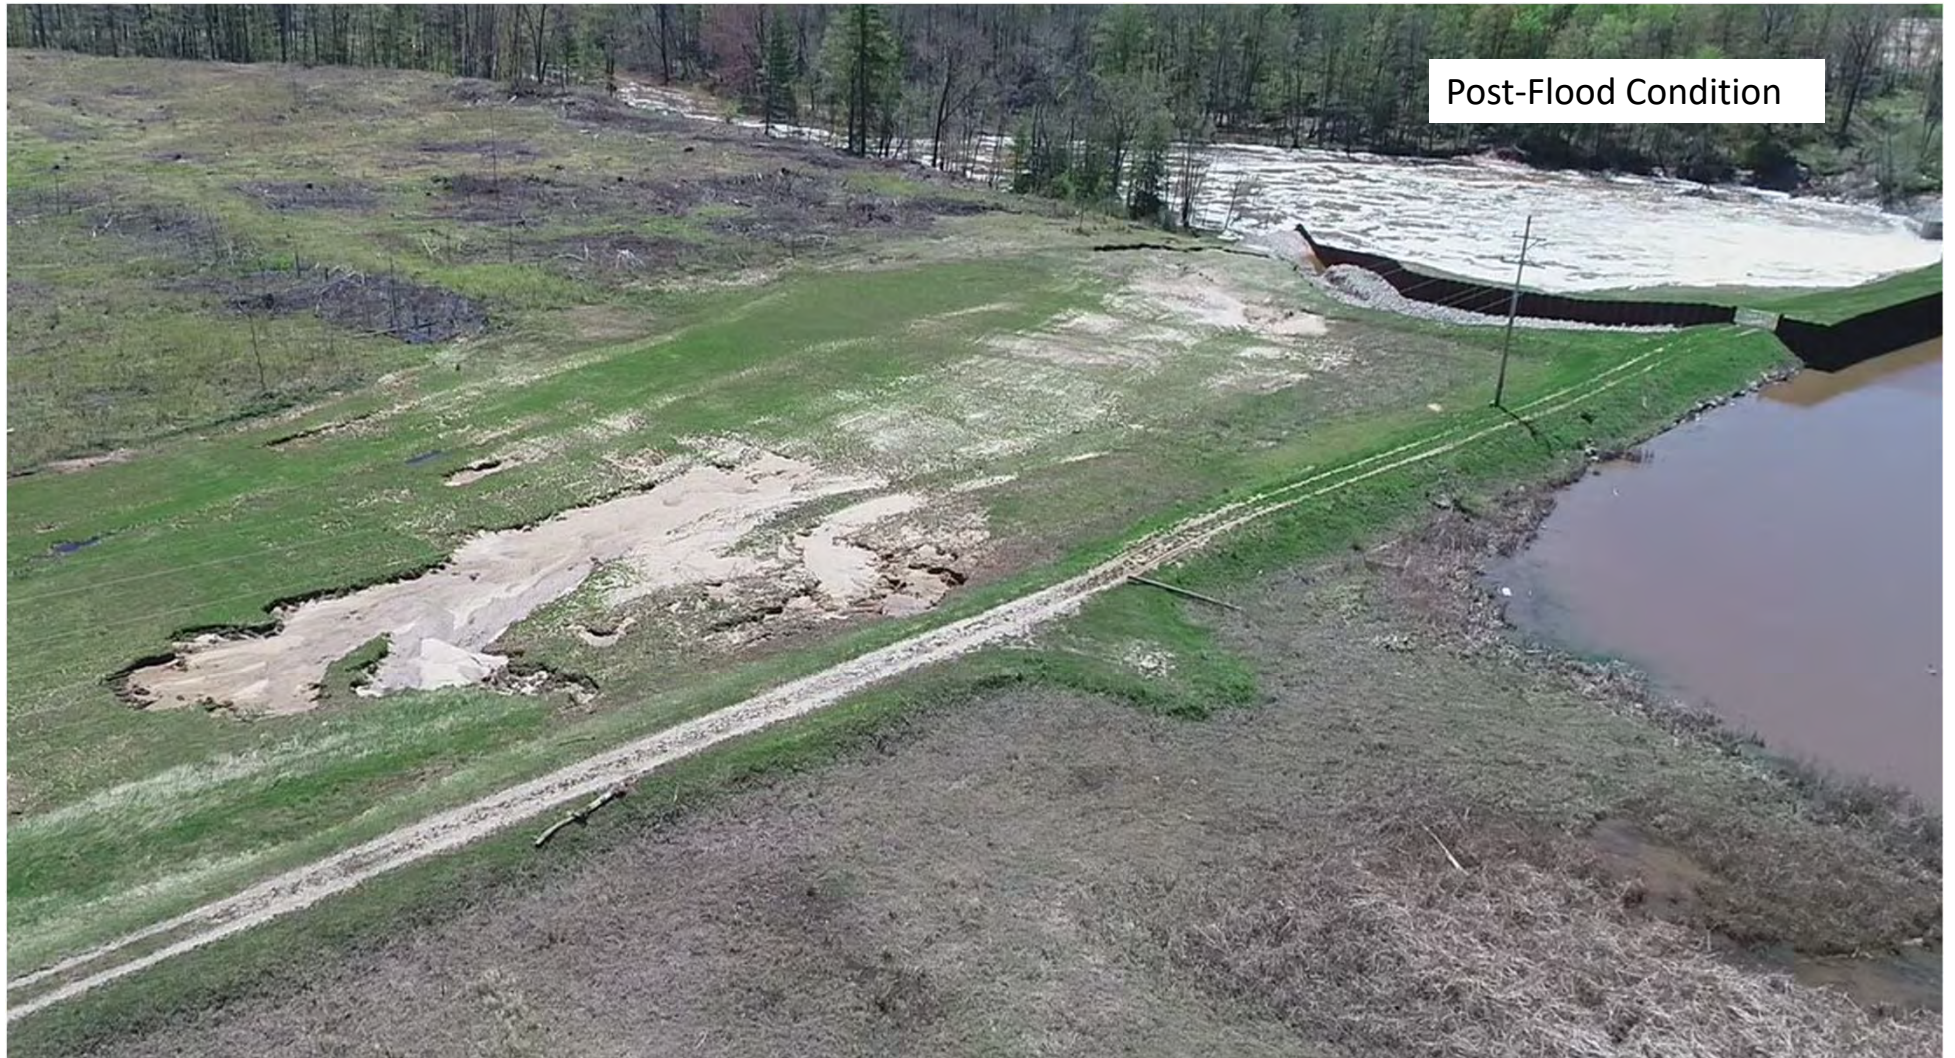
Post-Flood Condition
