**Secord Dam –
Gladwin County, Michigan**

**Four Lakes Task Force and Spicer Group,
Inc.**

Wetland Delineation Report

April 2021

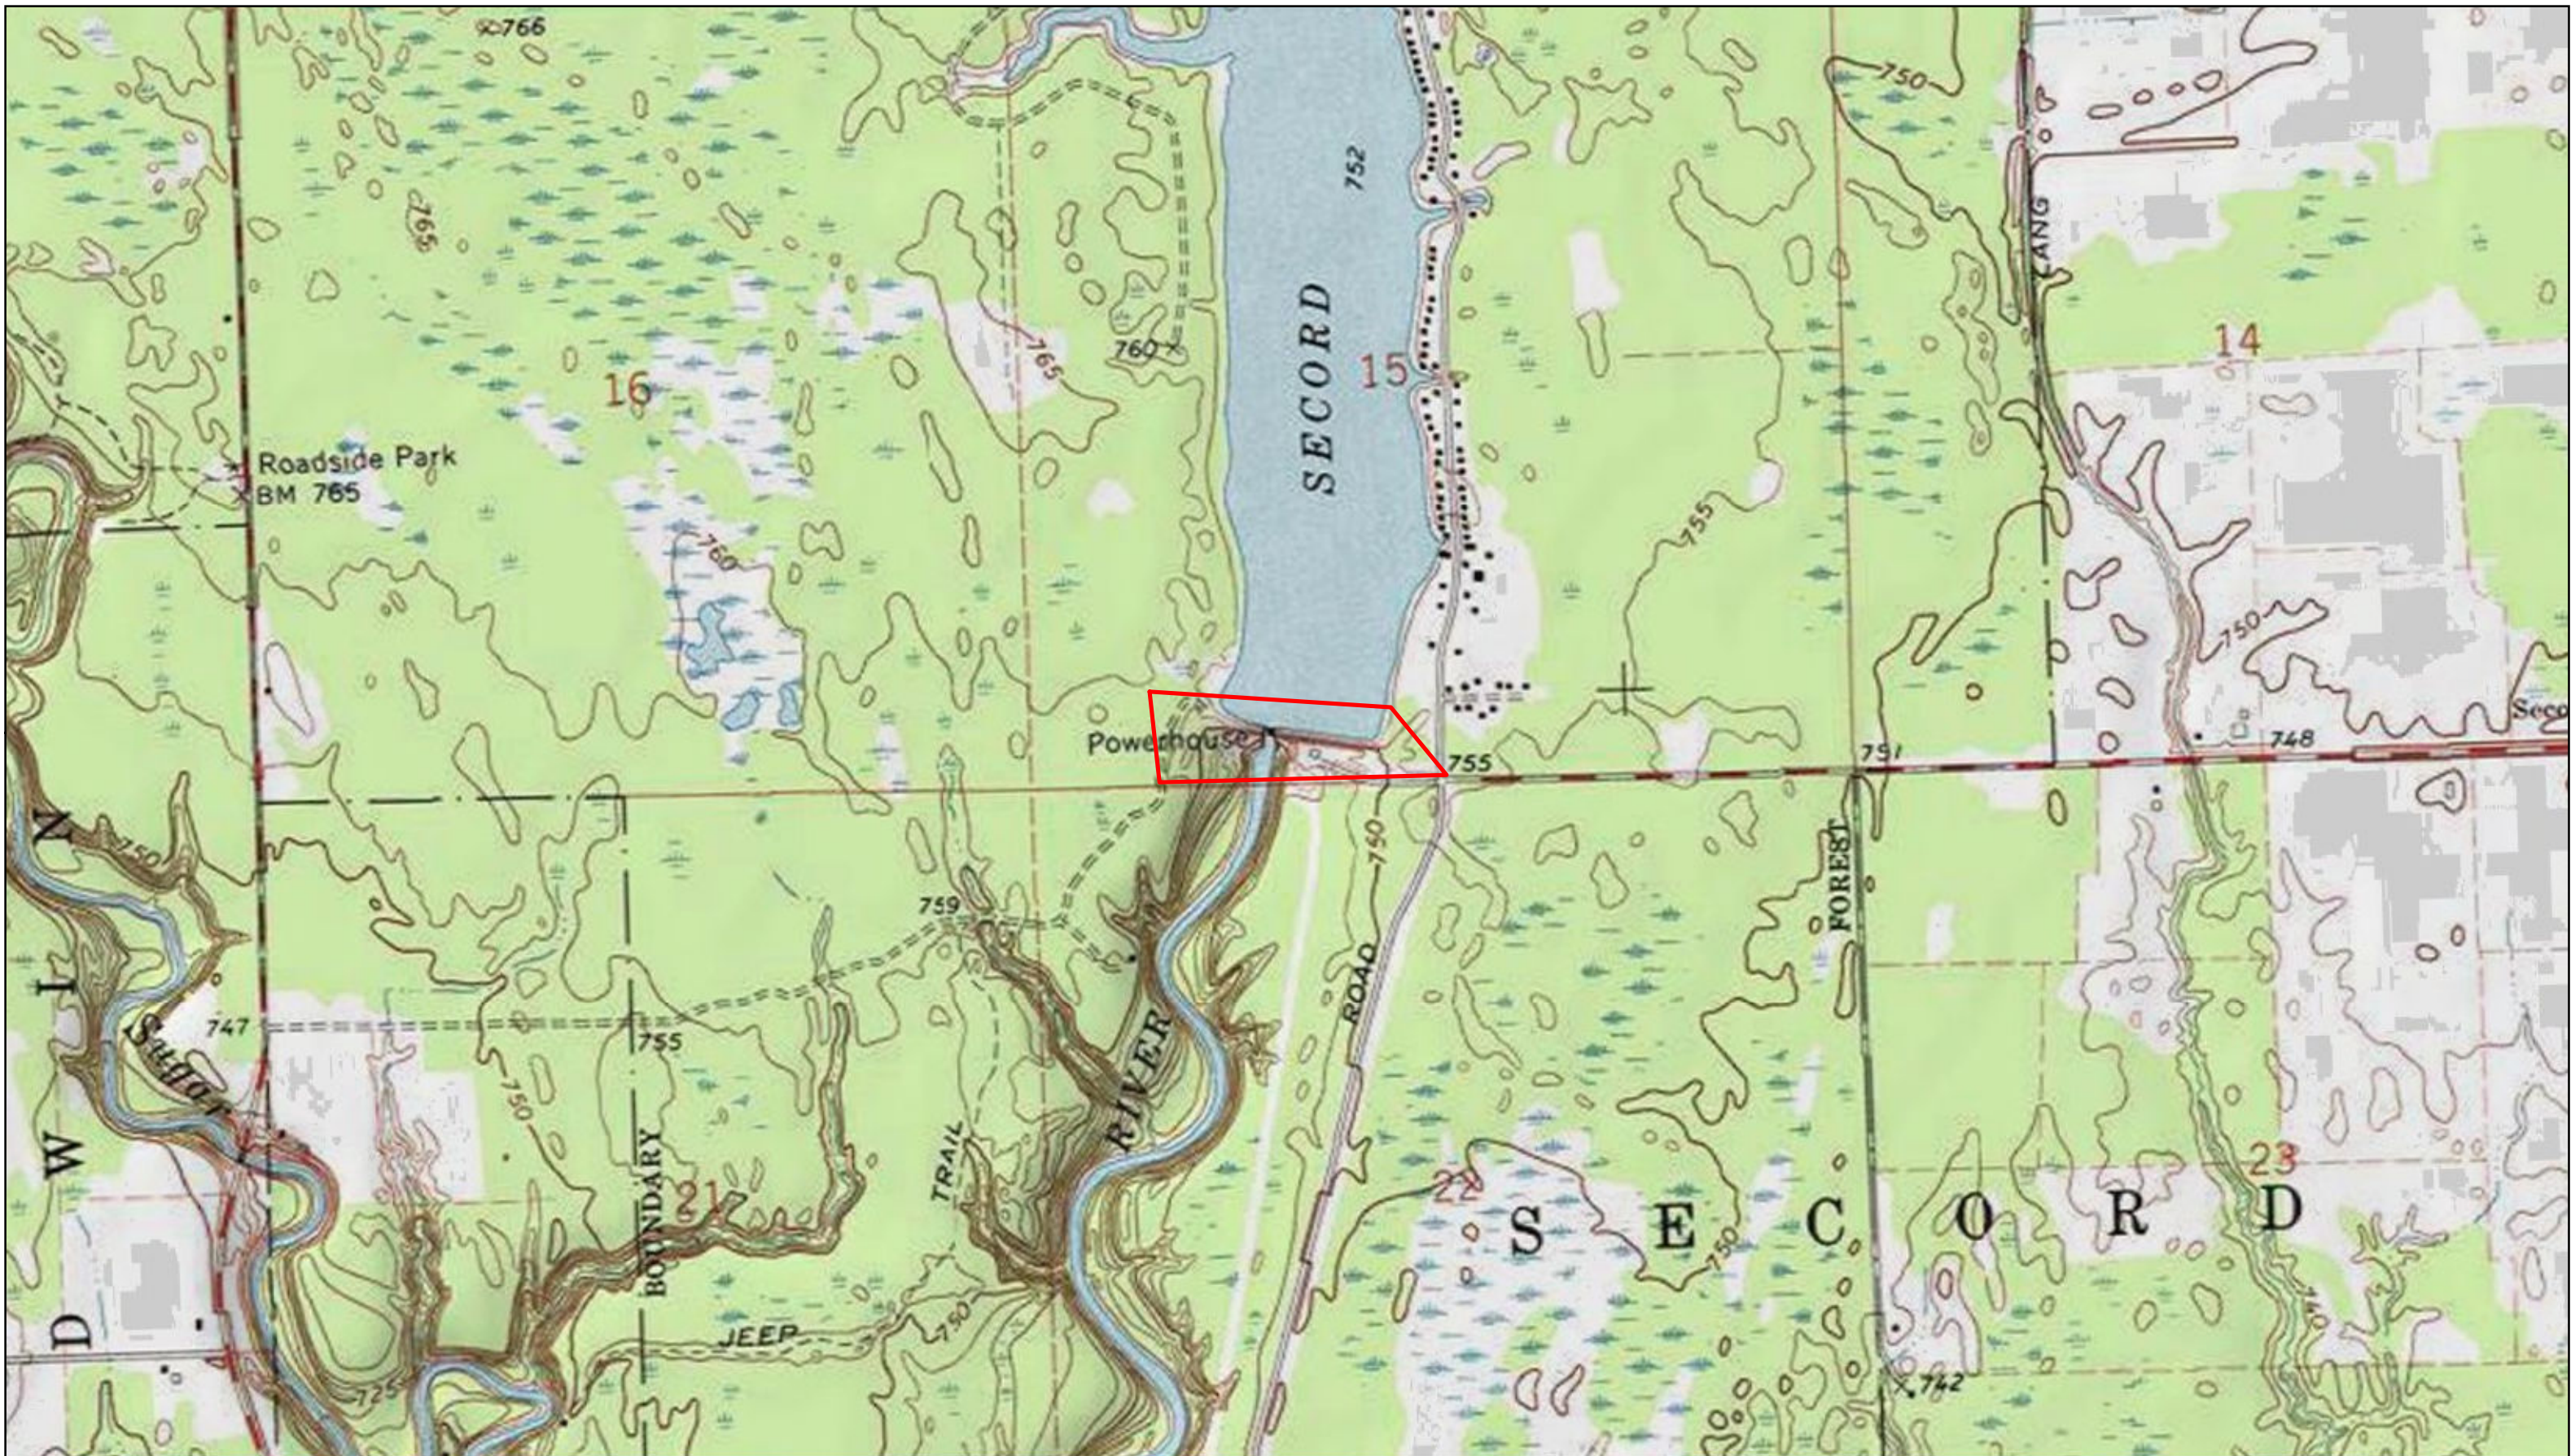
Figure 2
Topography

The USGS topographic map (Figure 2) shows gently sloping areas on either side of the Tittabawassee River that become steeper as they approach the banks of the river. Steep slopes also exist along the southern and northern edges of the Secord Dam berm.

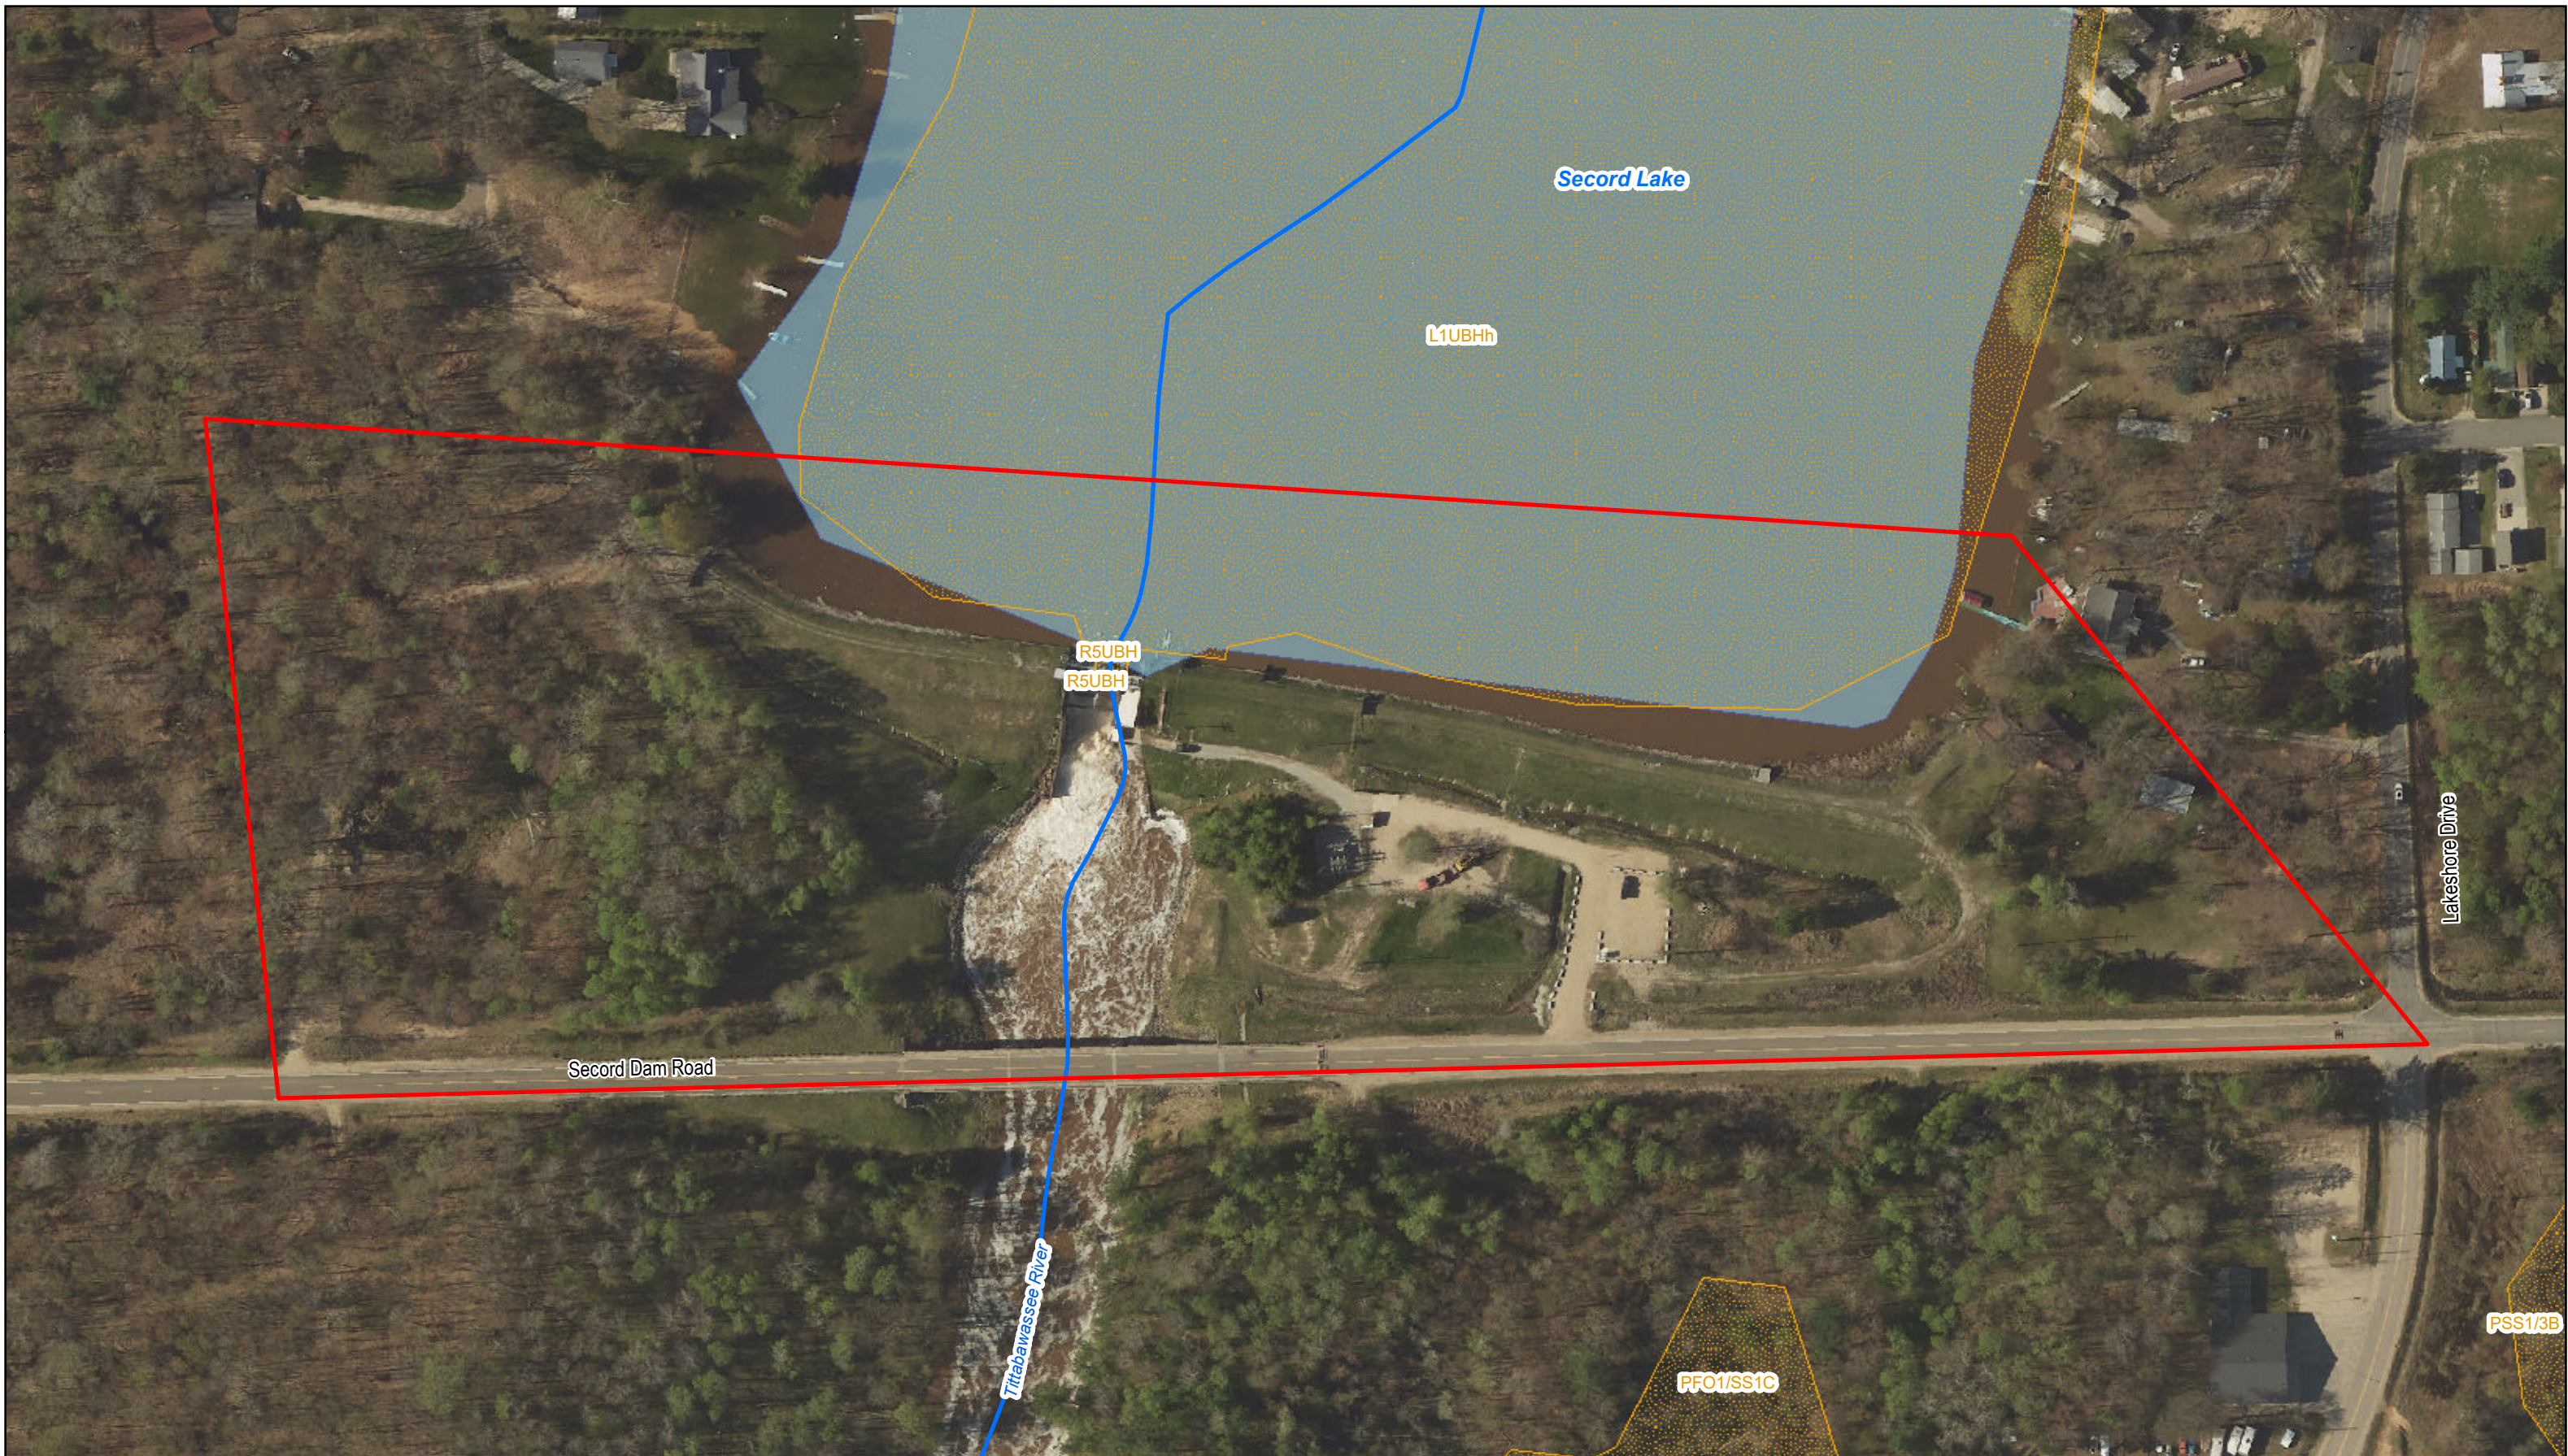
Figure 3
Hydrology

The NWI map of the survey area (Figure 3) shows approximately 3.04 acres of wetlands (Table 3-2). The lacustrine wetland area is mapped in the historic lakebed above Secord Dam. The riverine wetland is mapped in the Tittabawassee River course.

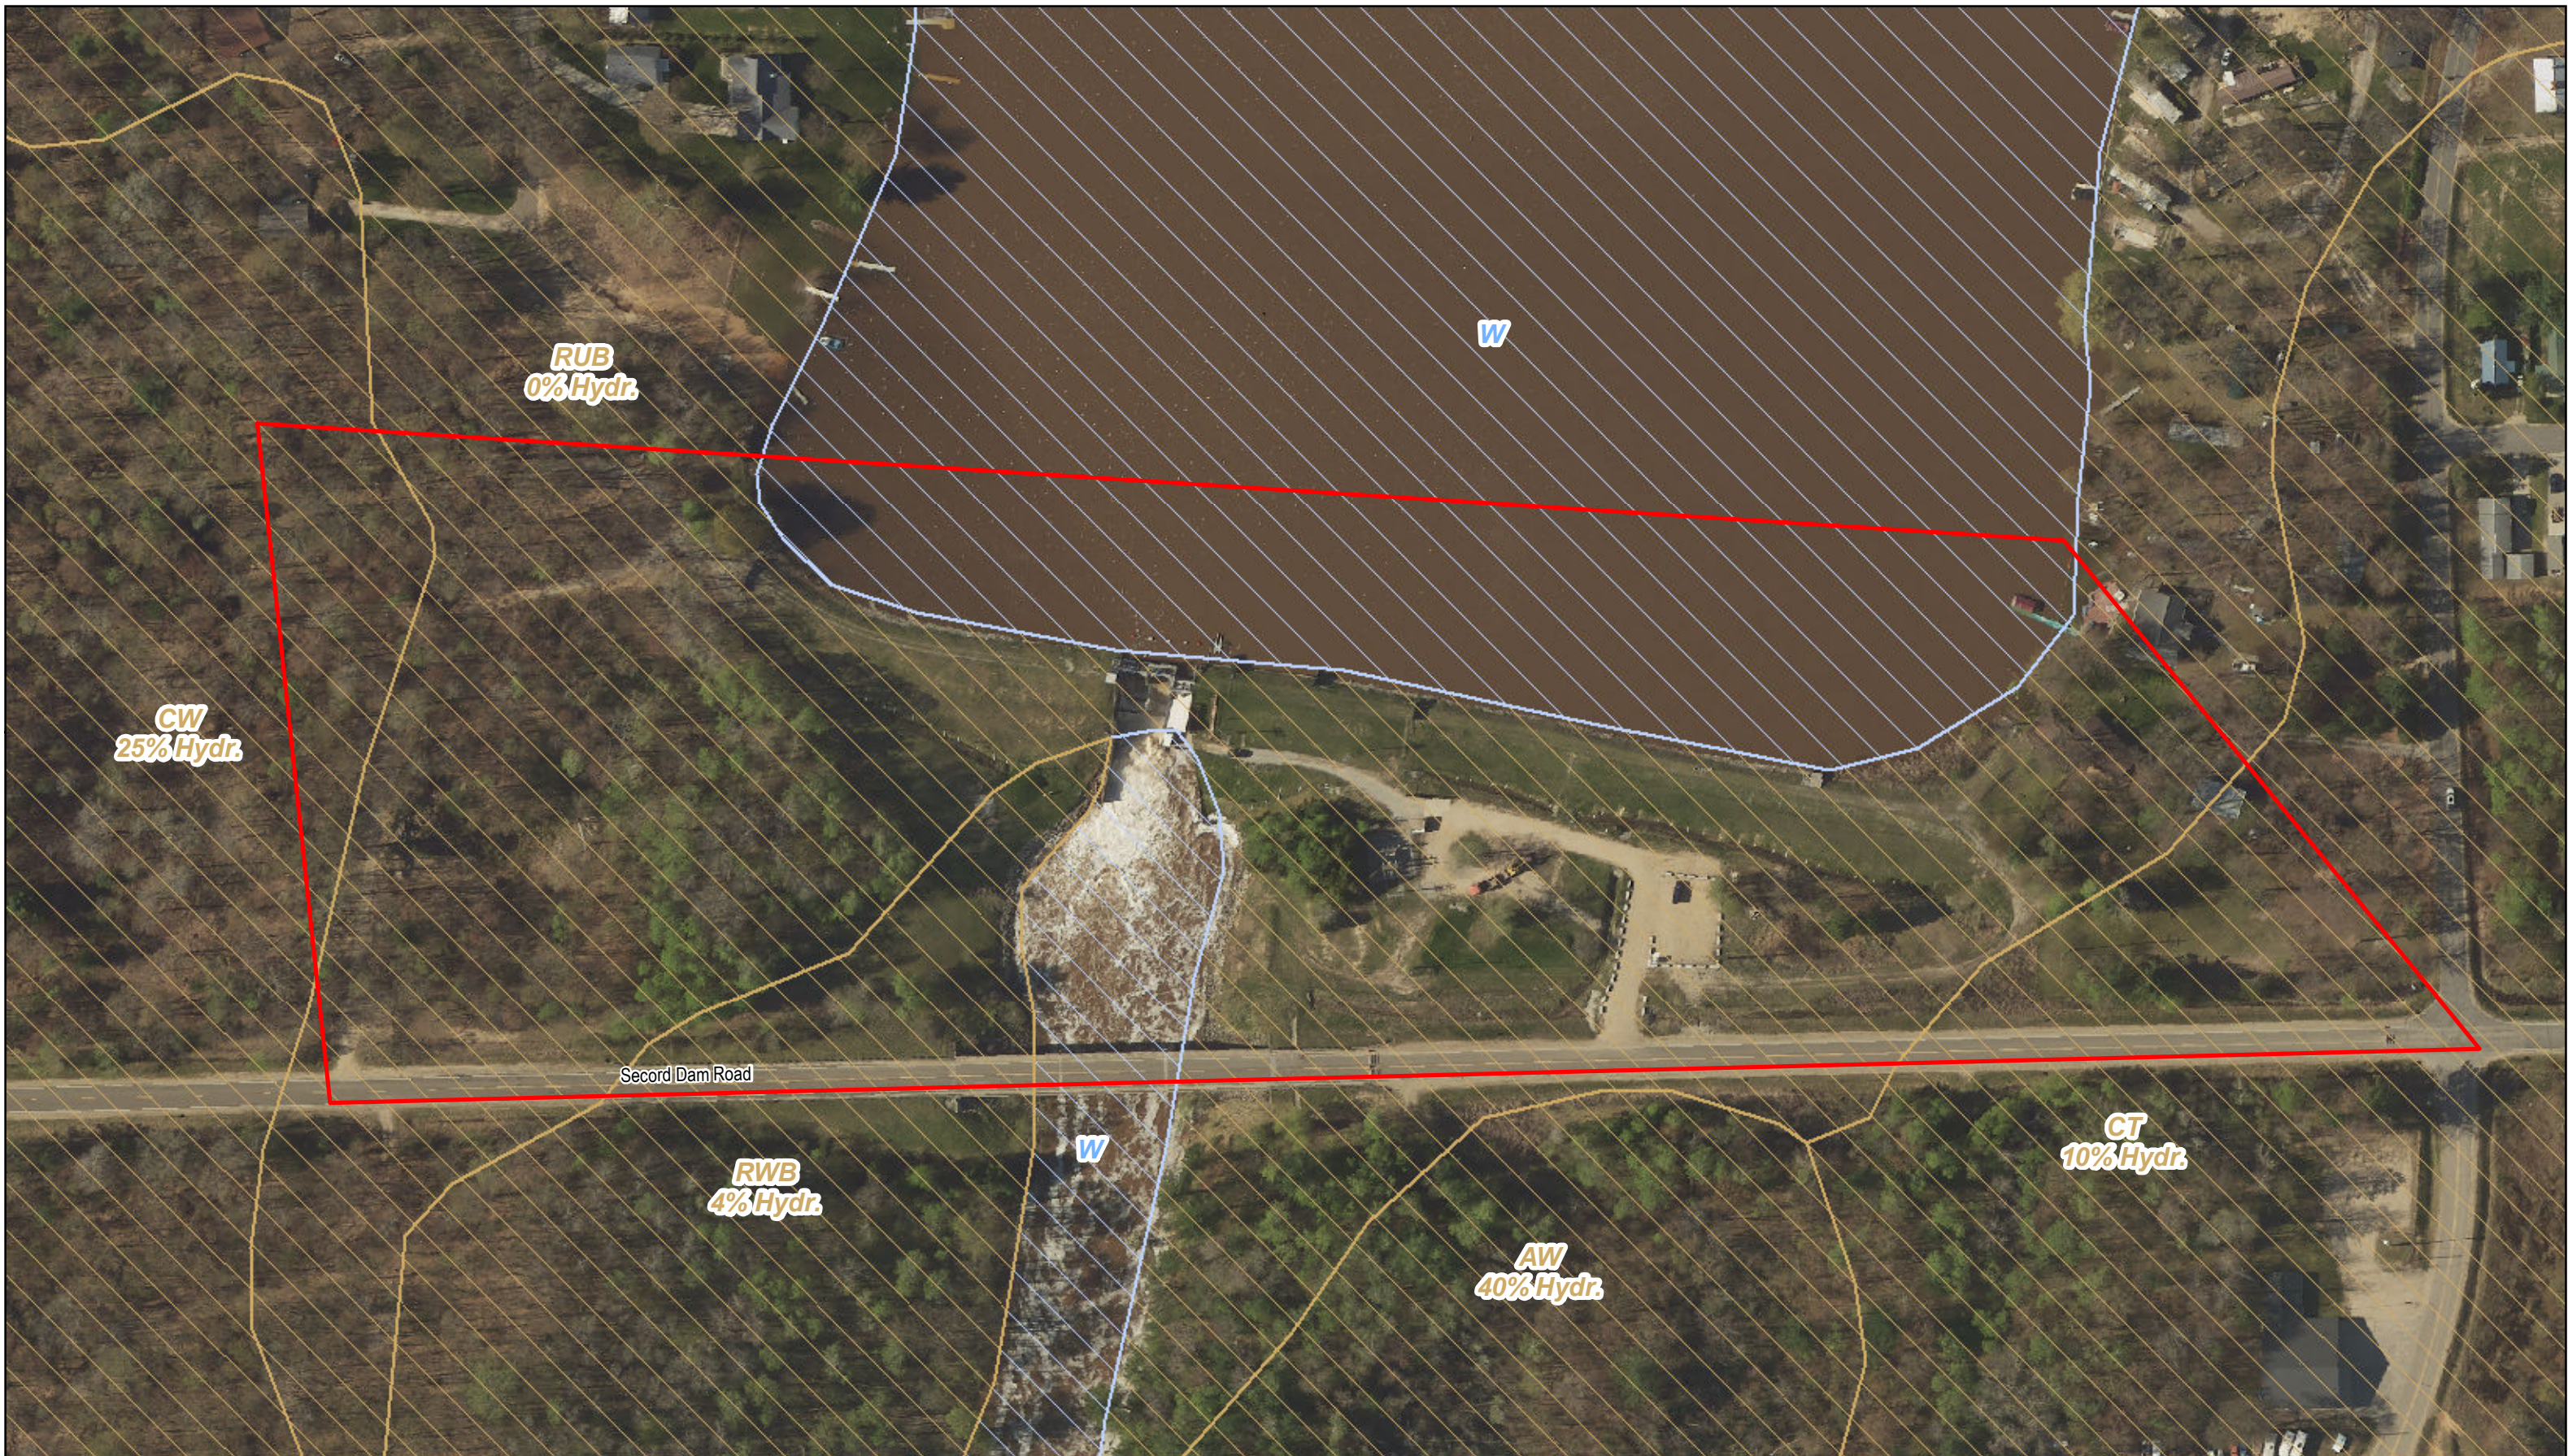
Figure 4
SSURGO Soil Type

The USDA-NRCS soil map of the survey area (Figure 4) identified five soil types, none of which are hydric (Table 3-1).

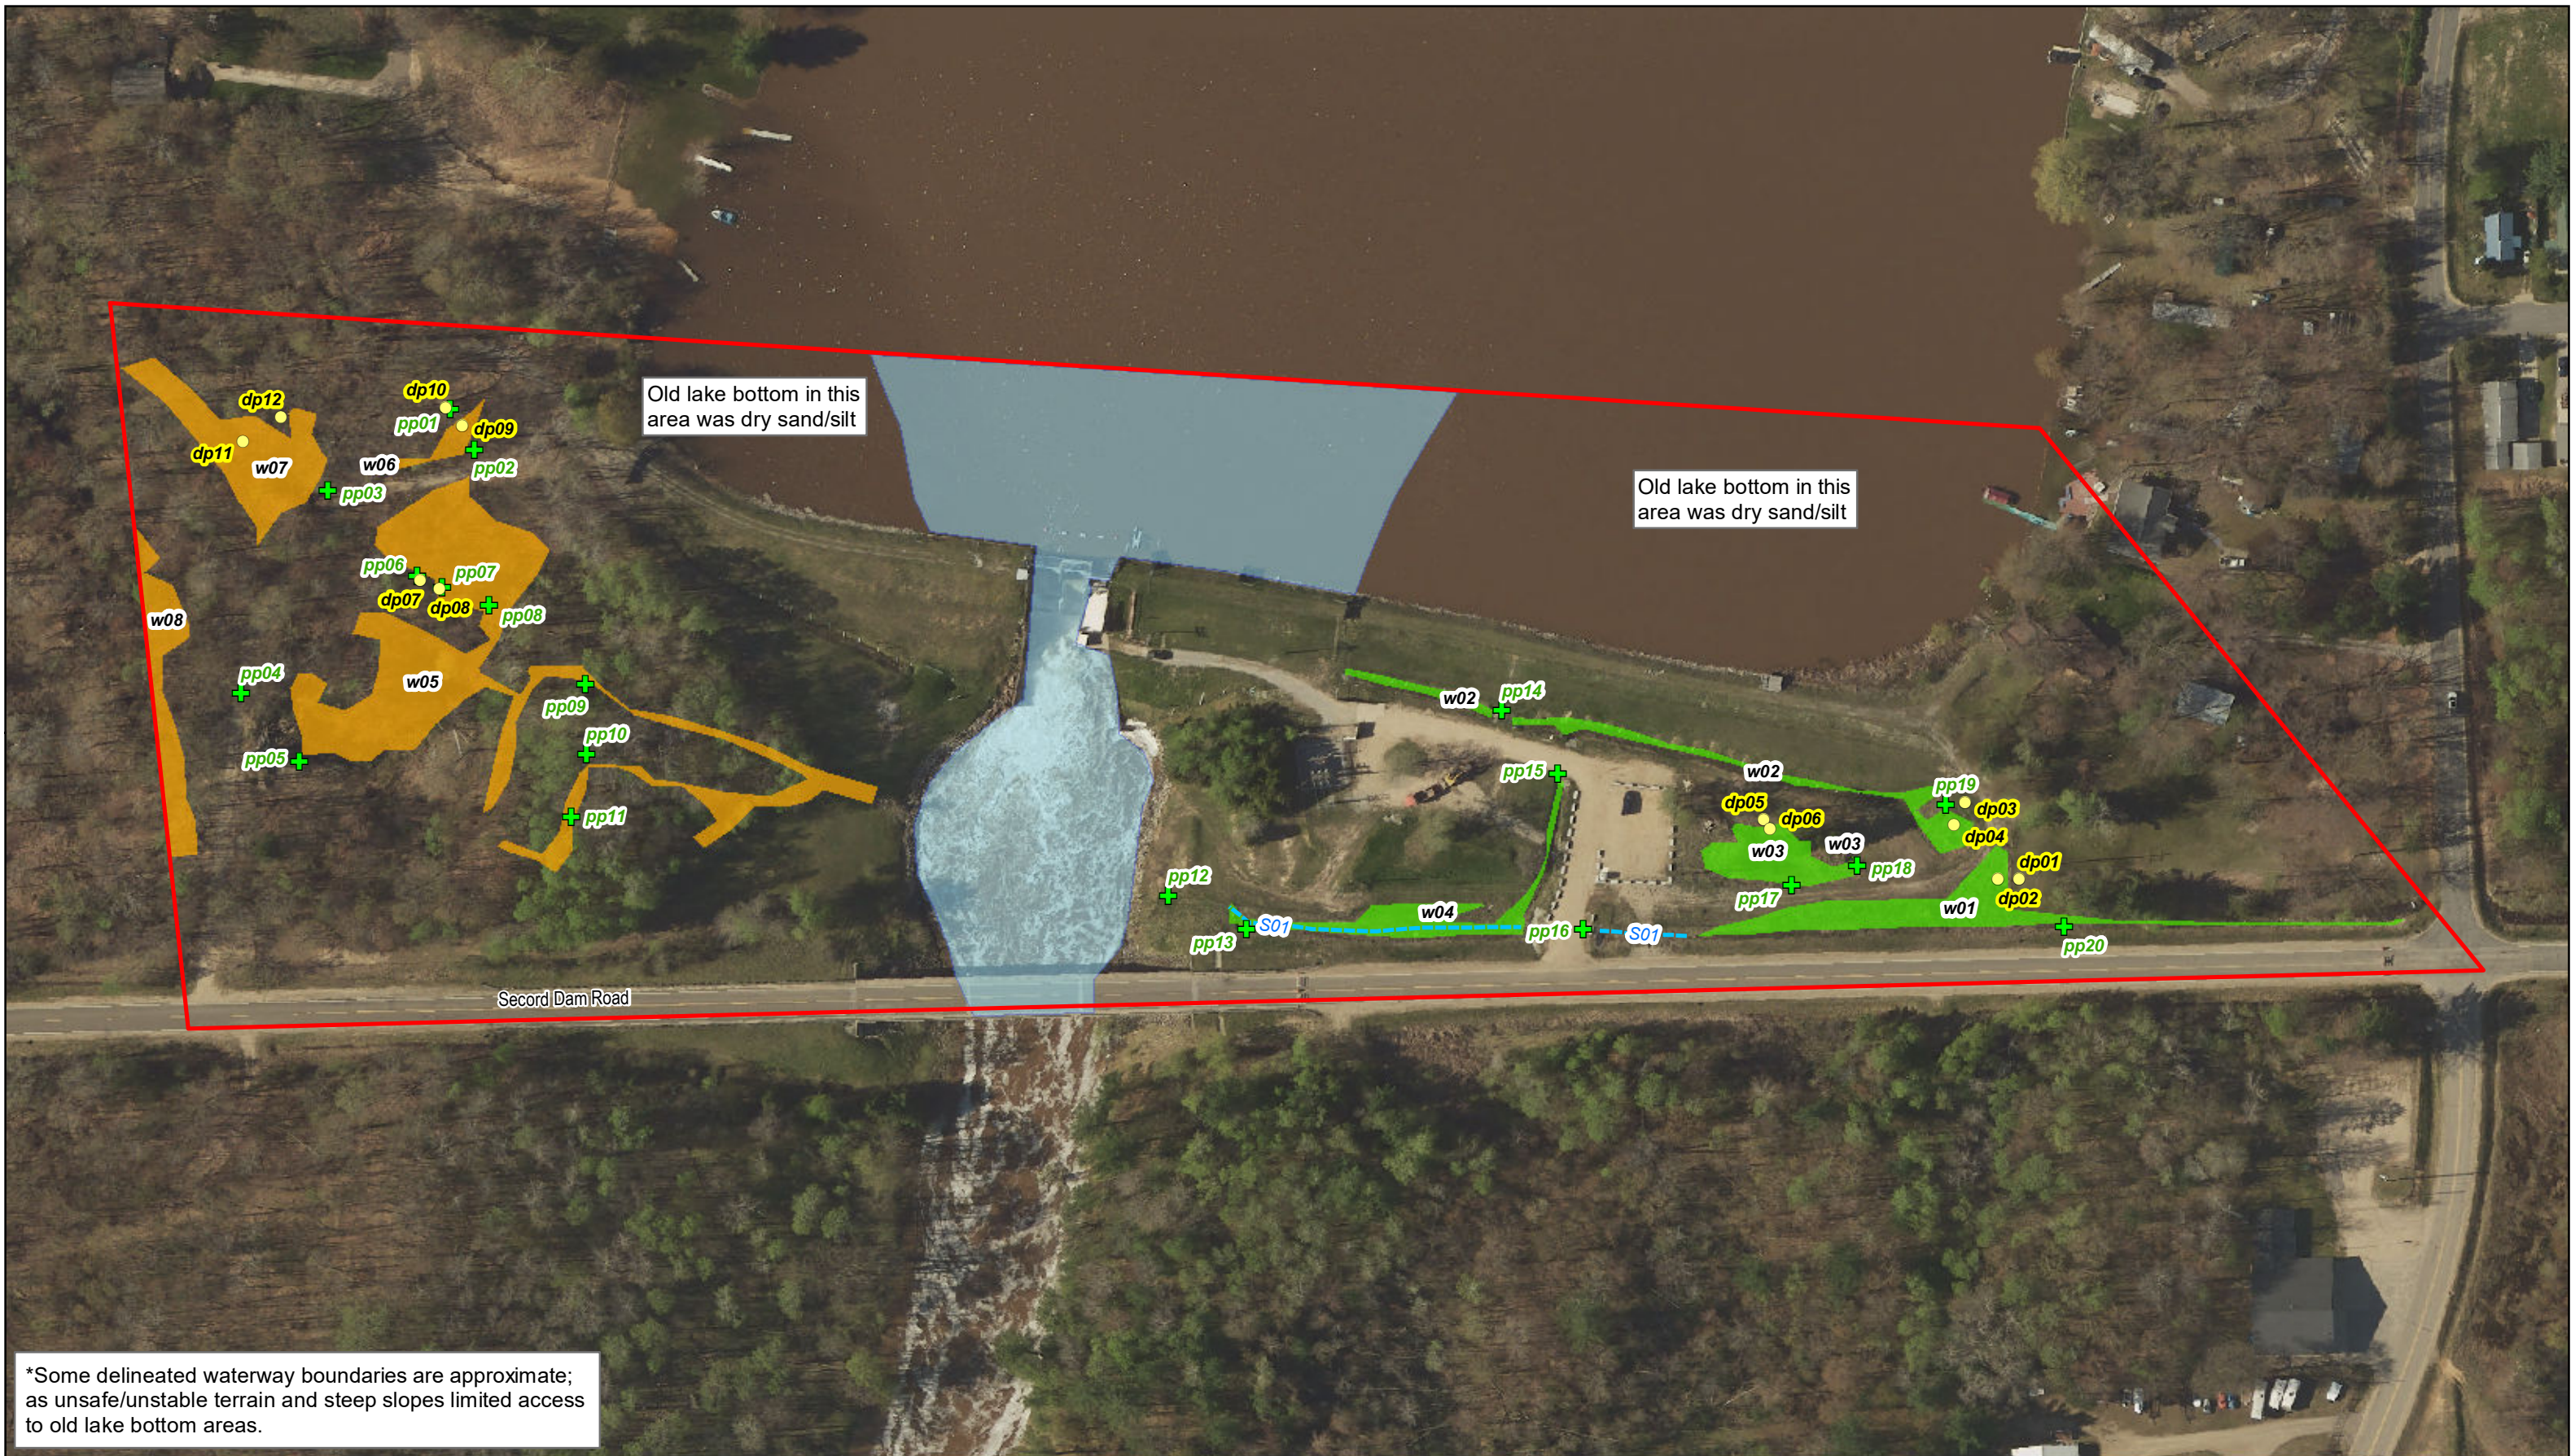
Figure 5
Wetland Delineation

Based on the field survey and review of desktop resources, it is our professional opinion that eight wetlands totaling 1.37 acres and two waterways exist within the survey area (Figure 5). Descriptions of the wetlands and waterways are provided below.

A total of eight wetlands were identified to community type within the survey area (Figure 5) according to Cowardin classification (Appendix C). Summaries of these features are provided below (Table 3-4), and more detailed information for associated data points may be found in wetland determination forms (Appendix B).

*Some delineated waterway boundaries are approximate; as unsafe/unstable terrain and steep slopes limited access to old lake bottom areas.
