**Smallwood Dam –  
Gladwin County, MI**

**Four Lakes Task Force and Spicer Group,  
Inc.**

**Wetland Delineation Report**

April 2021

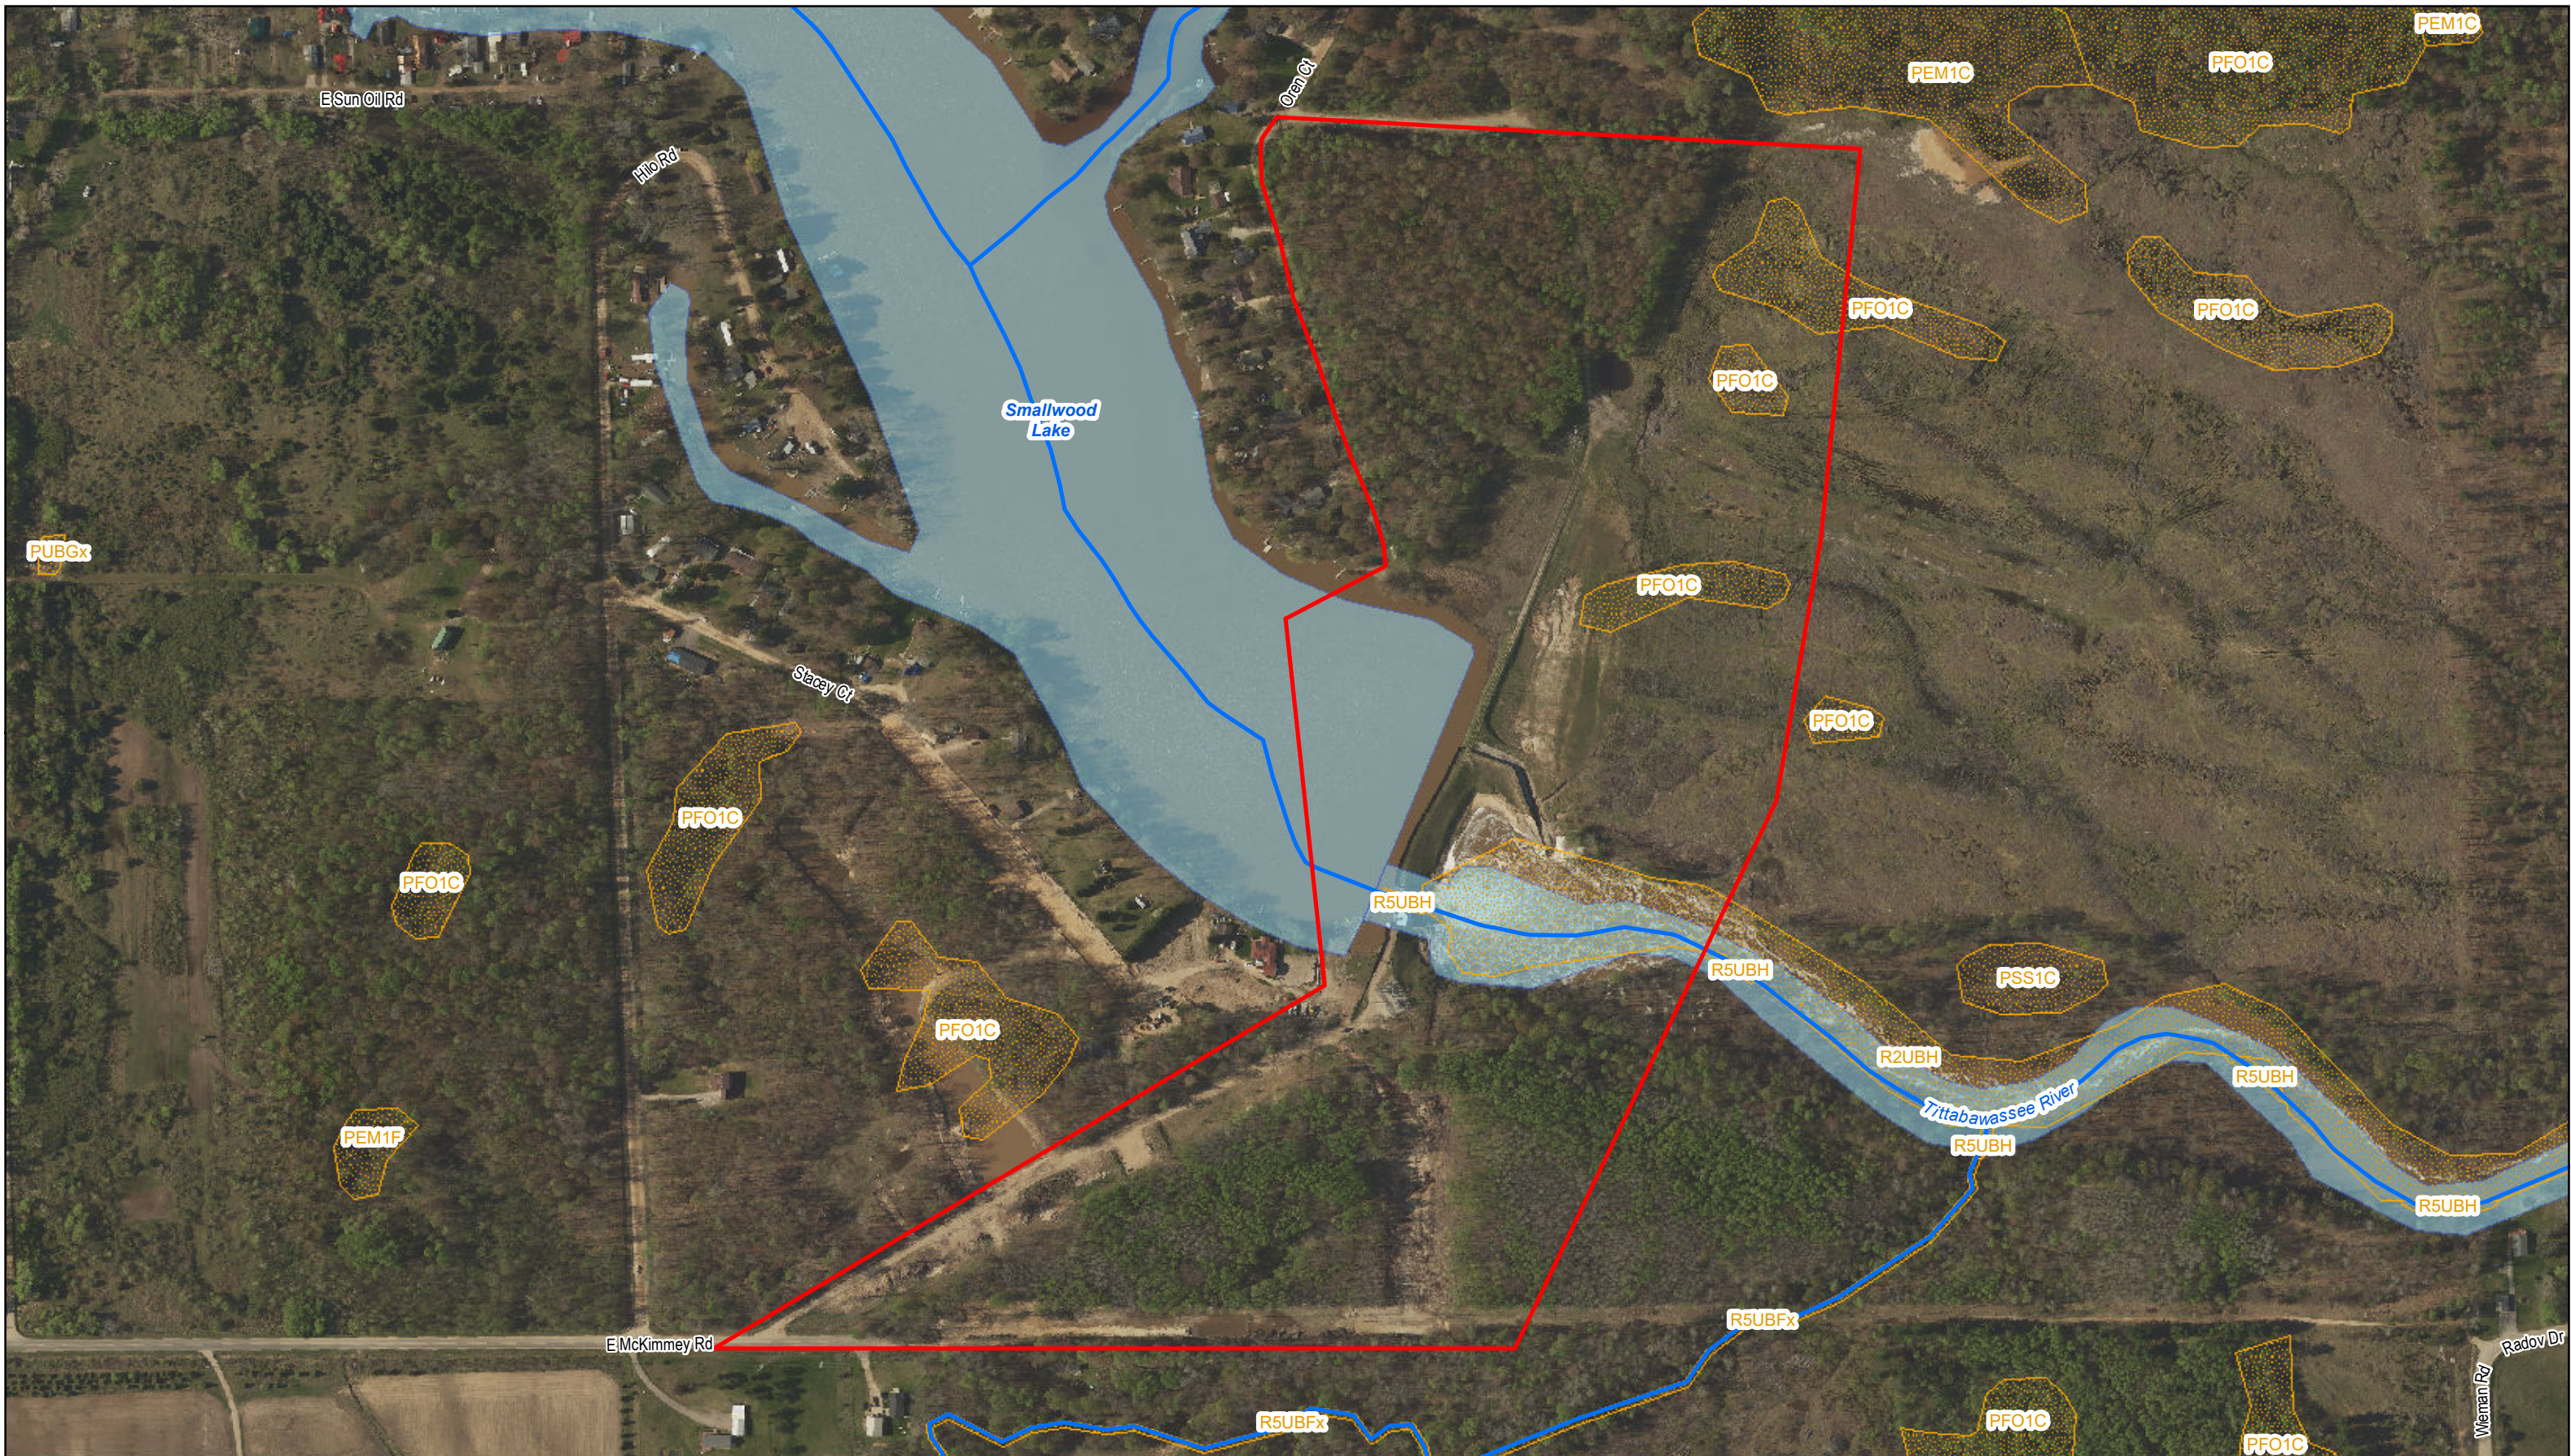
**Figure 3**  
**Hydrology**

**Hydrology  
Smallwood Dam Site  
Spicer Group  
Gladwin County, Michigan**

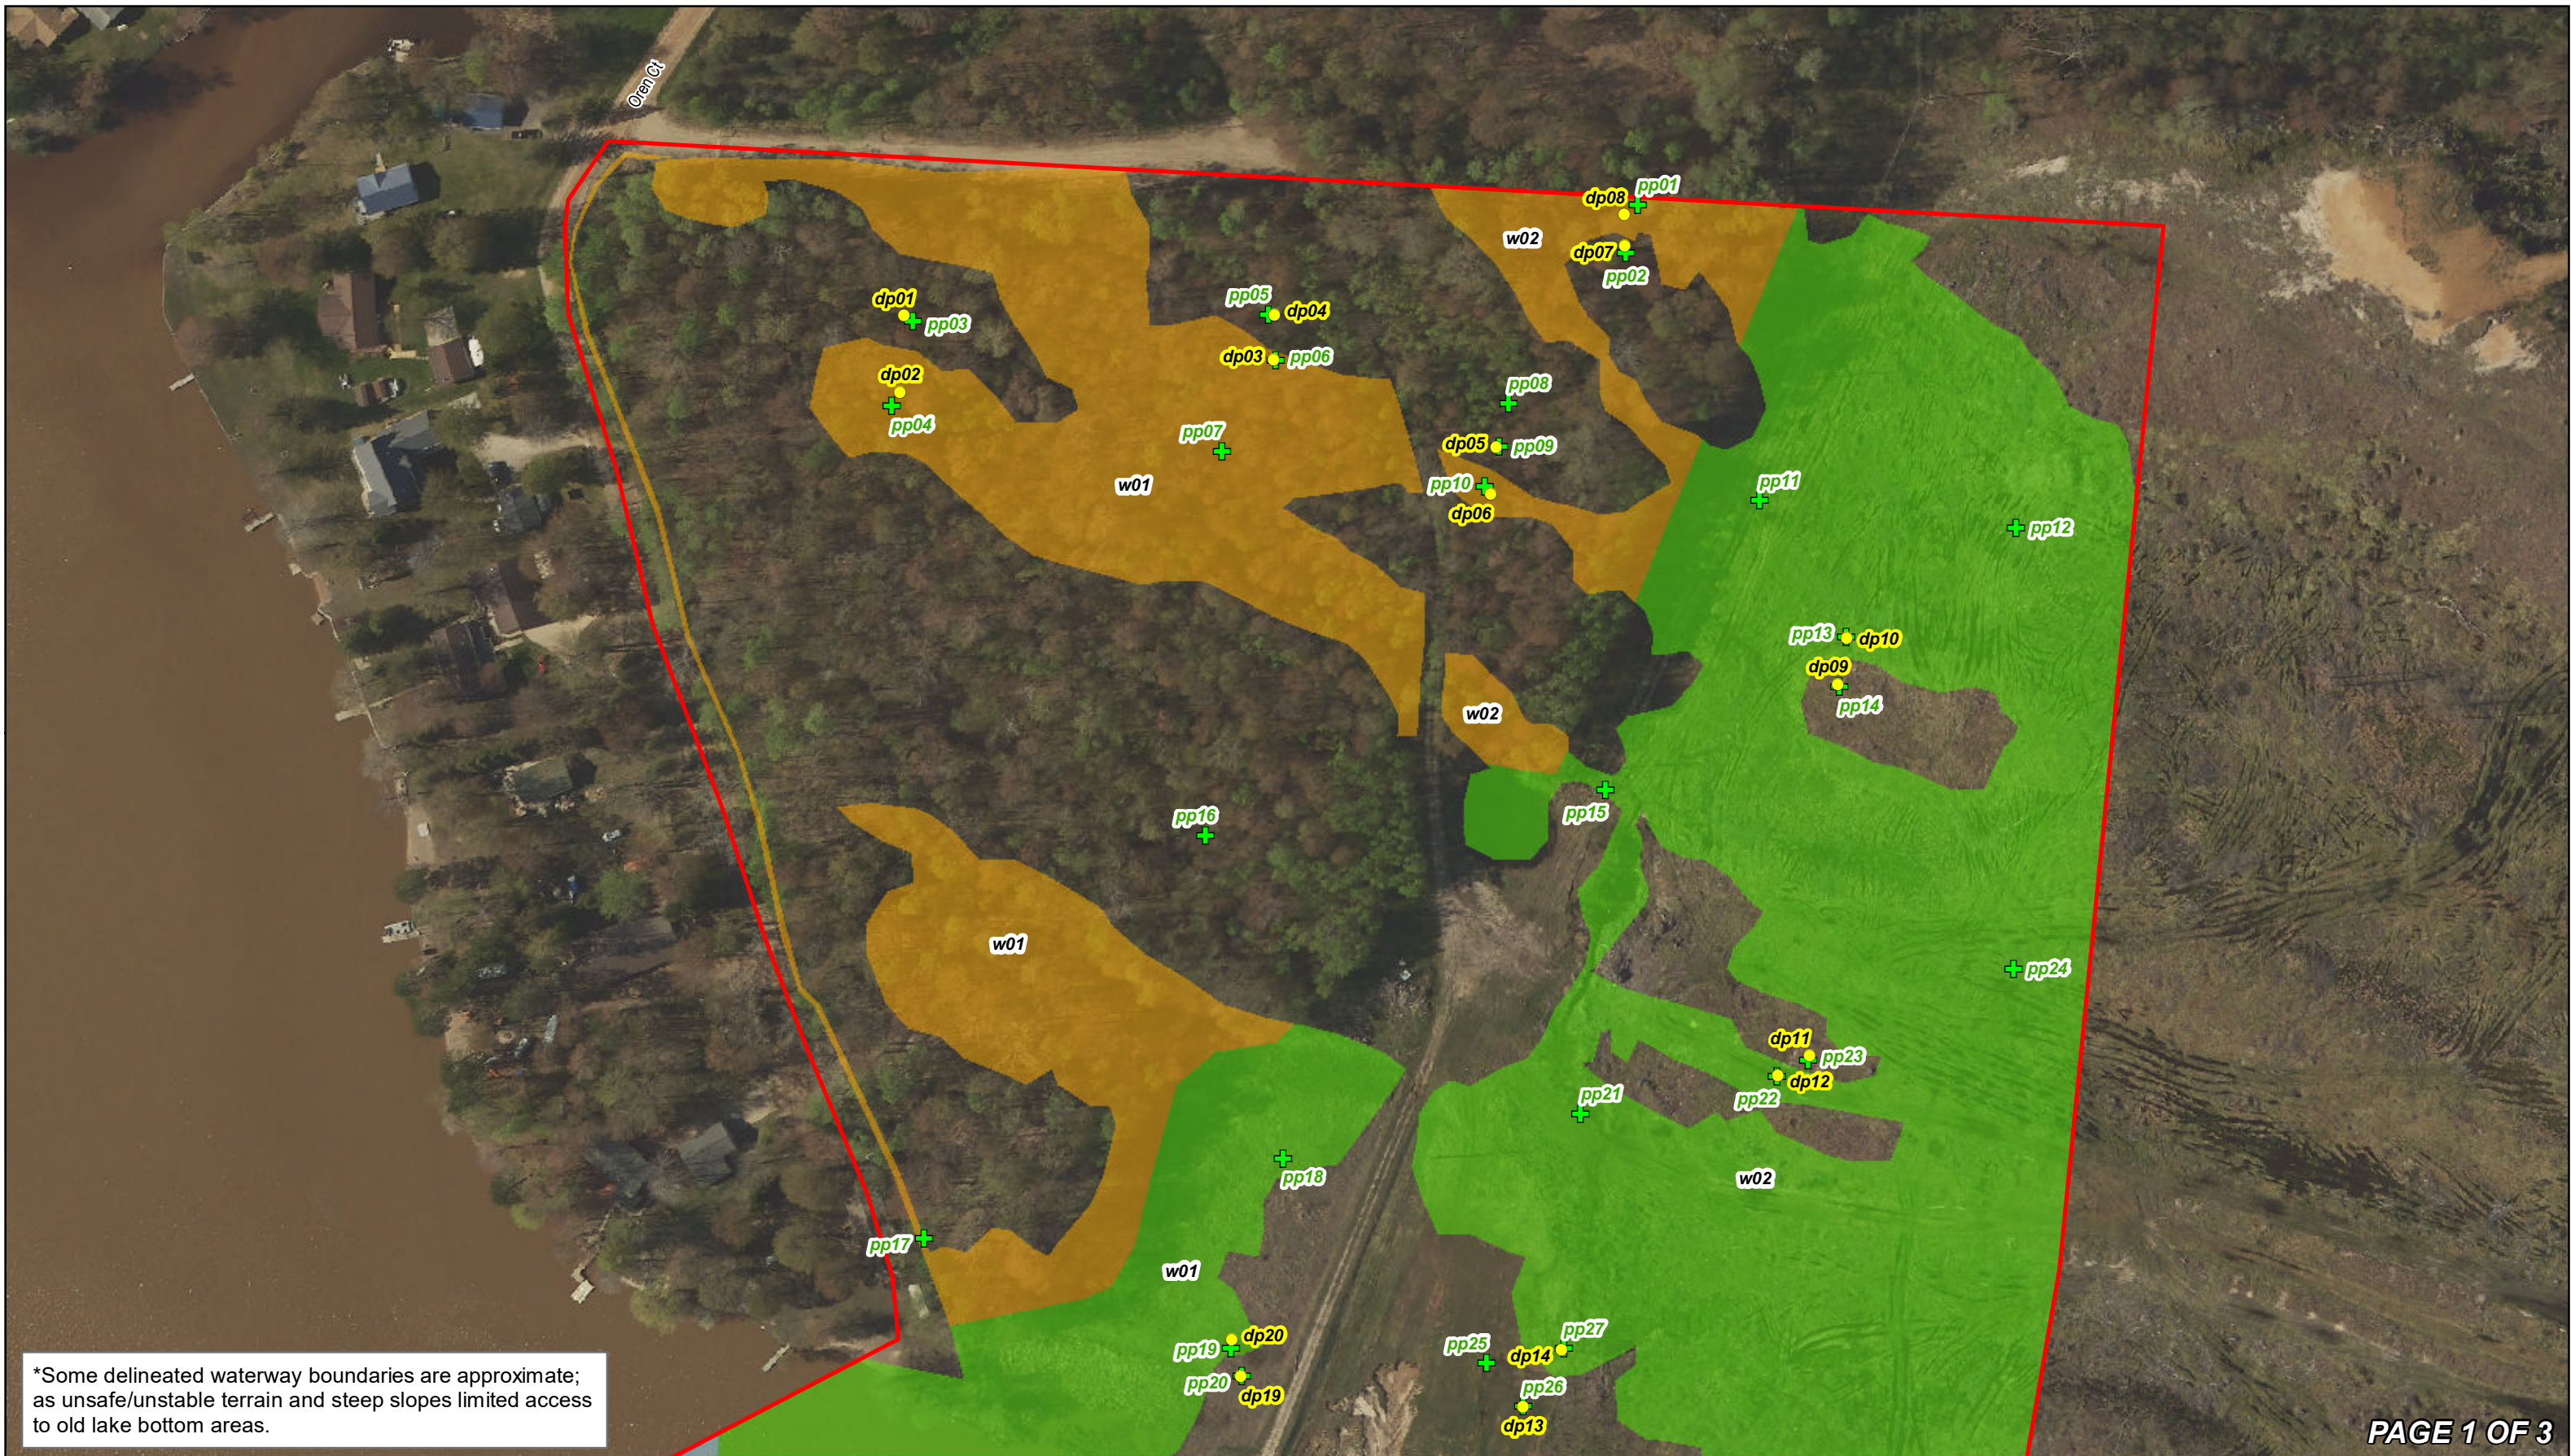
**Figure 5**  
**Wetland Delineation**

\*Some delineated waterway boundaries are approximate; as unsafe/unstable terrain and steep slopes limited access to old lake bottom areas.

Photographs (Appendix A) provide a visual representation of wetland communities and boundaries, as well as general site conditions at the time of inspection. Photos are geospatially referenced by their associated photo point location and presented with direction taken (e.g., “pp01 view West,” “pp02 view Northeast”). Photo point locations are depicted in the wetland delineation figure (Figure 5).

A total of seven wetlands were identified to community type within the survey area (Figure 5) according to Cowardin classification. Summaries of these features are provided below (Table 3-4), and more detailed information for associated data points may be found in wetland determination forms (Appendix B).

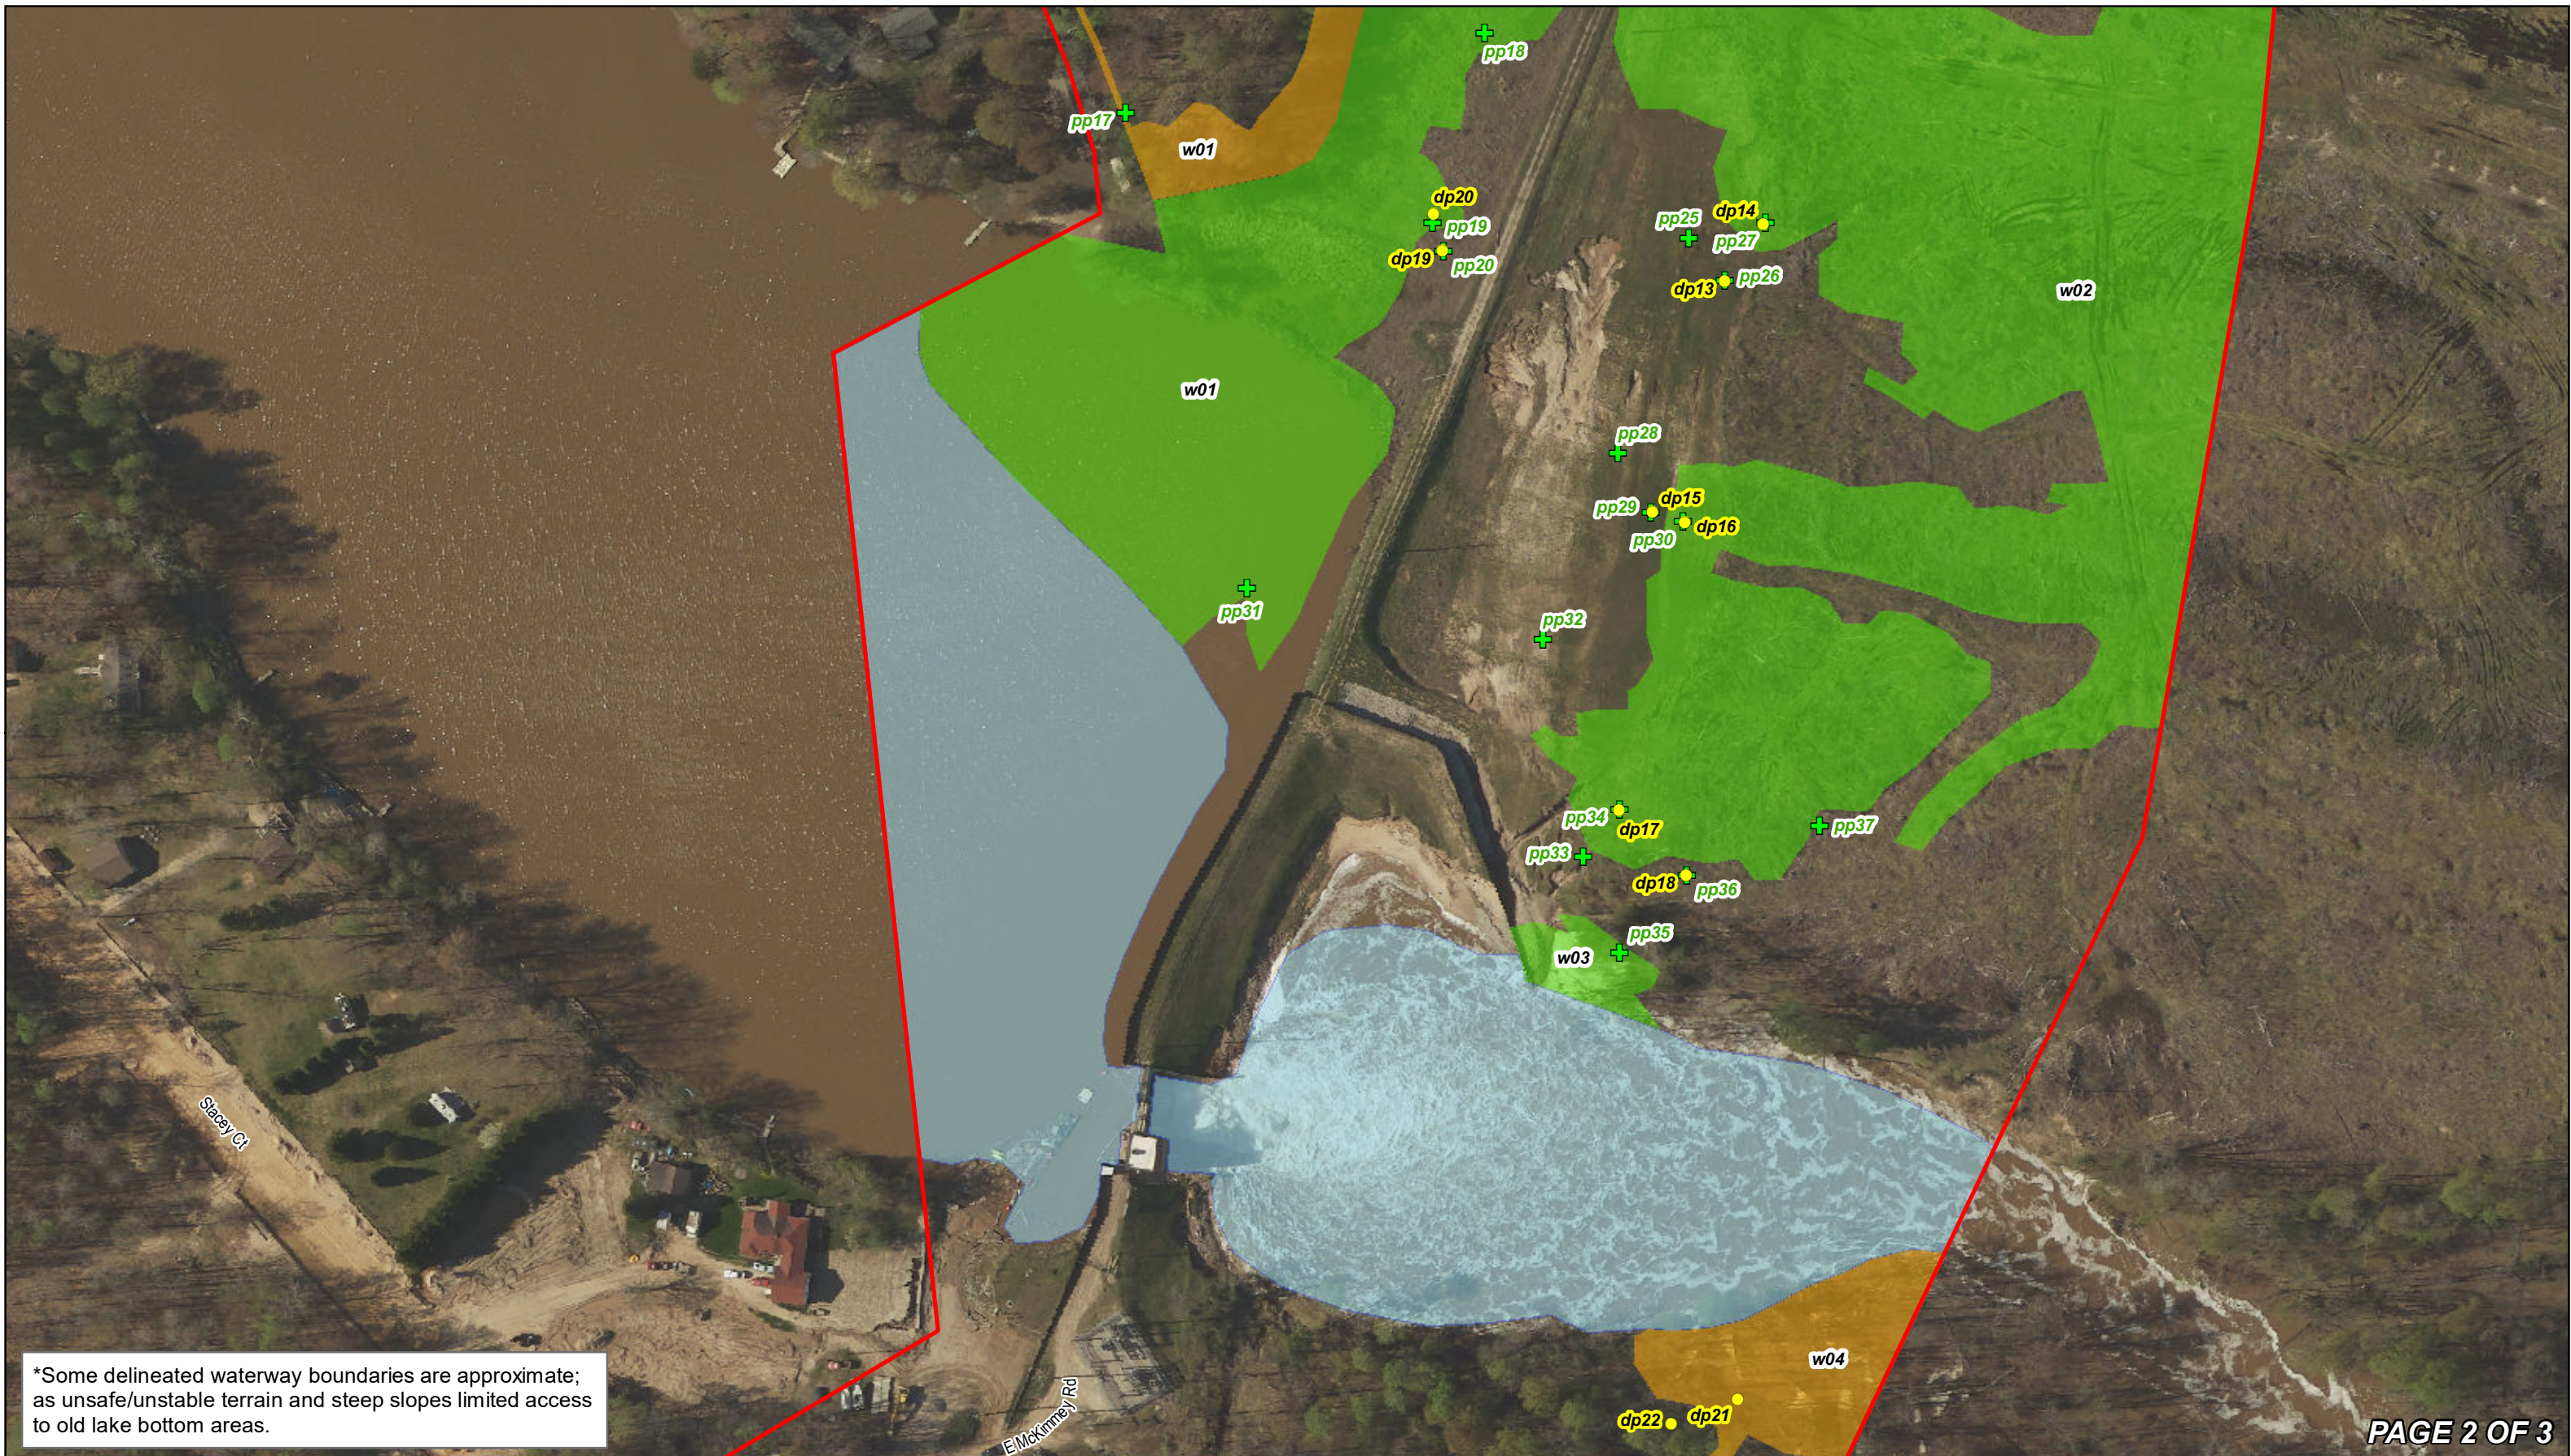
\*Some delineated waterway boundaries are approximate; as unsafe/unstable terrain and steep slopes limited access to old lake bottom areas.

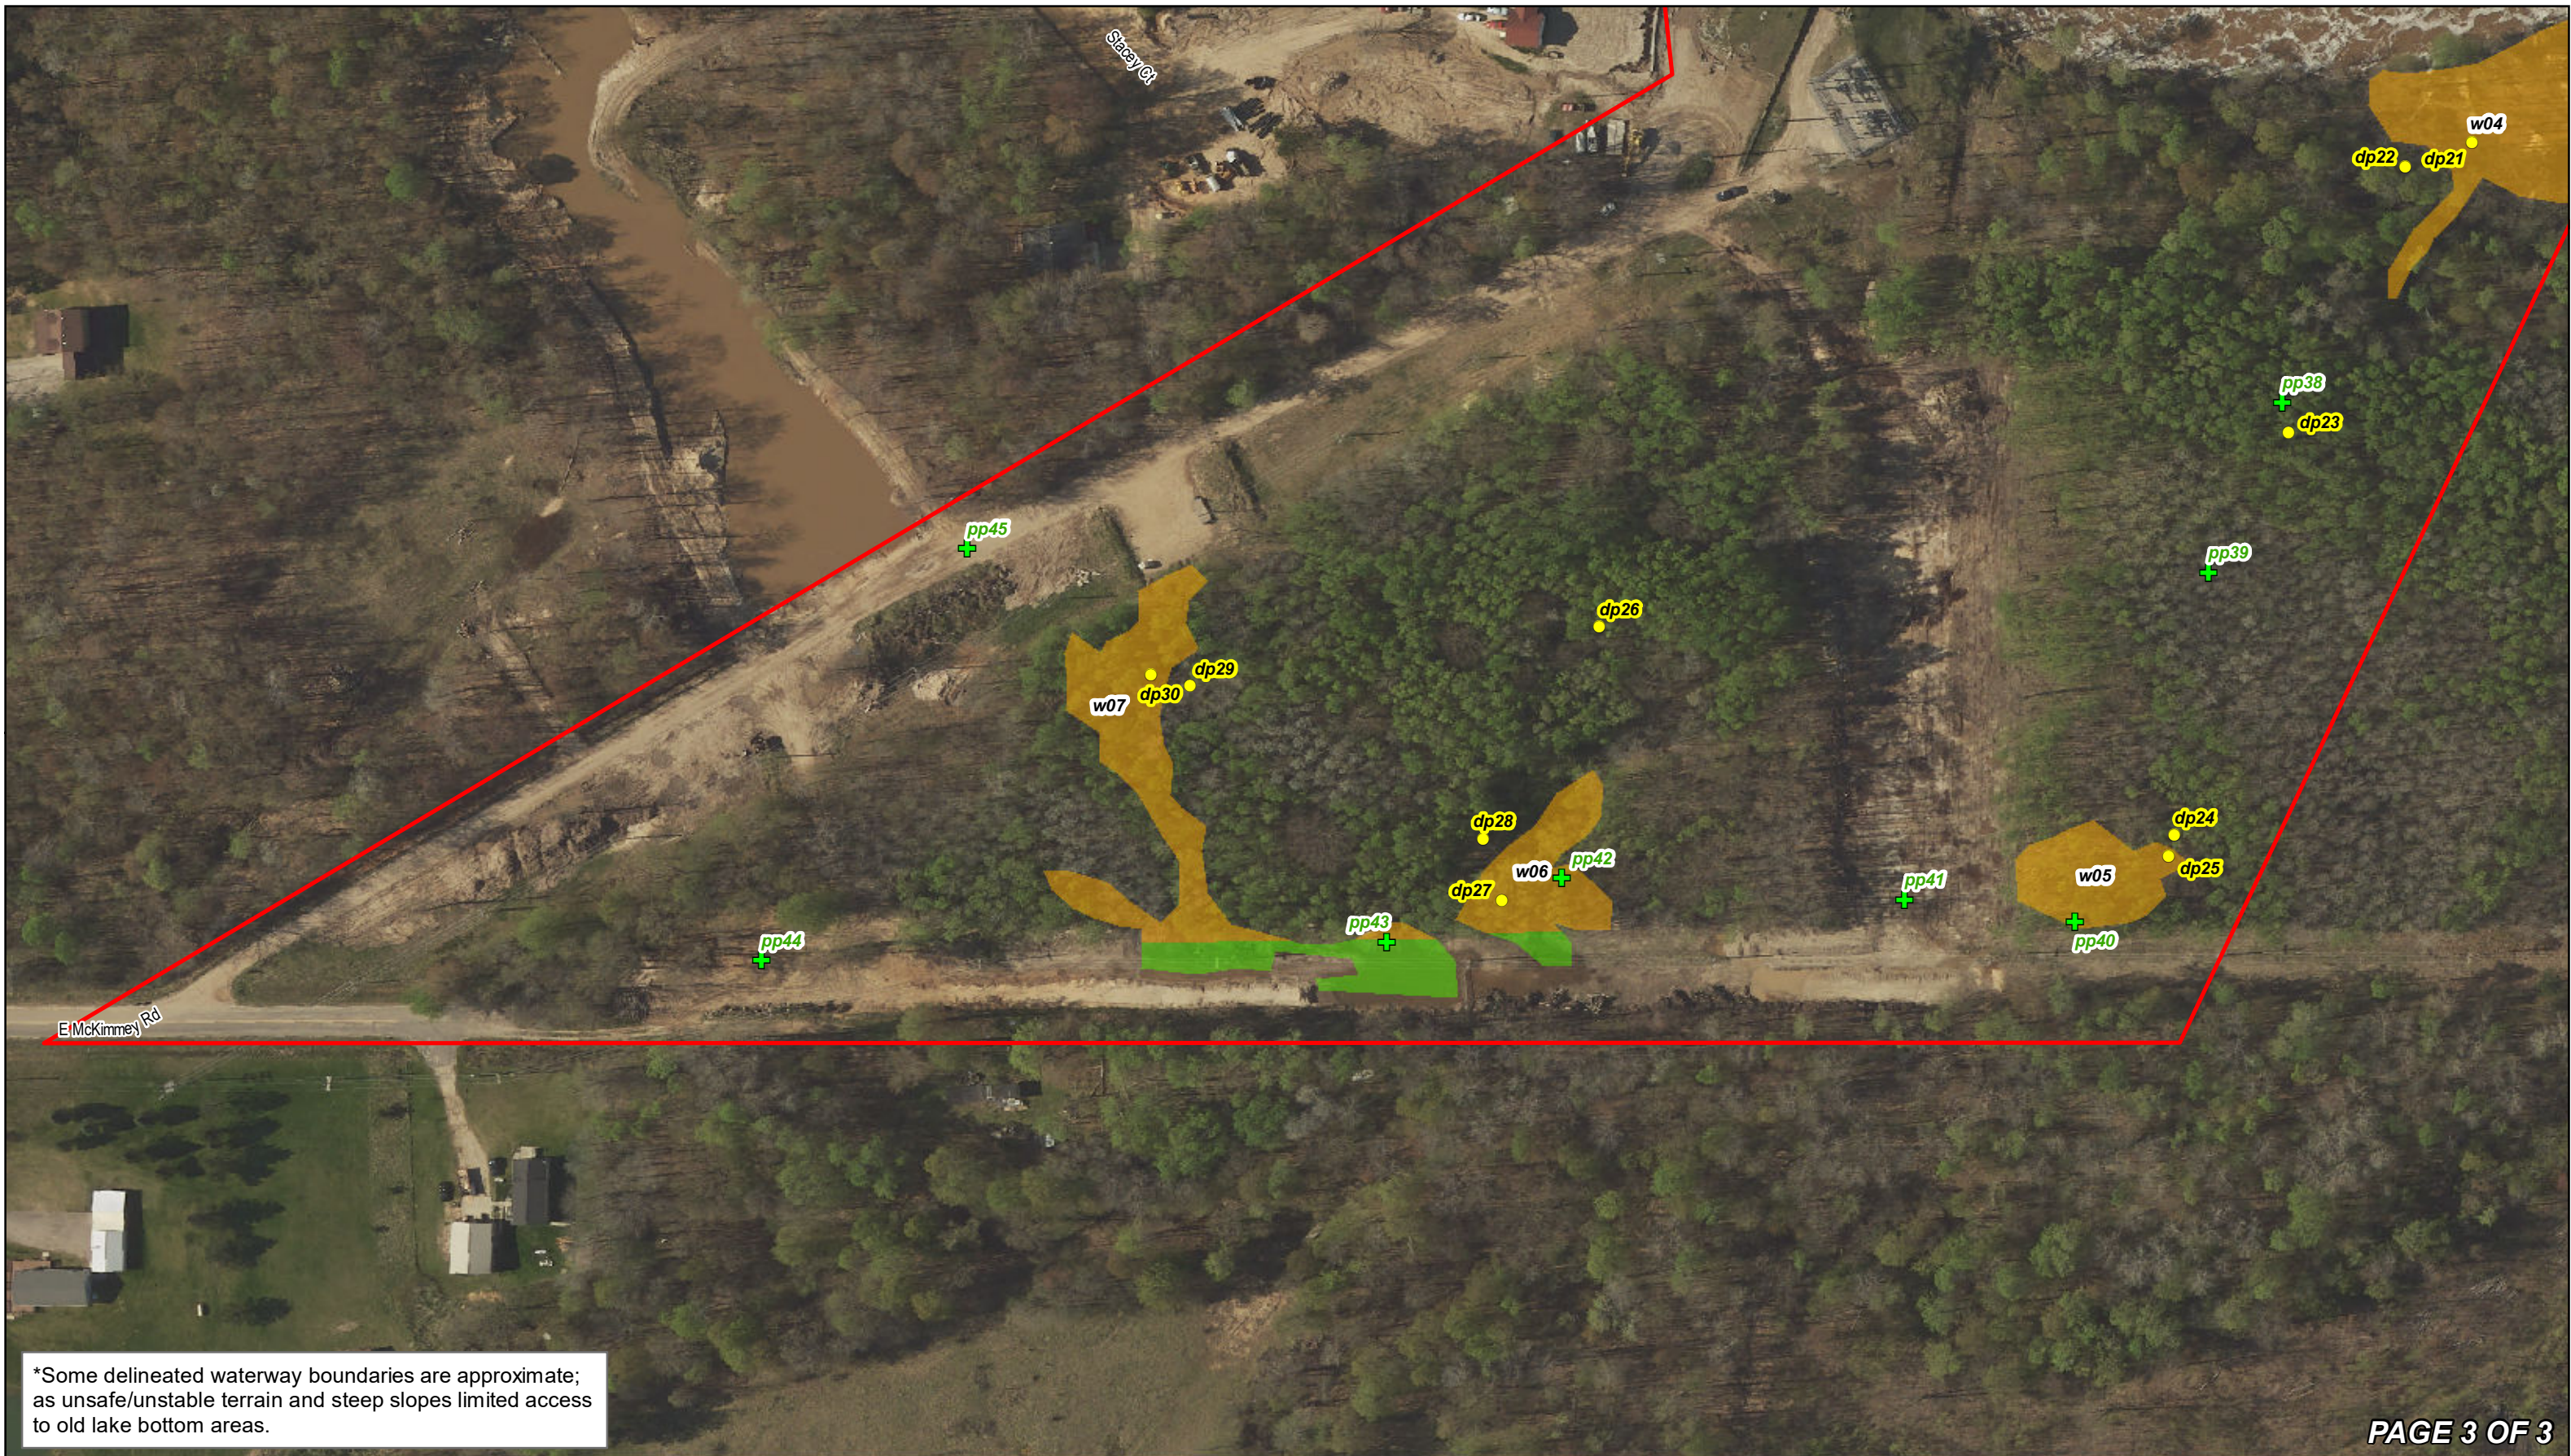
\*Some delineated waterway boundaries are approximate;  
as unsafe/unstable terrain and steep slopes limited access  
to old lake bottom areas.
