**Sanford Dam –
Midland County, Michigan**

**Four Lakes Task Force and Spicer Group,
Inc.**

Wetland Delineation Report

April 2021

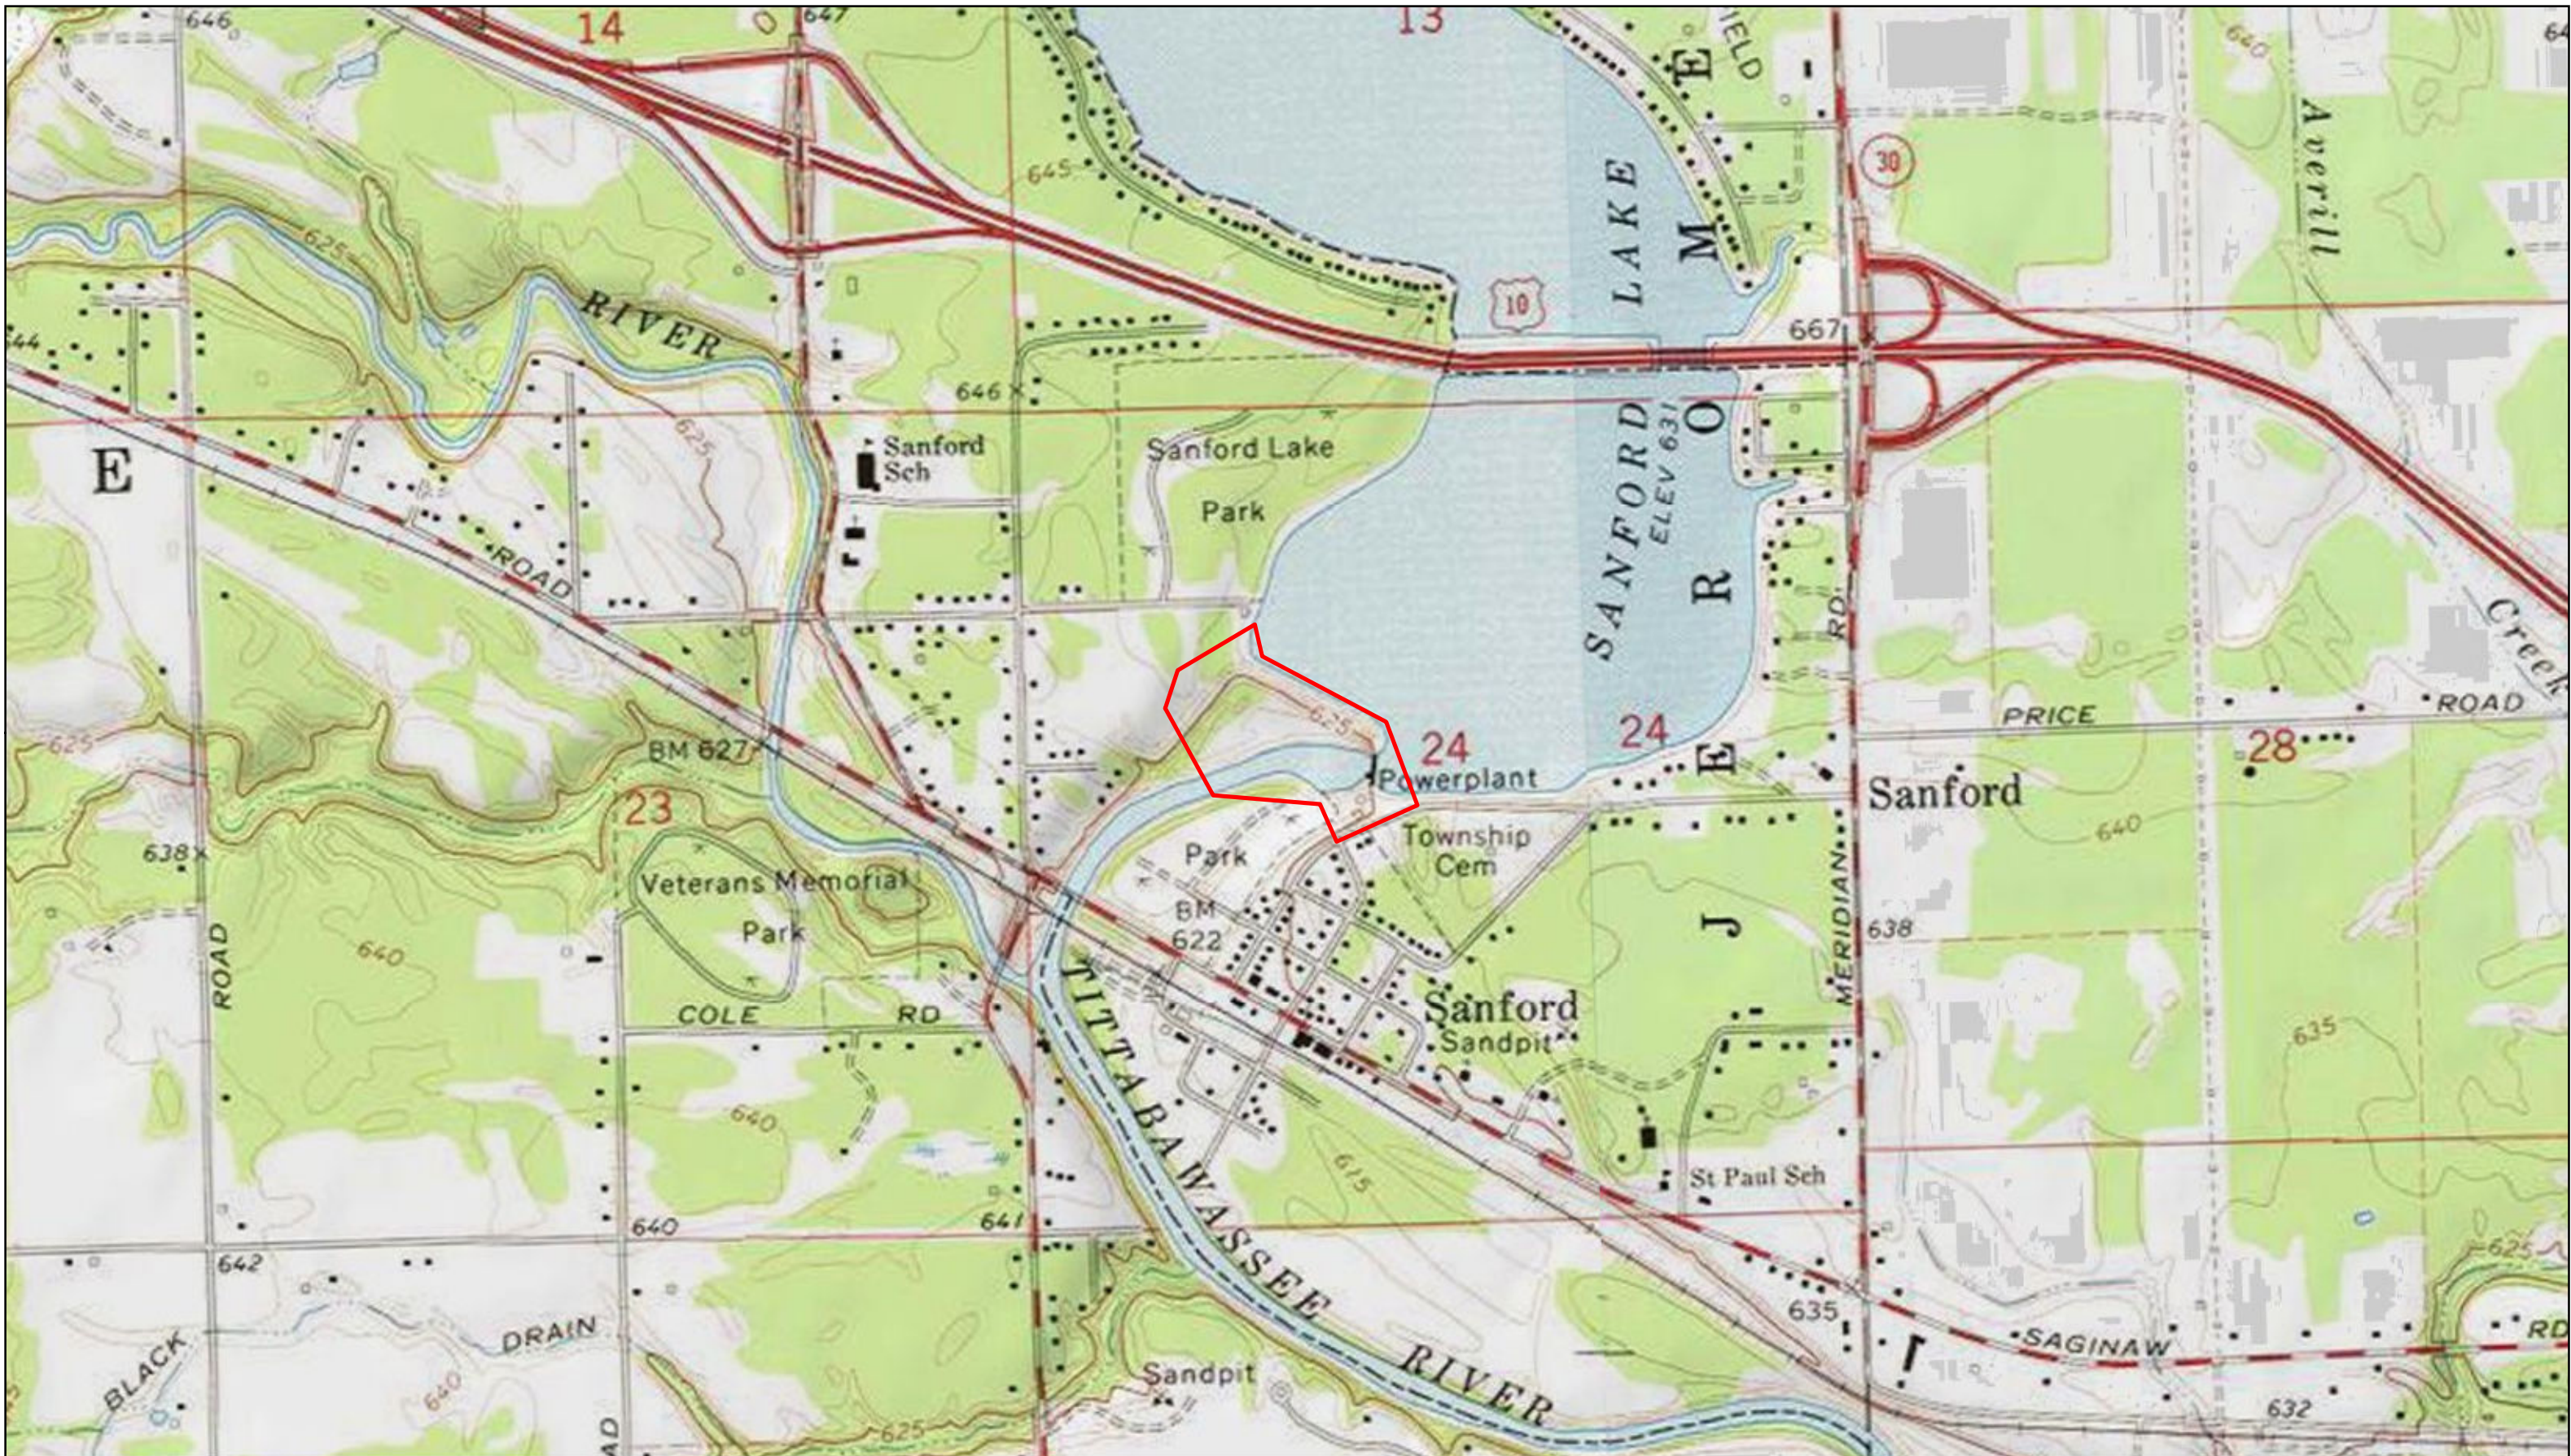
Figure 2
Topography

The USGS topographic map (Figure 2) shows gently sloping areas on either side of the Tittabawassee River. Steep slopes exist along the edges of the Sanford Dam berm.

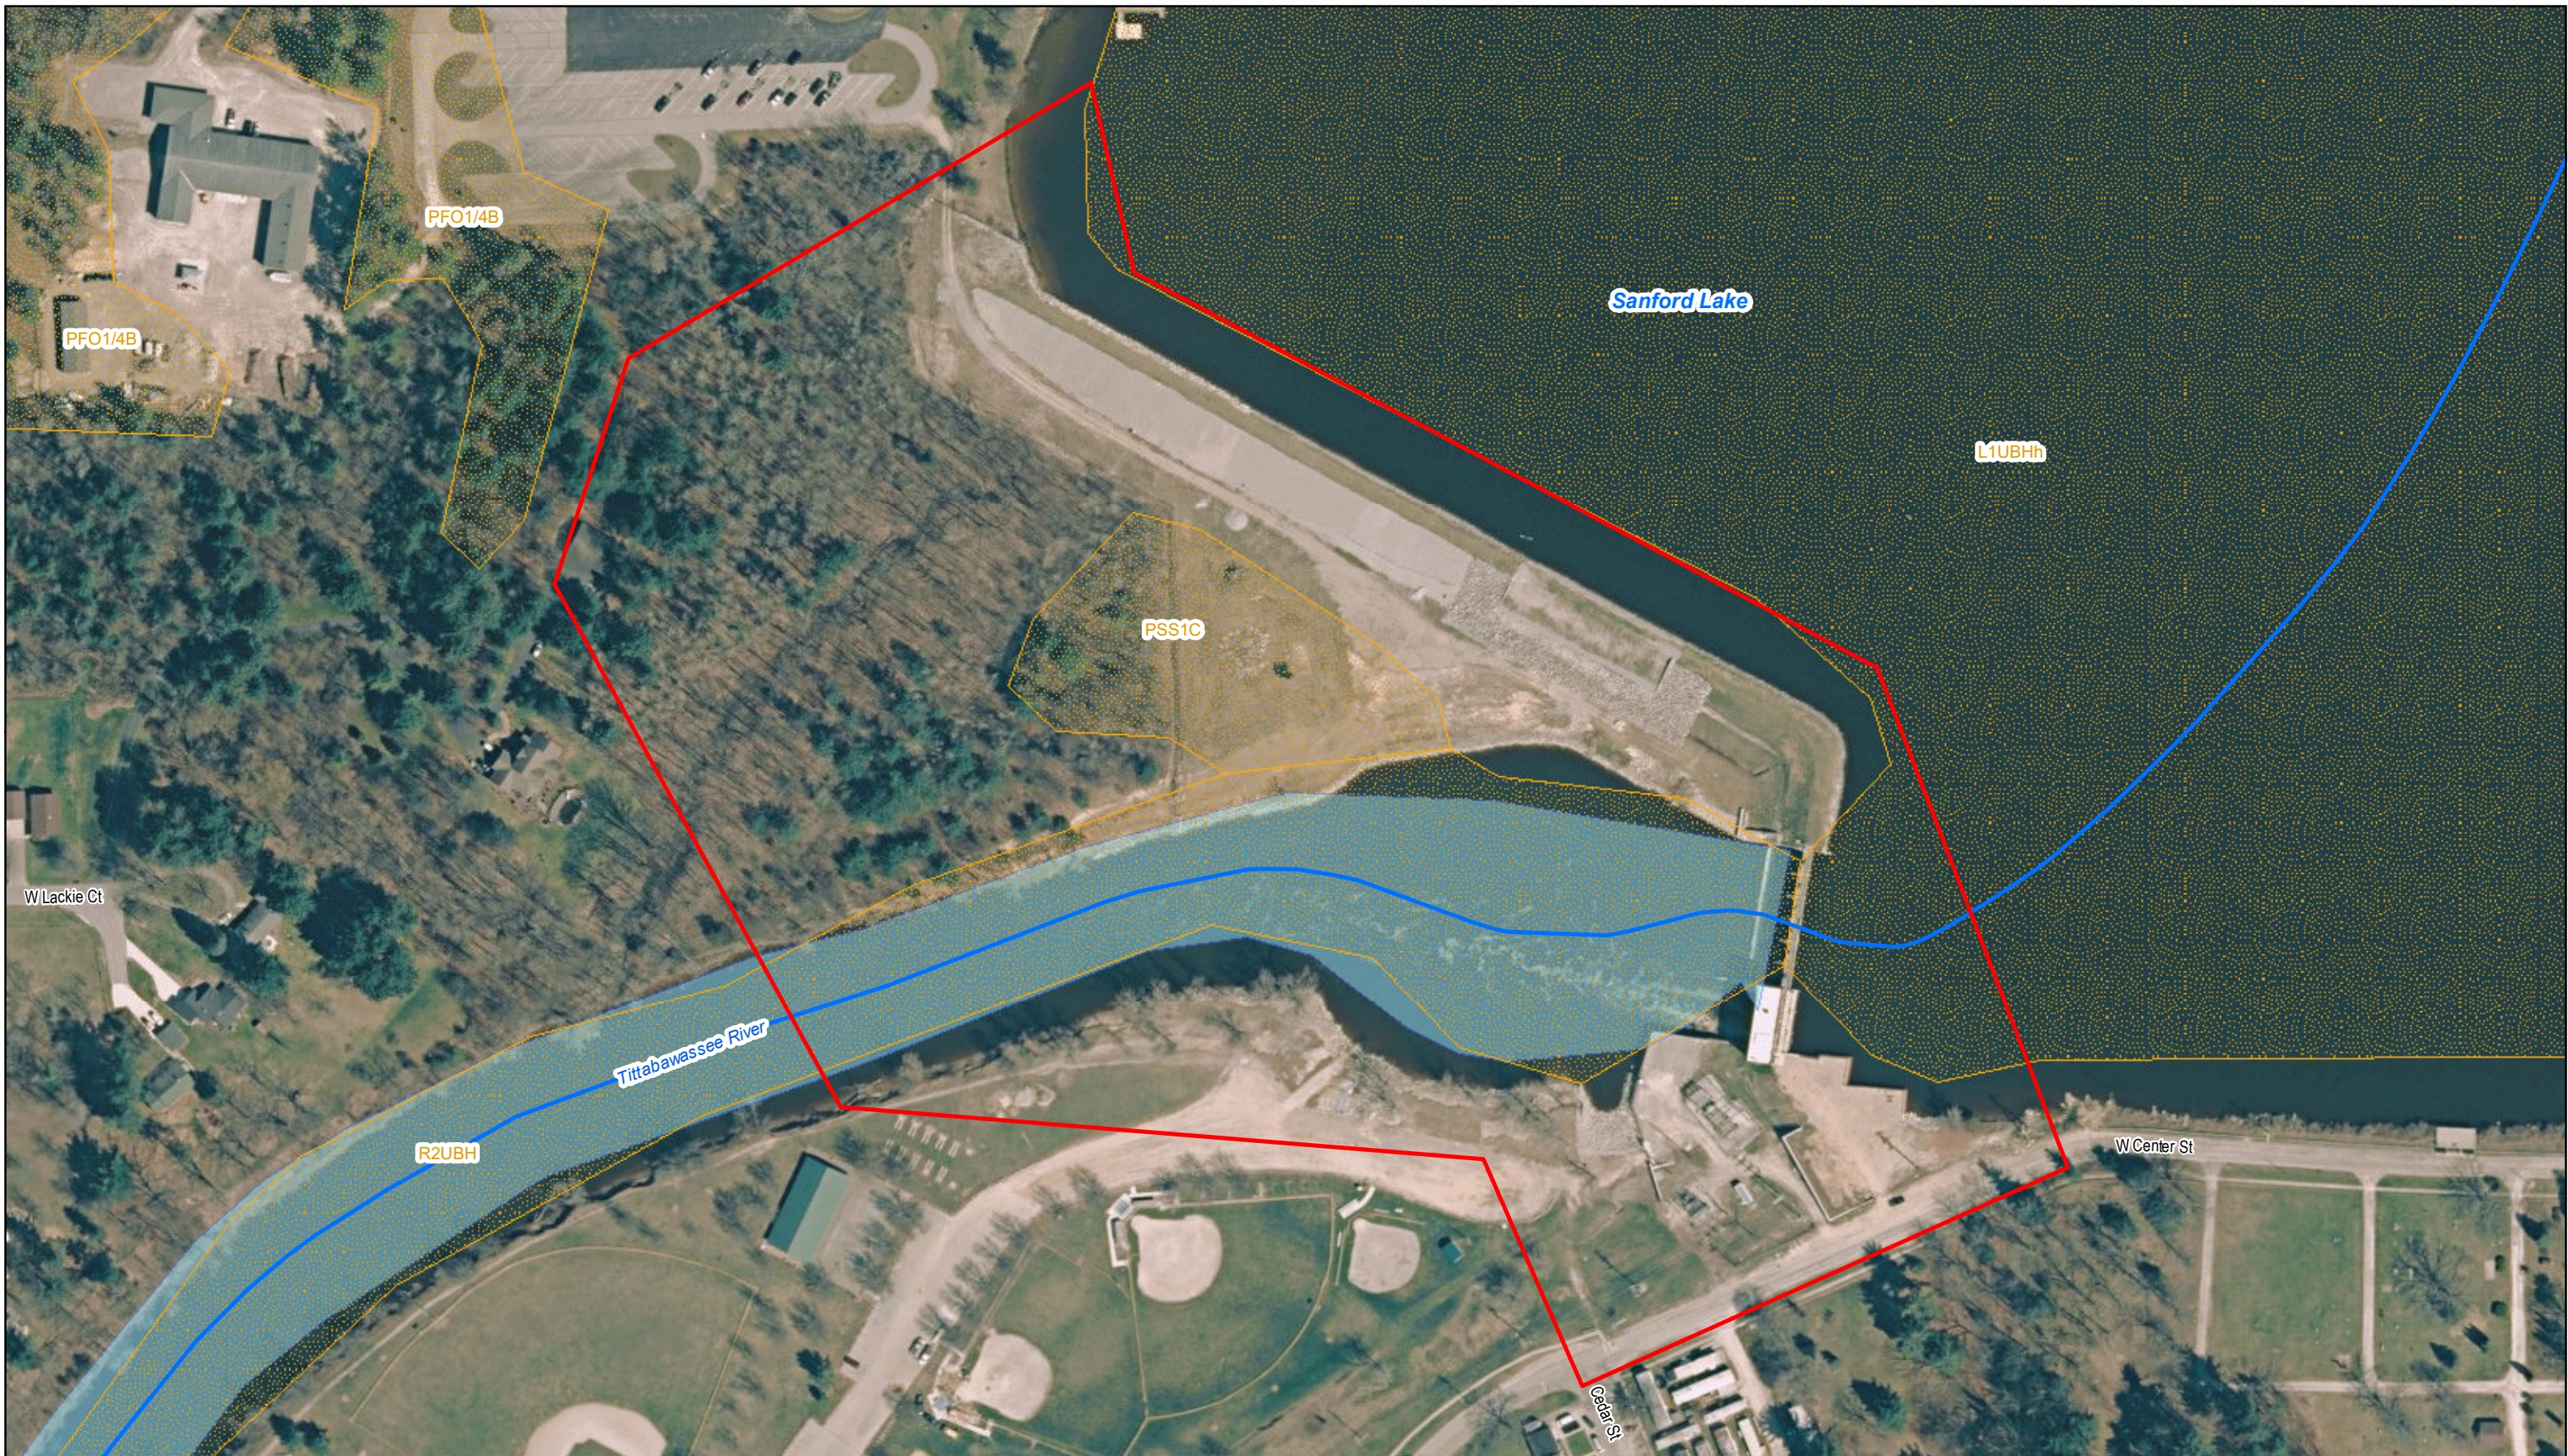
Figure 3
Hydrology

The NWI map of the survey area (Figure 3) shows approximately 8.25 acres of wetlands (Table 3-2). The lacustrine wetland area is mapped in the historic Sanford Lake lakebed above Sanford Dam. The riverine wetland is mapped in the Tittabawassee River course.

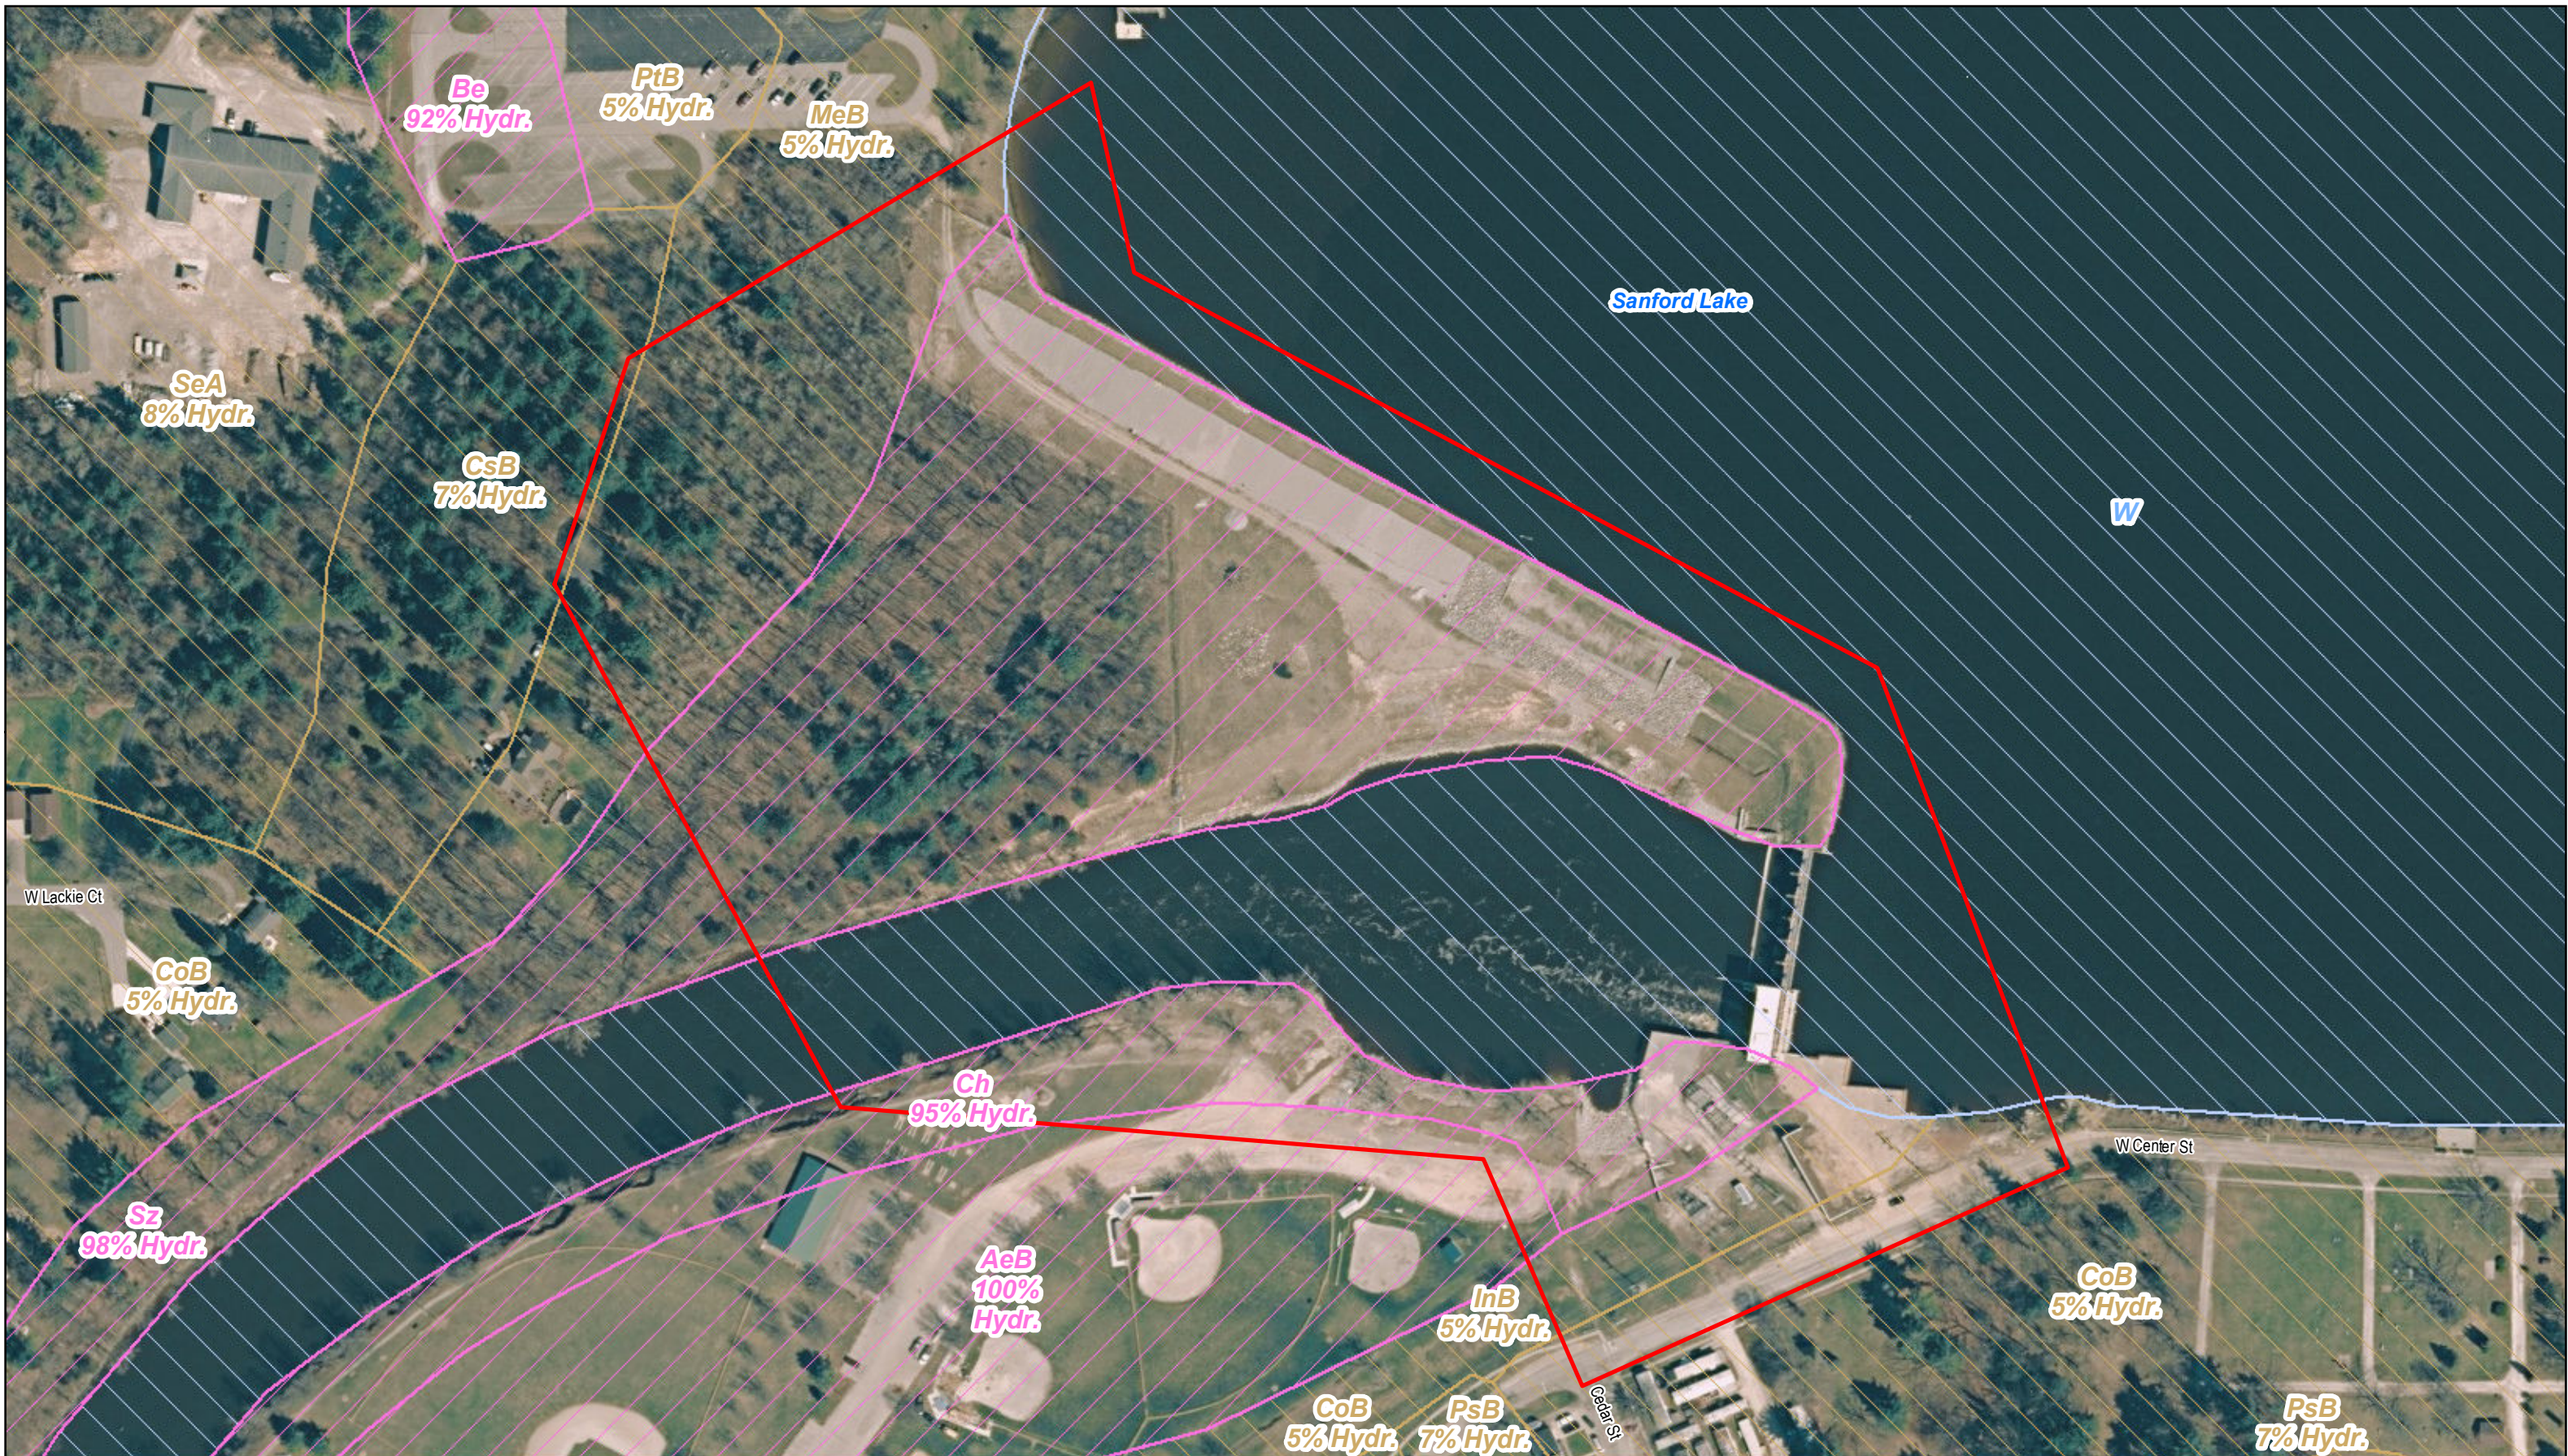
Figure 4
SSURGO Soil Type

The USDA-NRCS soil map of the survey area (Figure 4) identified eight soil types, three of which are hydric (Table 3-1).

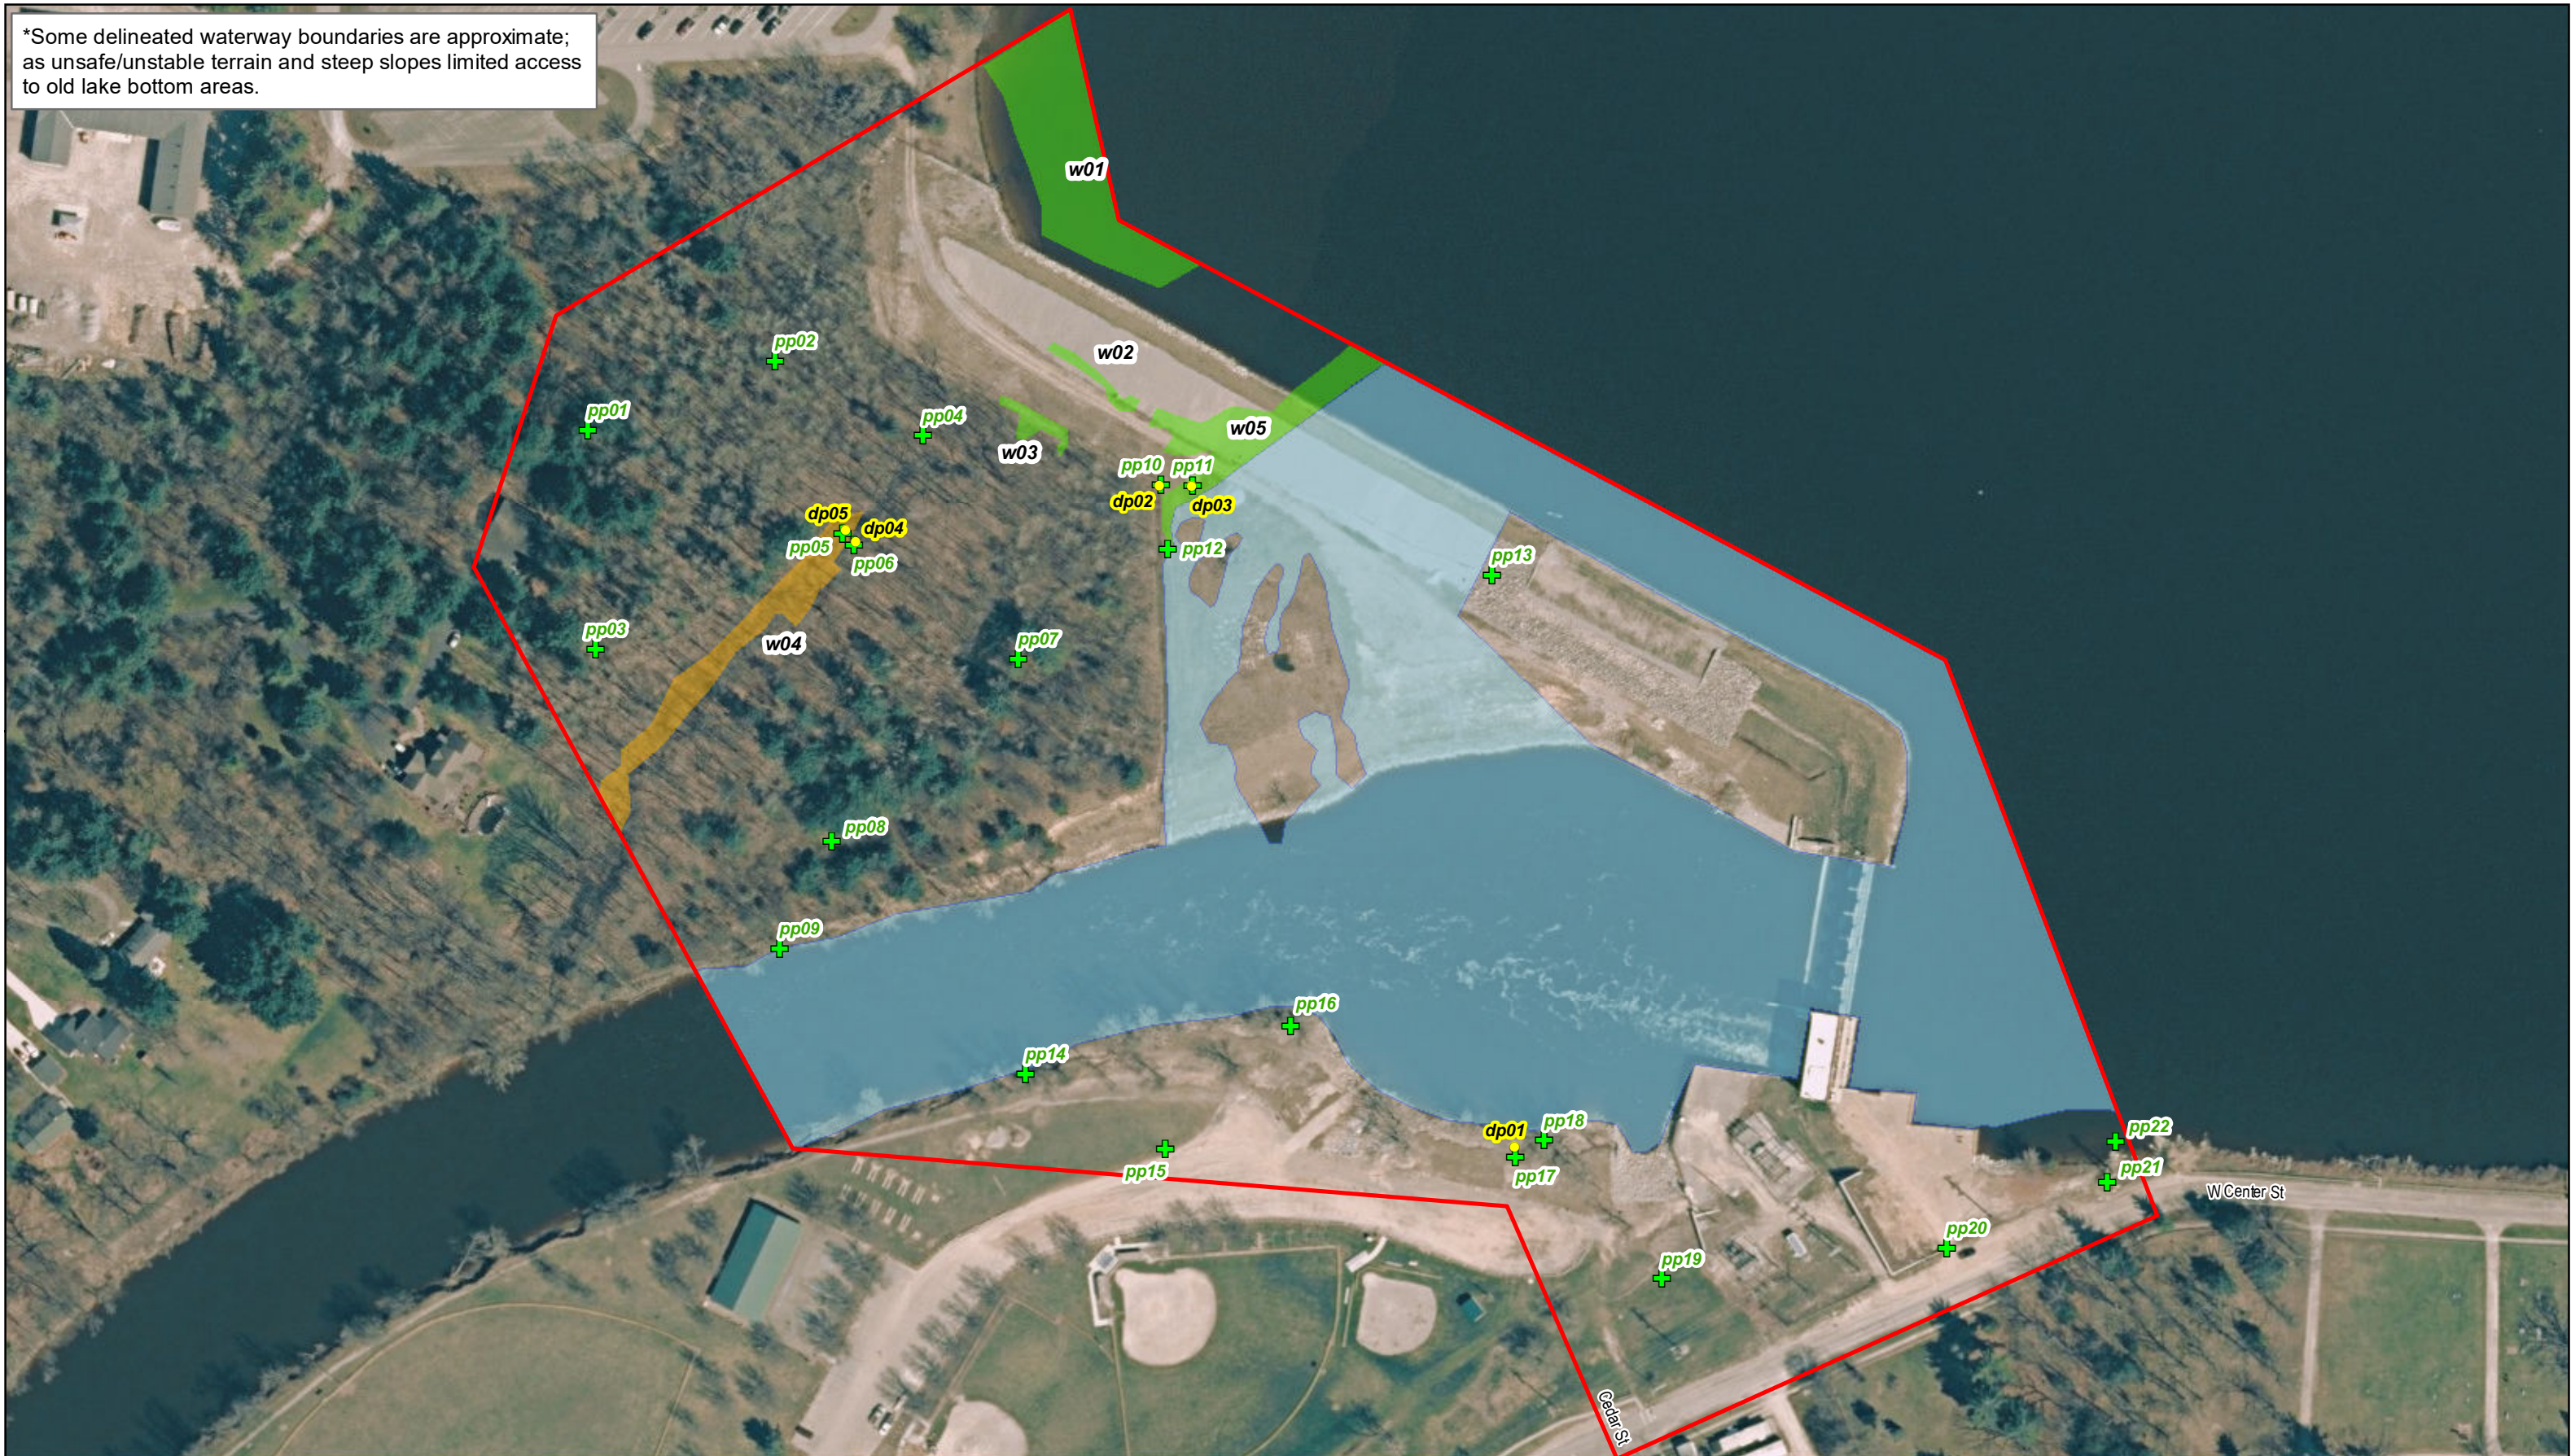
Figure 5
Wetland Delineation

A total of five wetlands were identified to community type within the survey area (Figure 5) according to Cowardin classification (Appendix C). Summaries of these features are provided below (Table 3-4), and more detailed information for associated data points may be found in wetland determination forms (Appendix B).

*Some delineated waterway boundaries are approximate; as unsafe/unstable terrain and steep slopes limited access to old lake bottom areas.

Based on the field survey and review of desktop resources, it is our professional opinion that five wetlands totaling 0.95 acres and one waterway exist within the survey area (Figure 5). Descriptions of the wetlands and waterways are provided below.

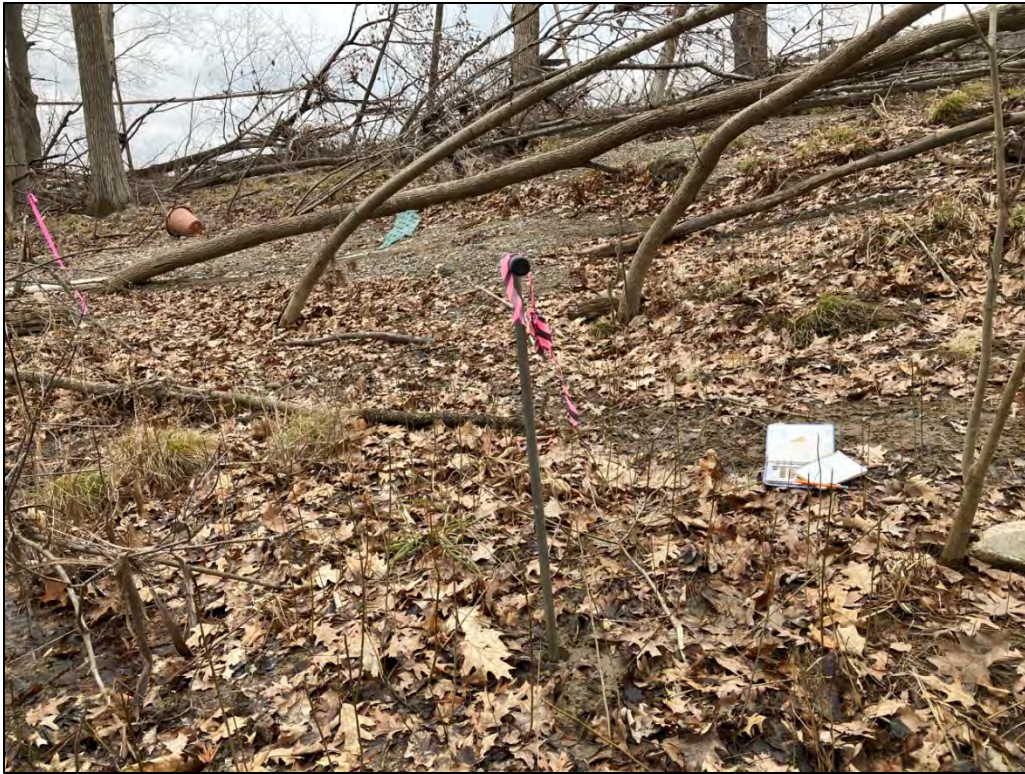
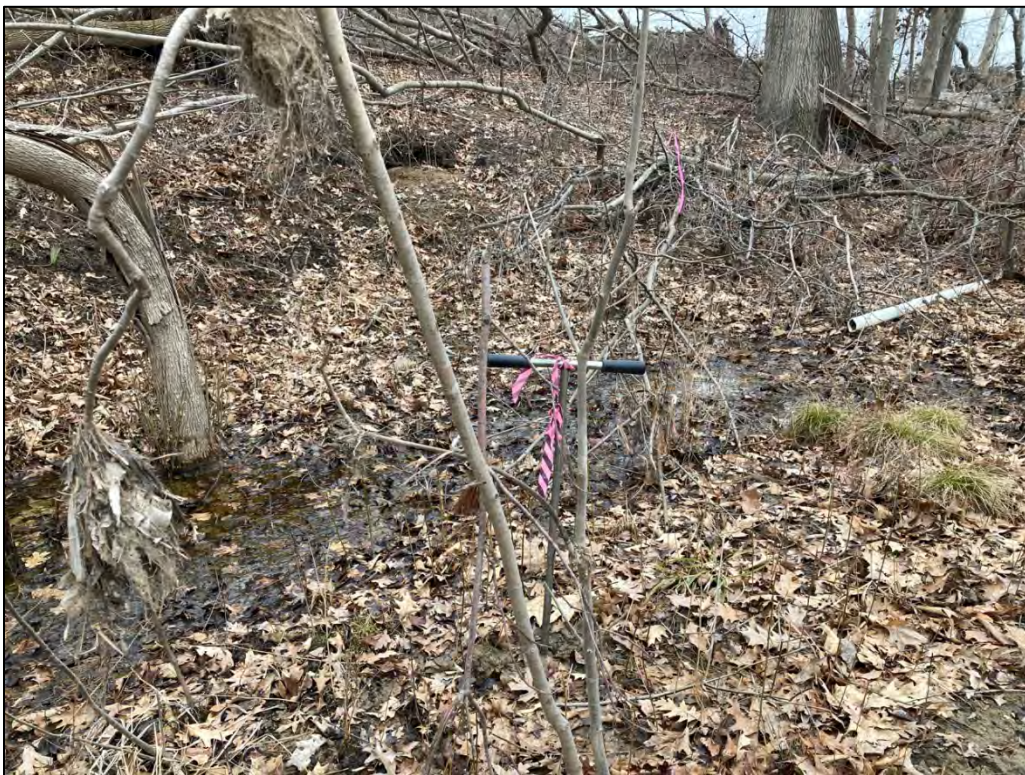
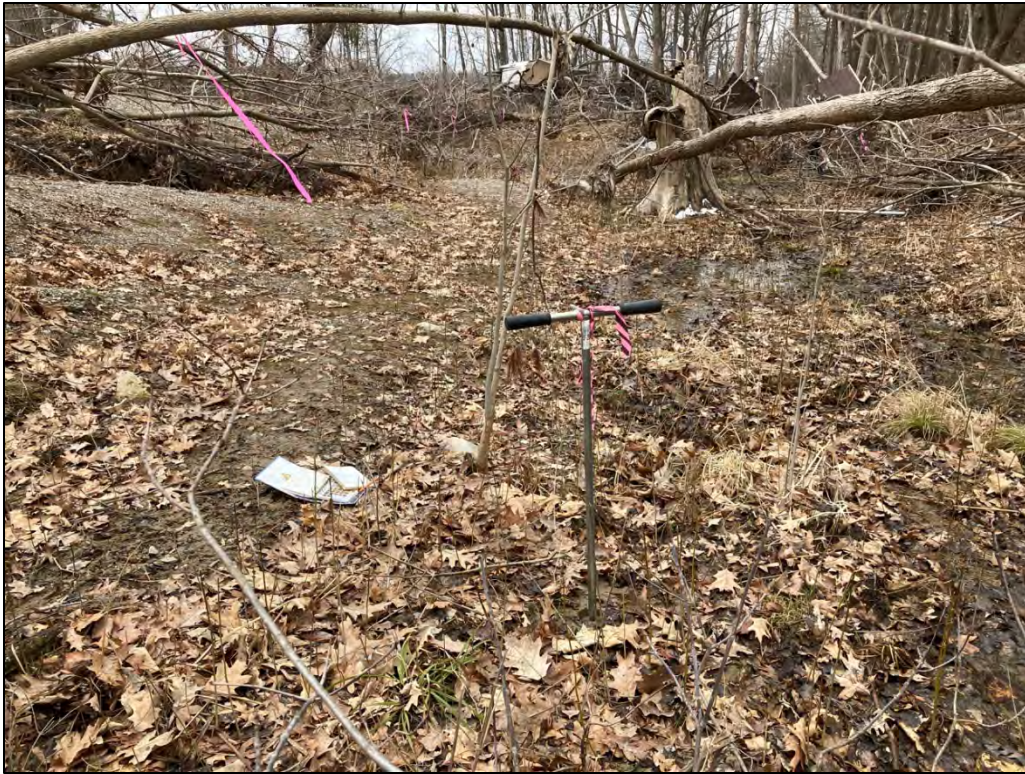
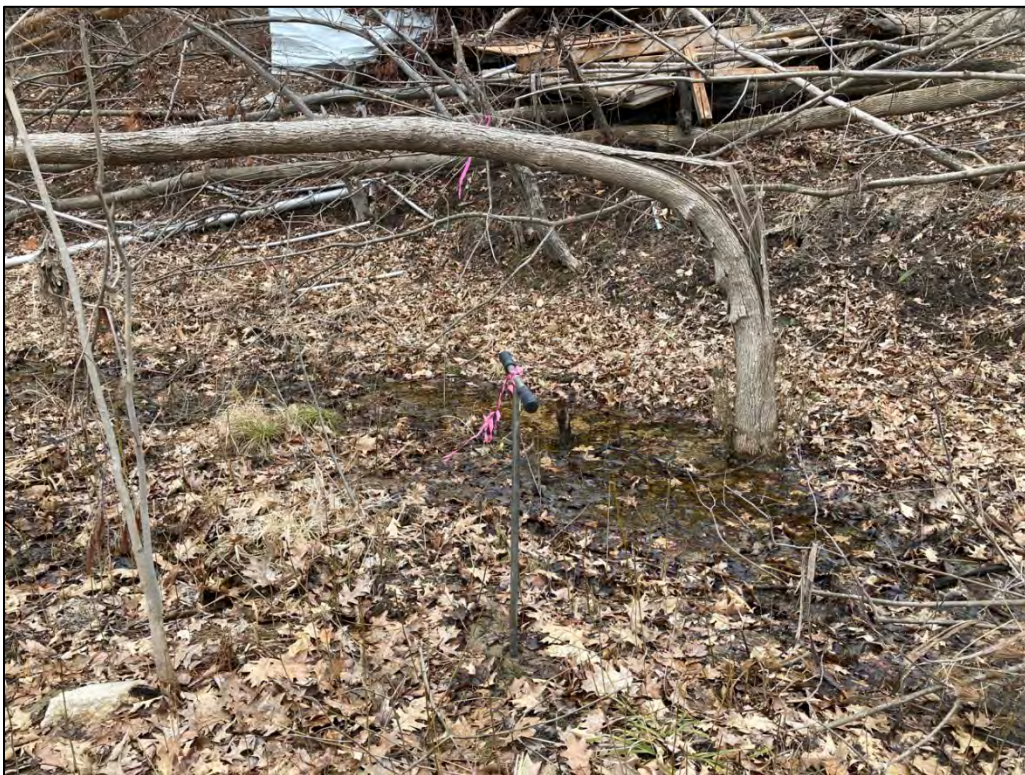
Photograph pp05 view East at dp05

Photograph pp05 view North at dp05

Photograph pp05 view South ad dp05

Photograph pp05 view West at dp05

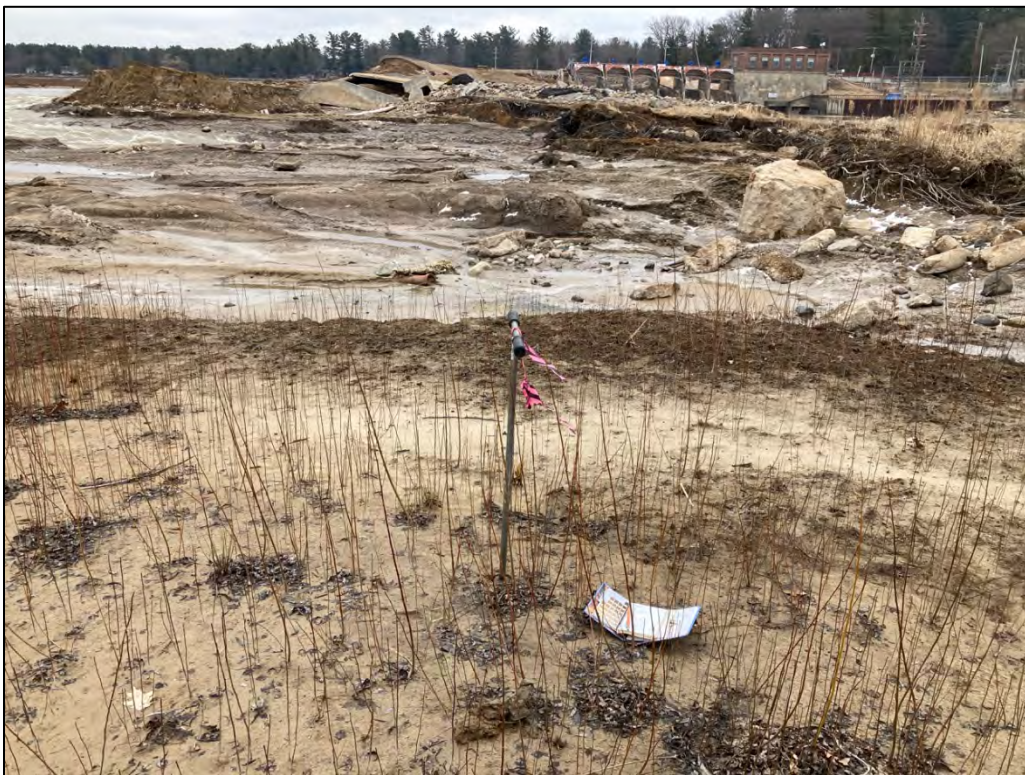
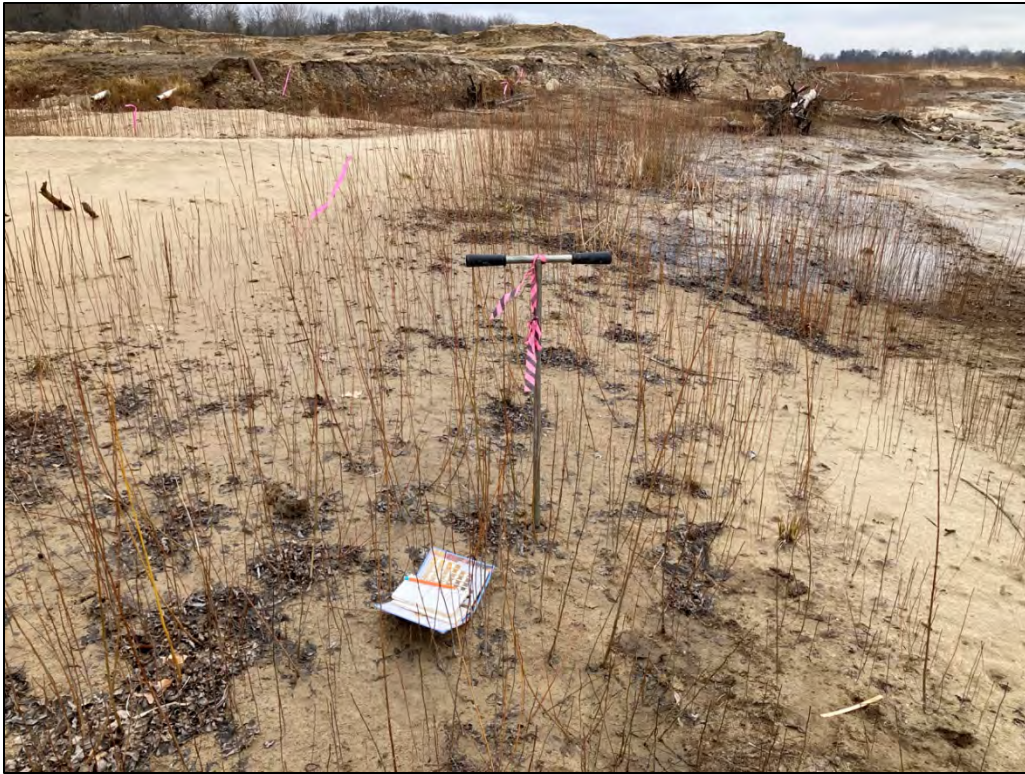
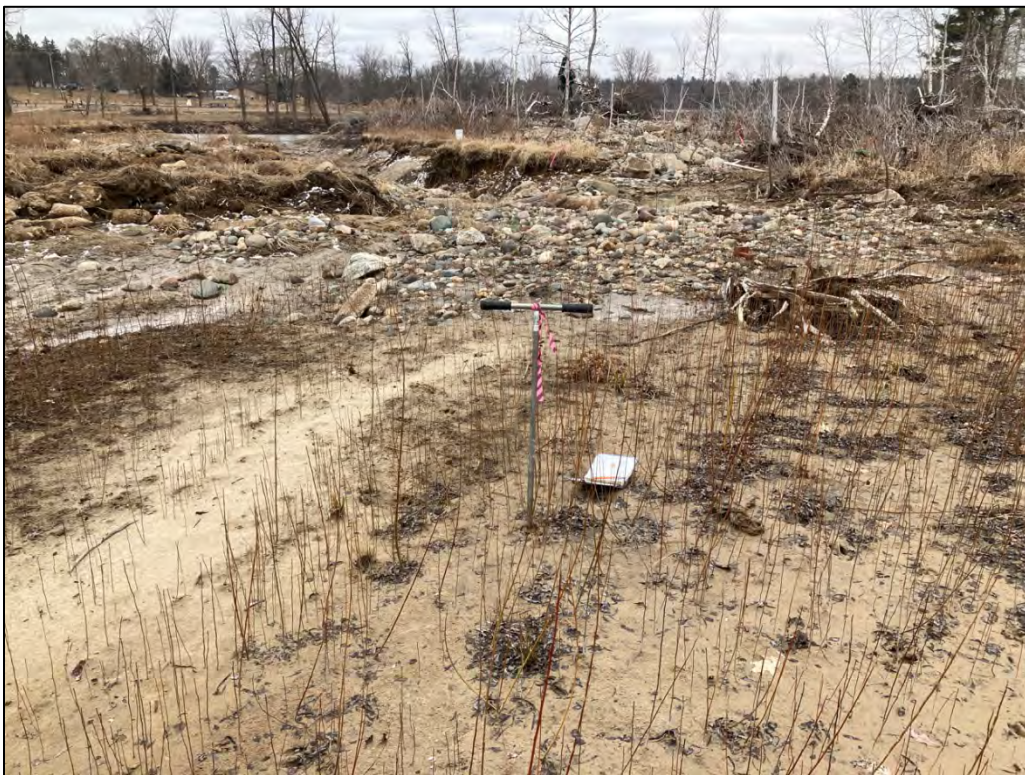
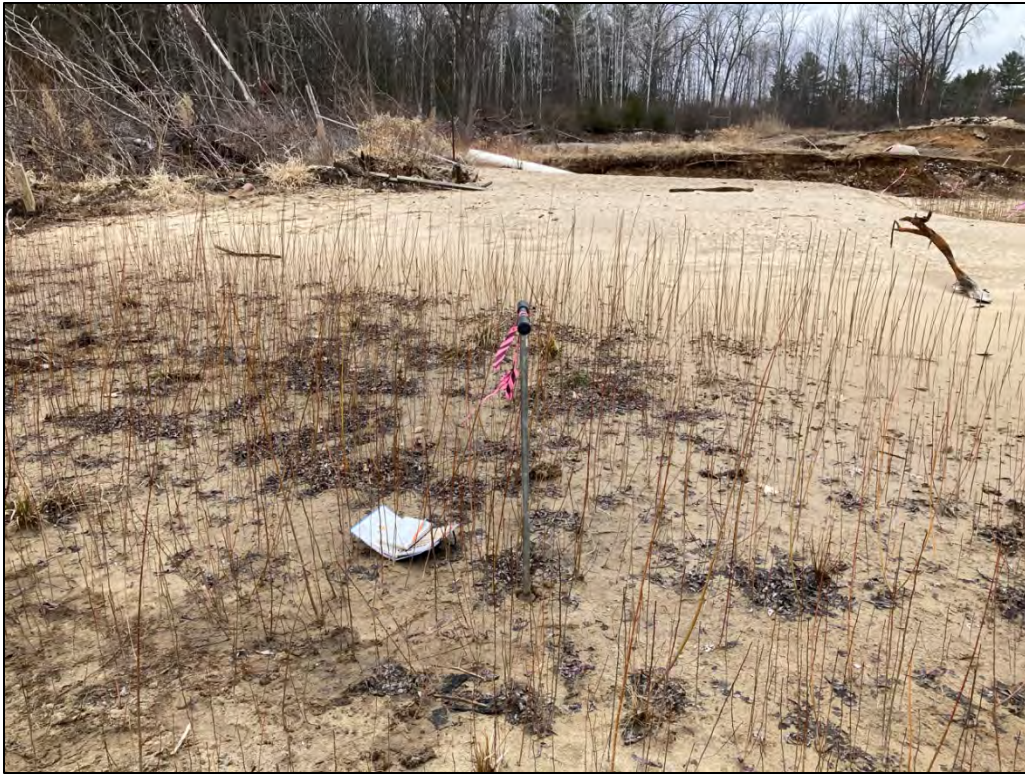
Photograph pp11 view East at dp03

Photograph pp11 view North at dp03

Photograph pp11 view South at dp03

Photograph pp11 view West at dp03
