Four Lakes Task Force and Spicer Group, Inc.

Pre- and Post-Disaster Wetland Analysis

March 5, 2021

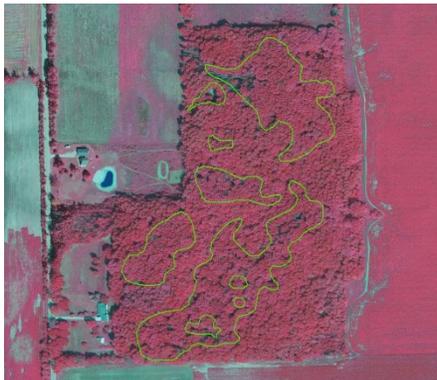
Examples of the imagery and LiDAR data derivative outputs that were reviewed are provided below. A combination of these resources was reviewed to assist in determination of the potential extent of pre- and post-disaster wetlands within the review area. Actual mapped pre-disaster wetlands are identified in green.
