Four Lakes Task Force Engineering and Technical Symposium

Session 3 - Design Engineering and Construction

October 20, 2022

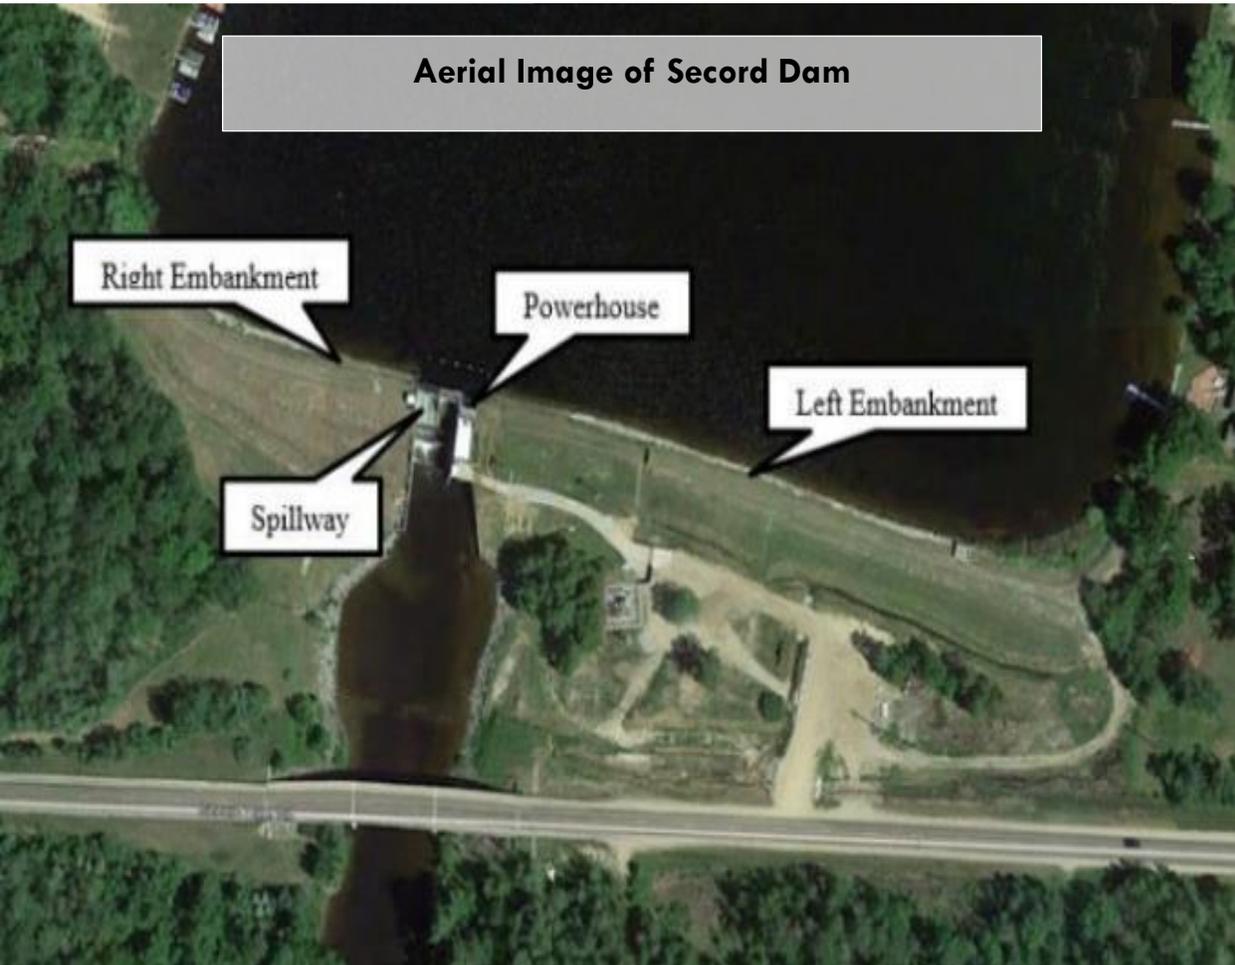
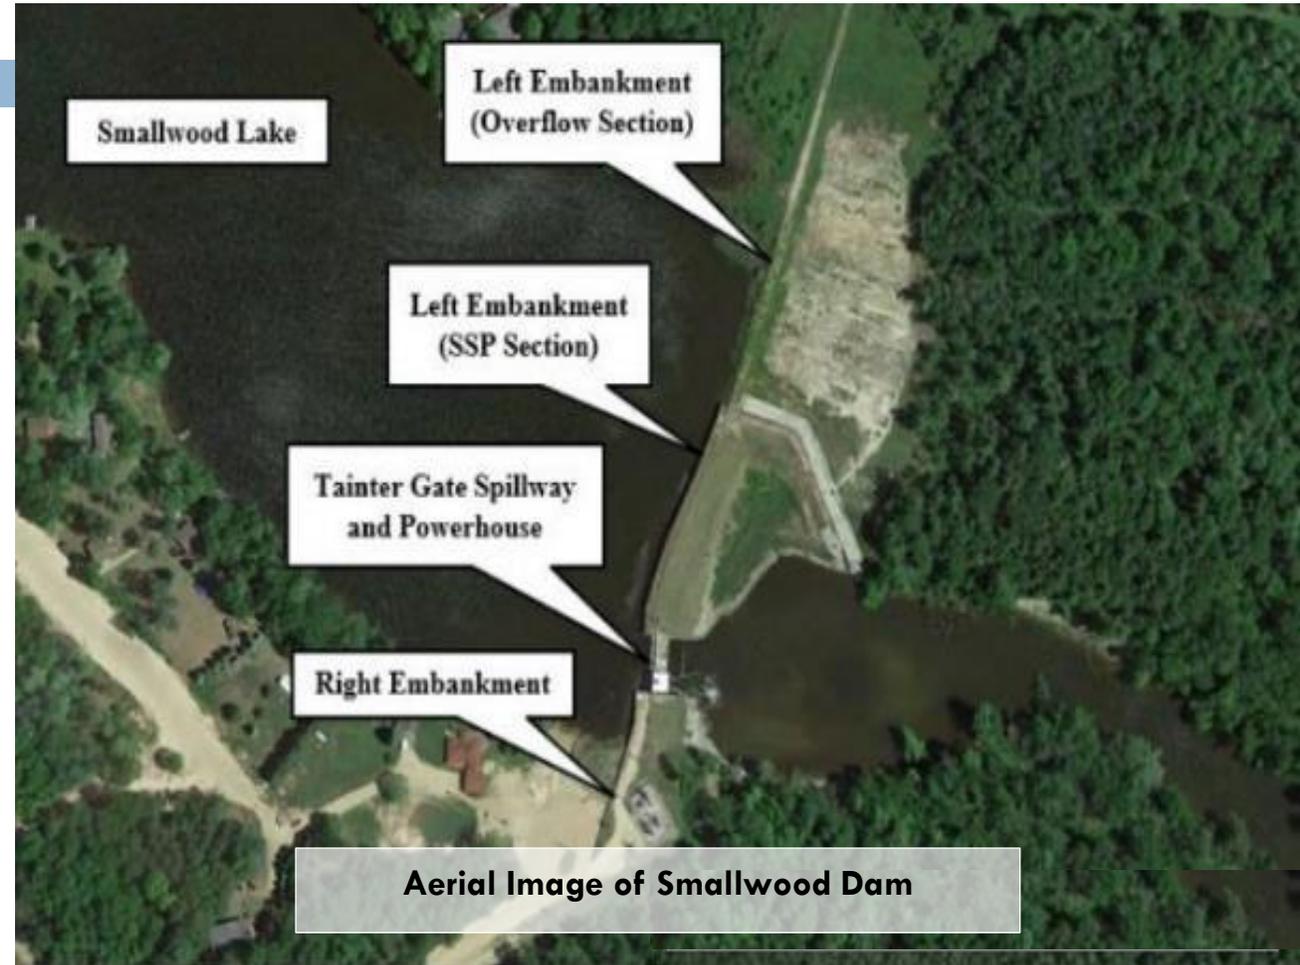
Secord and Smallwood Dams – Dam Safety Issues

Insufficient spillway discharge capacity – reduced pool operating condition

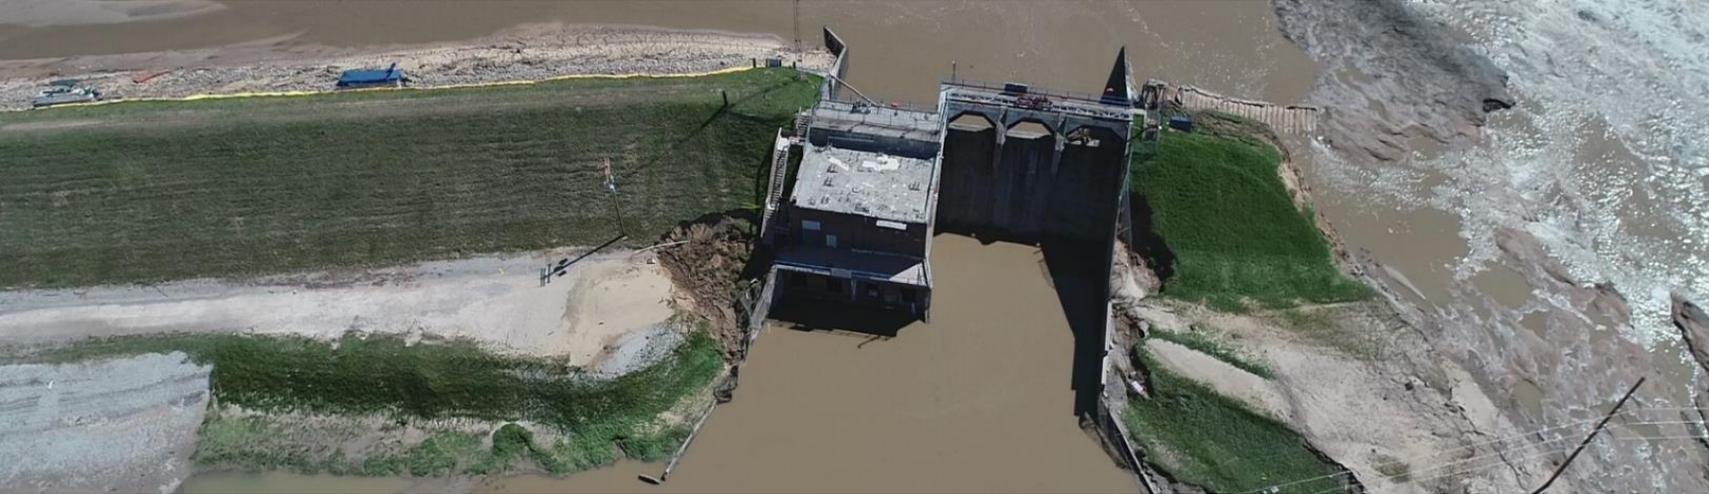
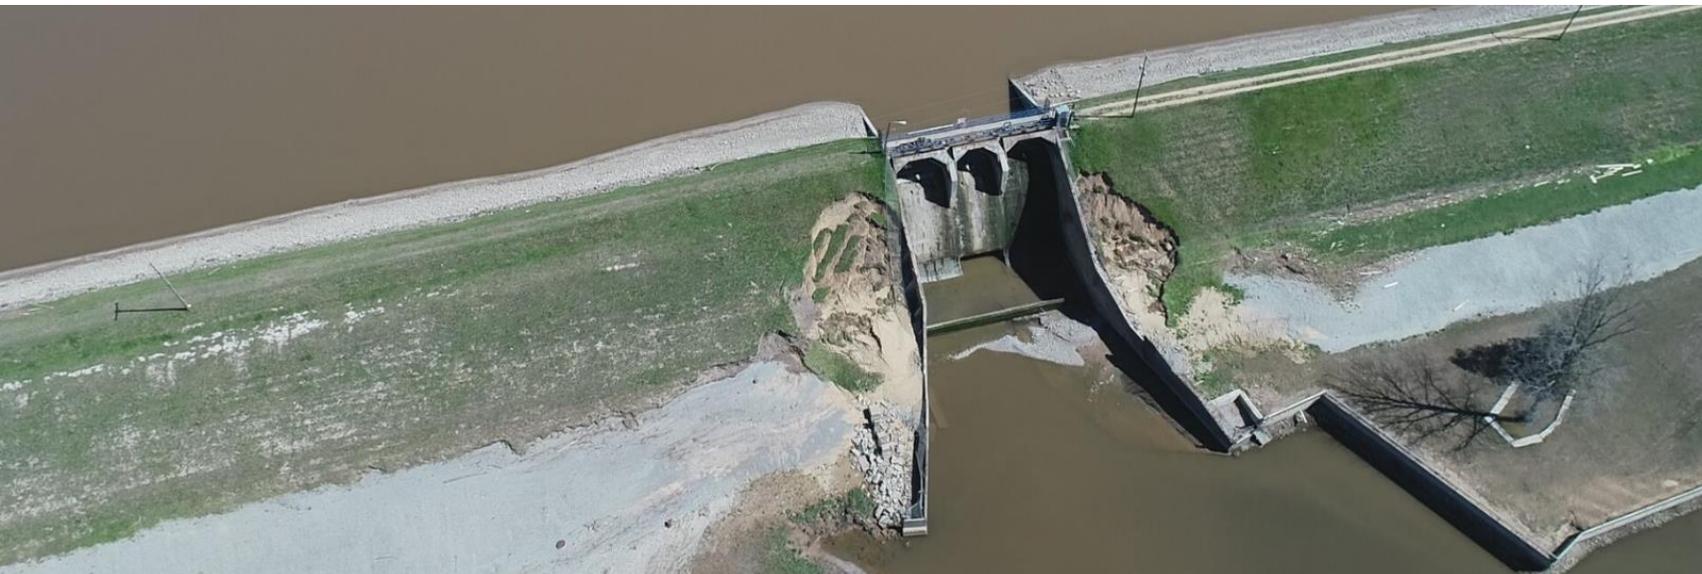
Edenville Post-Flood Condition – Dam Safety Issues

- Inadequate Spillway Capacity
- Embankment Dam Stability
 - ▣ Unstable under flood loading
 - ▣ Uncontrolled seepage
- Breached Left Embankment Needs to be restored – perfect spot for adding auxiliary spillway capacity

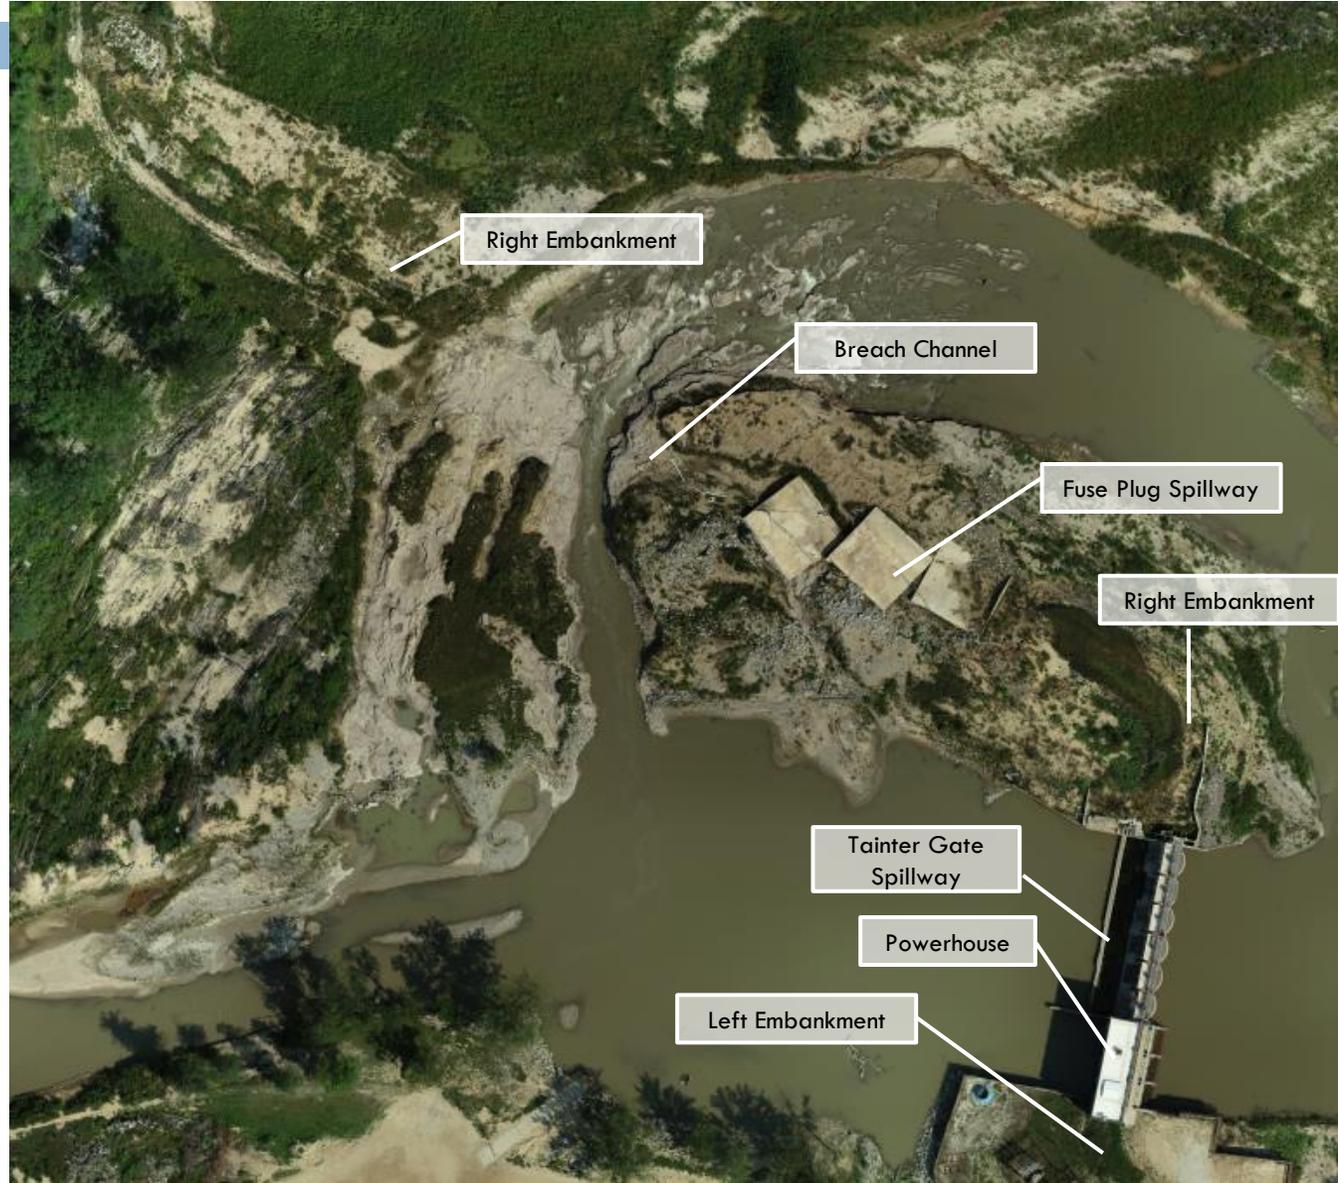
Sanford Dam Pre- and Post-Flood

- ❑ Inadequate Spillway Capacity
- ❑ Right Embankment Breached
- ❑ Left Embankment Overtopped and Damaged

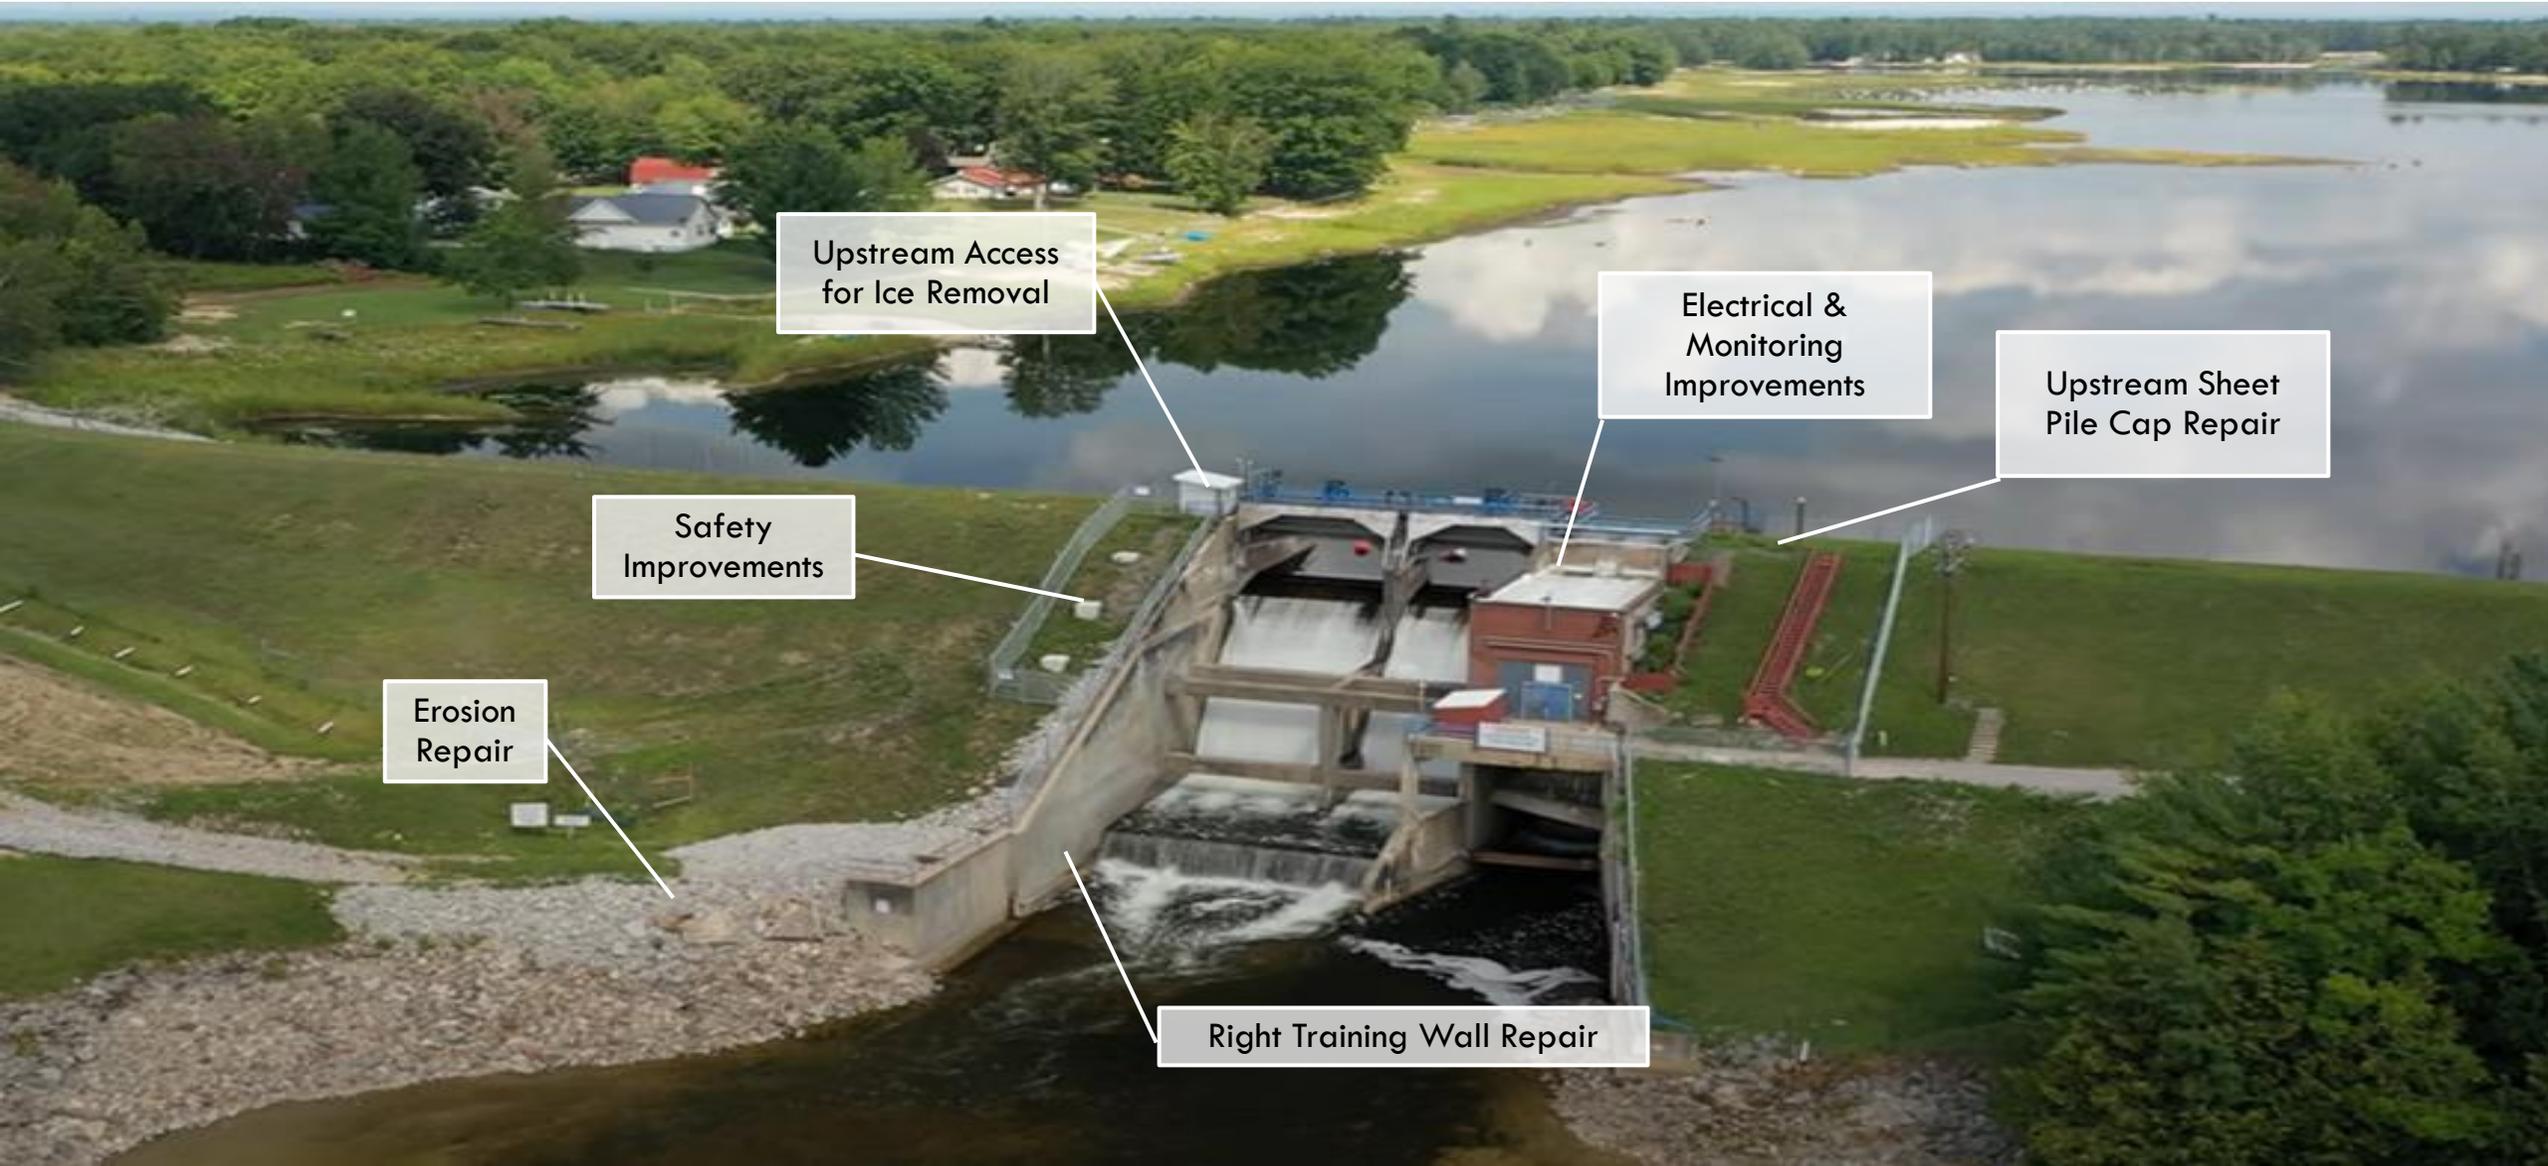
Secord Dam – Current Status (Post-Flood Interim Repairs)

Upstream Access
for Ice Removal

Safety
Improvements

Erosion
Repair

Right Training Wall Repair

Electrical &
Monitoring
Improvements

Upstream Sheet
Pile Cap Repair

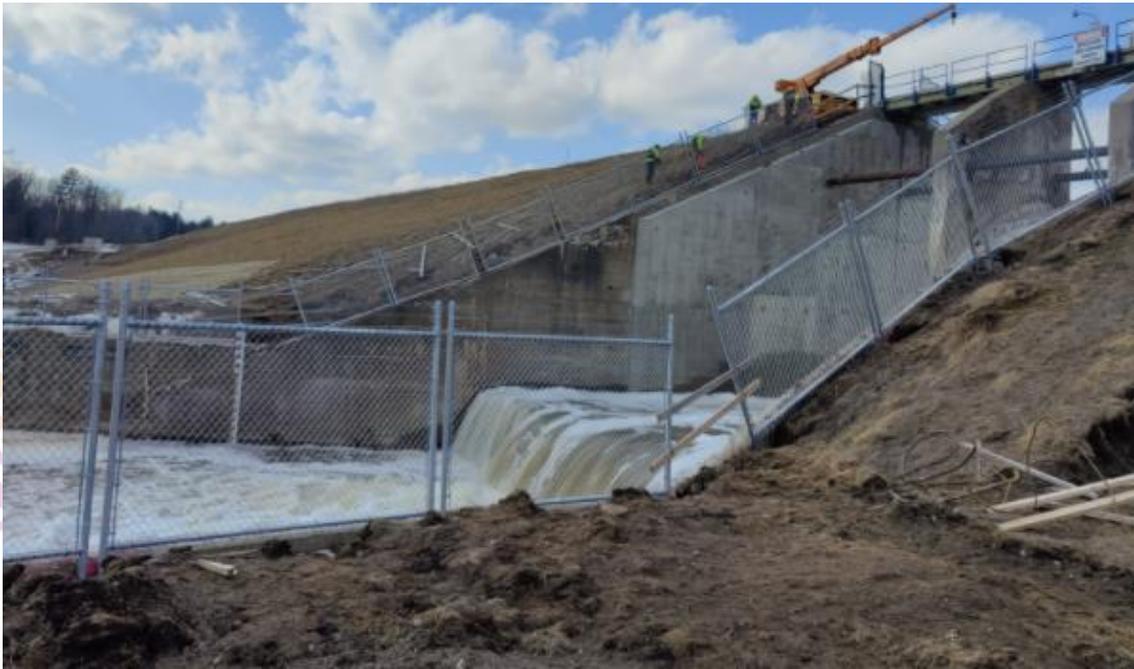
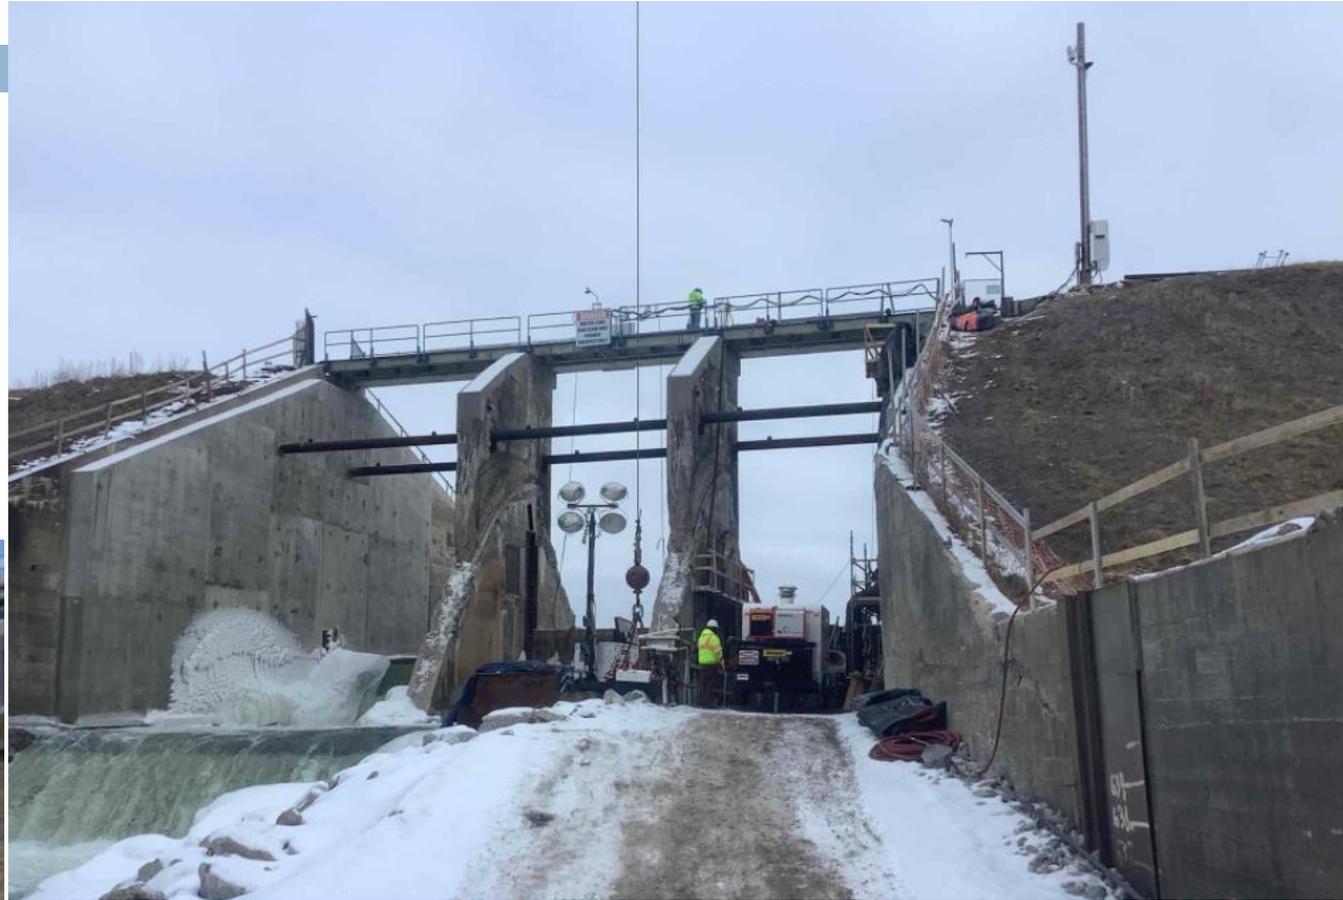
Edenville Dam Phase I – Interim Stabilization at Tobacco (TBO) Spillway

- ❑ Re-established Tobacco River flow
- ❑ Removed Gates and Rollways
- ❑ Added Stepped Spillways
- ❑ Braced Piers and Walls
- ❑ Restored Downstream River Channel

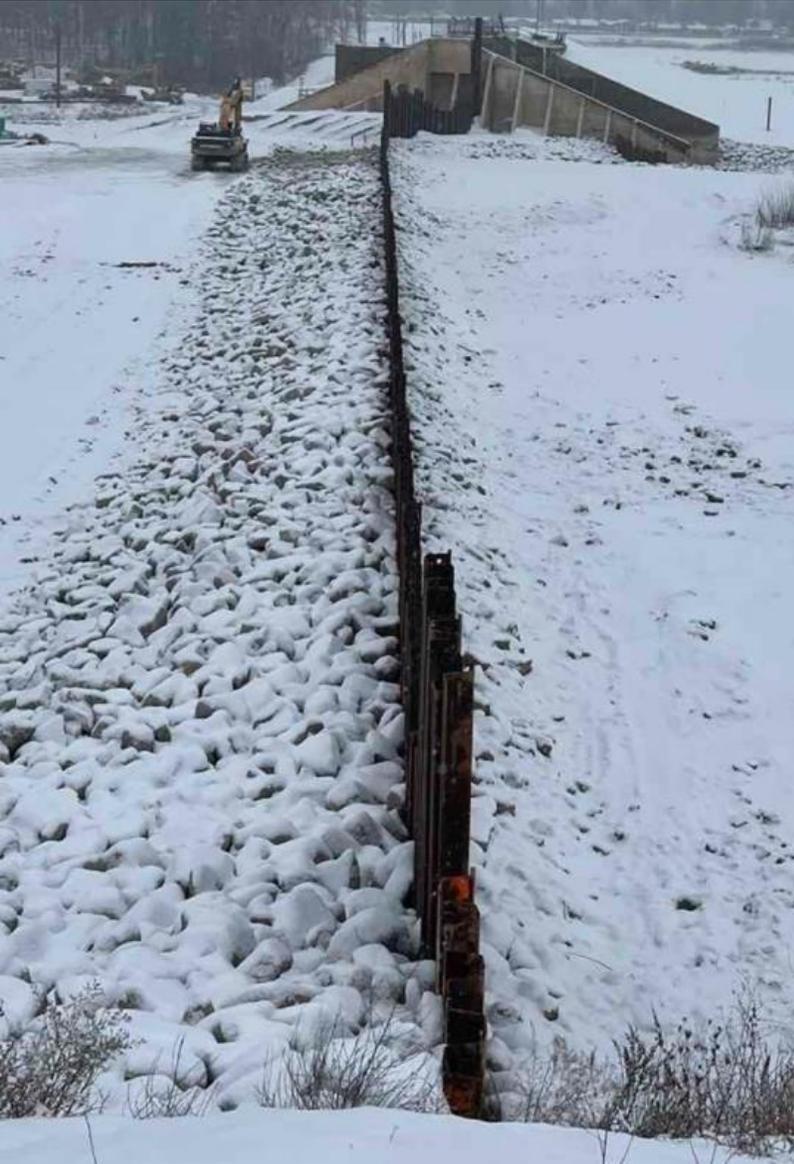
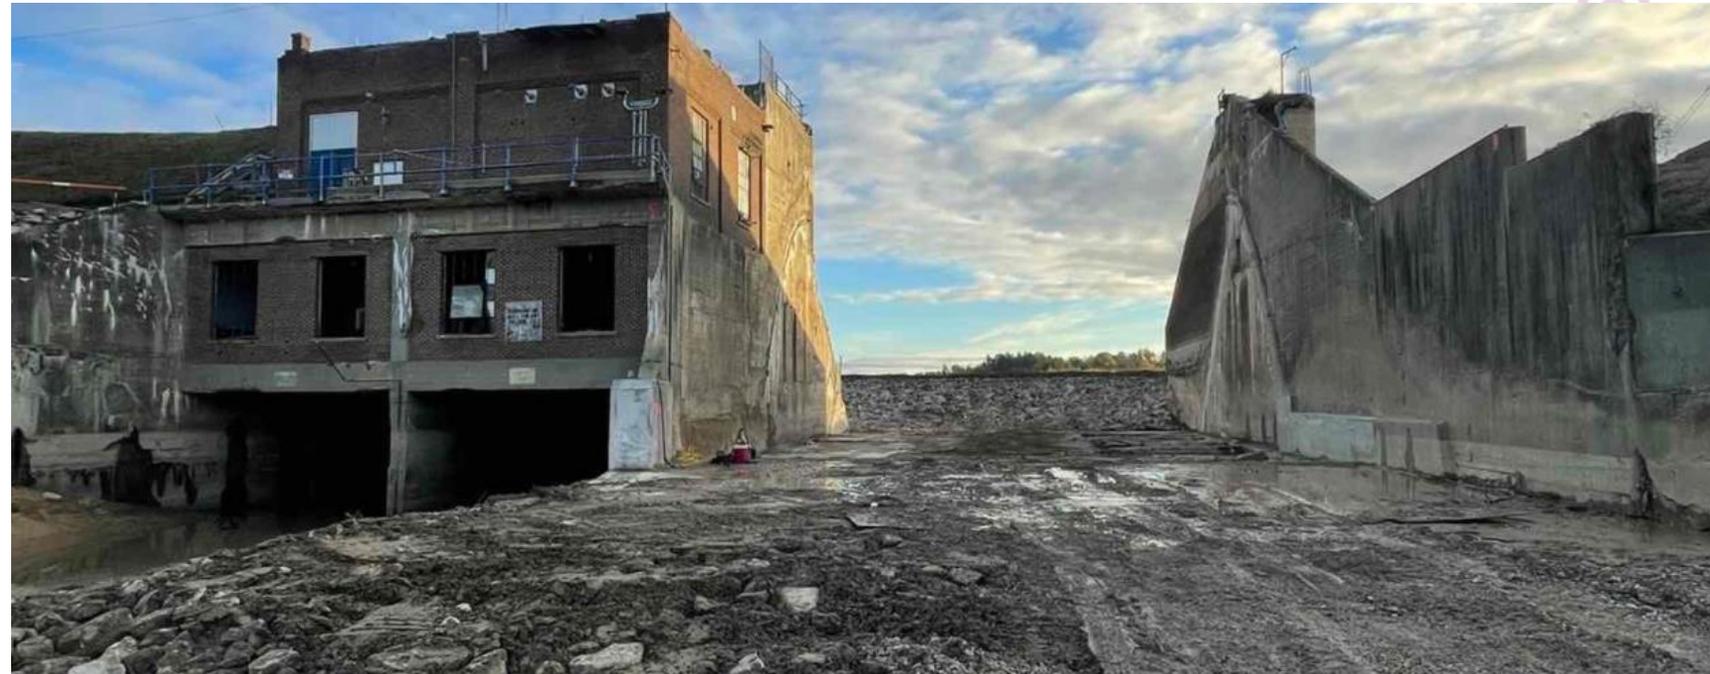
Edenville Dam Phase II – Interim Stabilization at Tittabawasse (TBW) Dam

- Re-established TBW river flow
- Installed I-Wall across Breach
- Removed Spillway Gates, Rollway and Piers
- Repaired Upstream Embankment Slopes

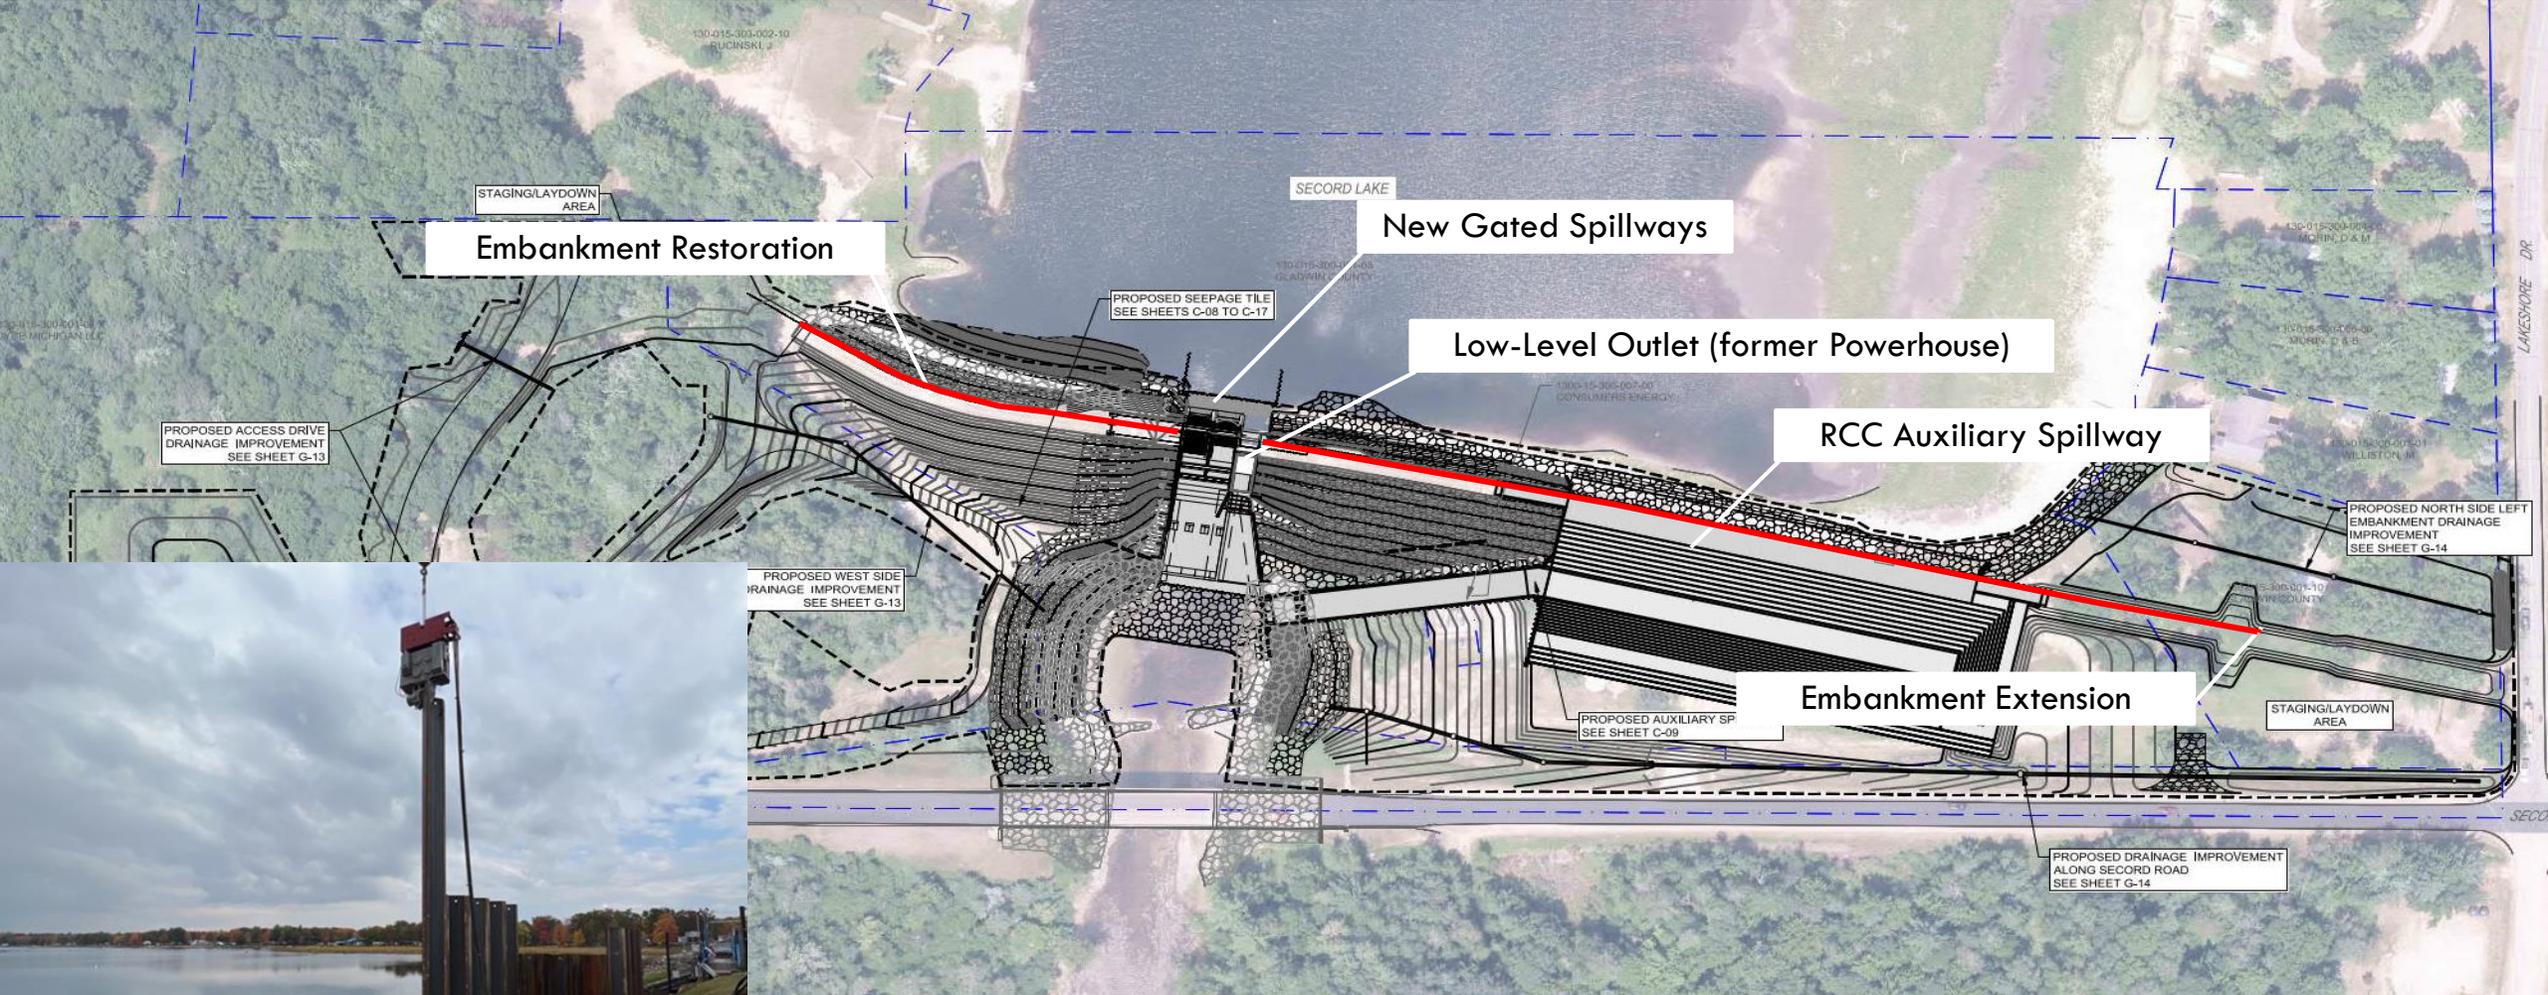
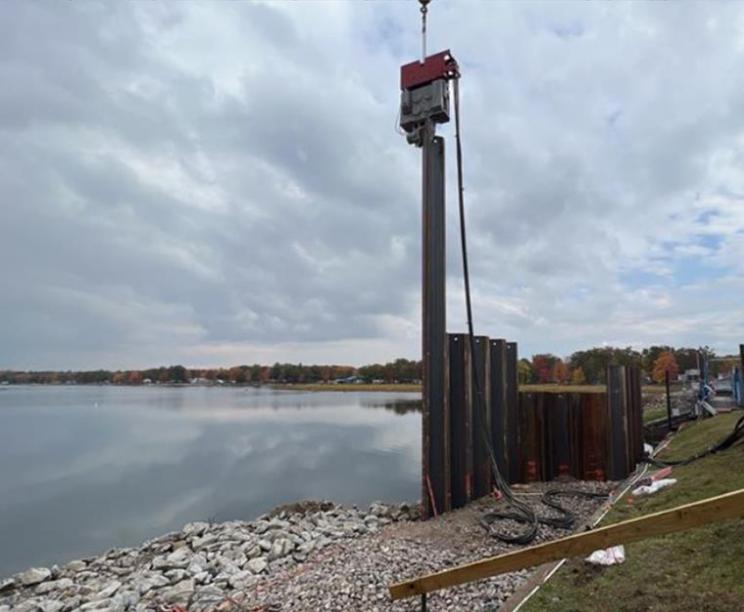
Secord Dam – Restoration (2022 to 2024)

Seepage Barrier wall installation currently underway

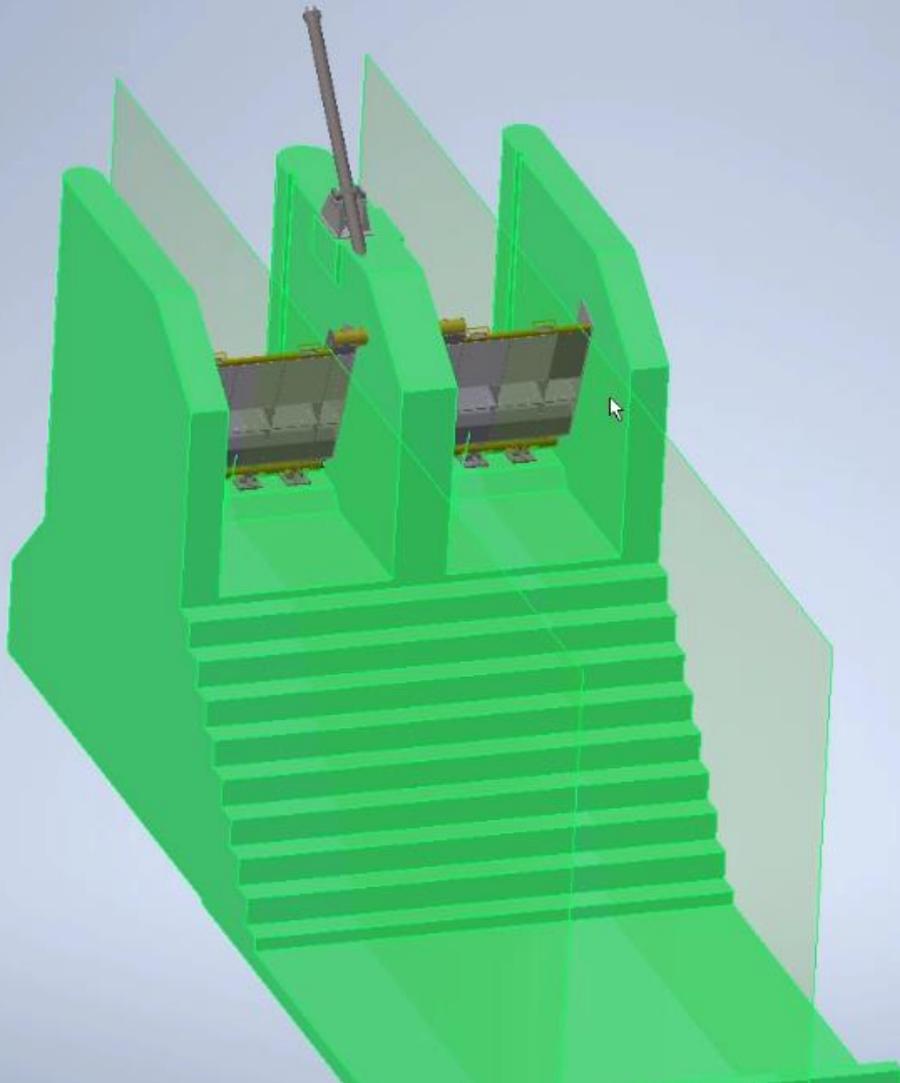
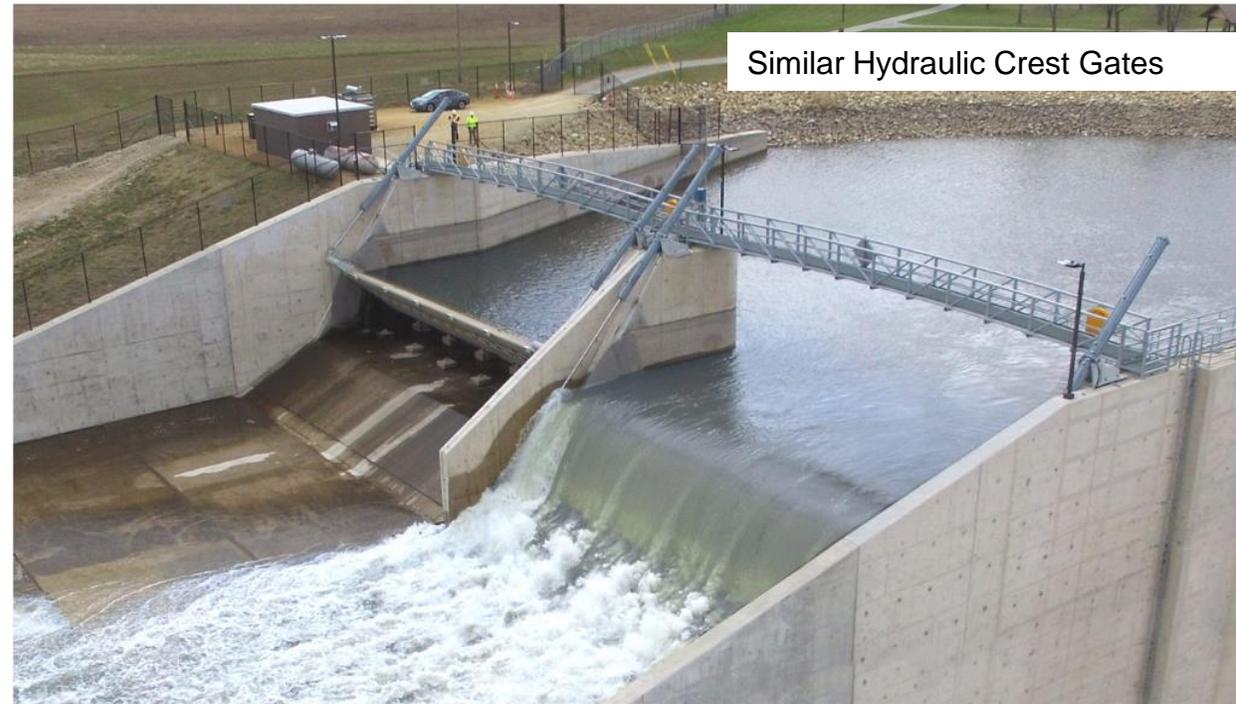
Secord and Smallwood Dams – New Taller Spillway Gates

Similar Hydraulic Crest Gates

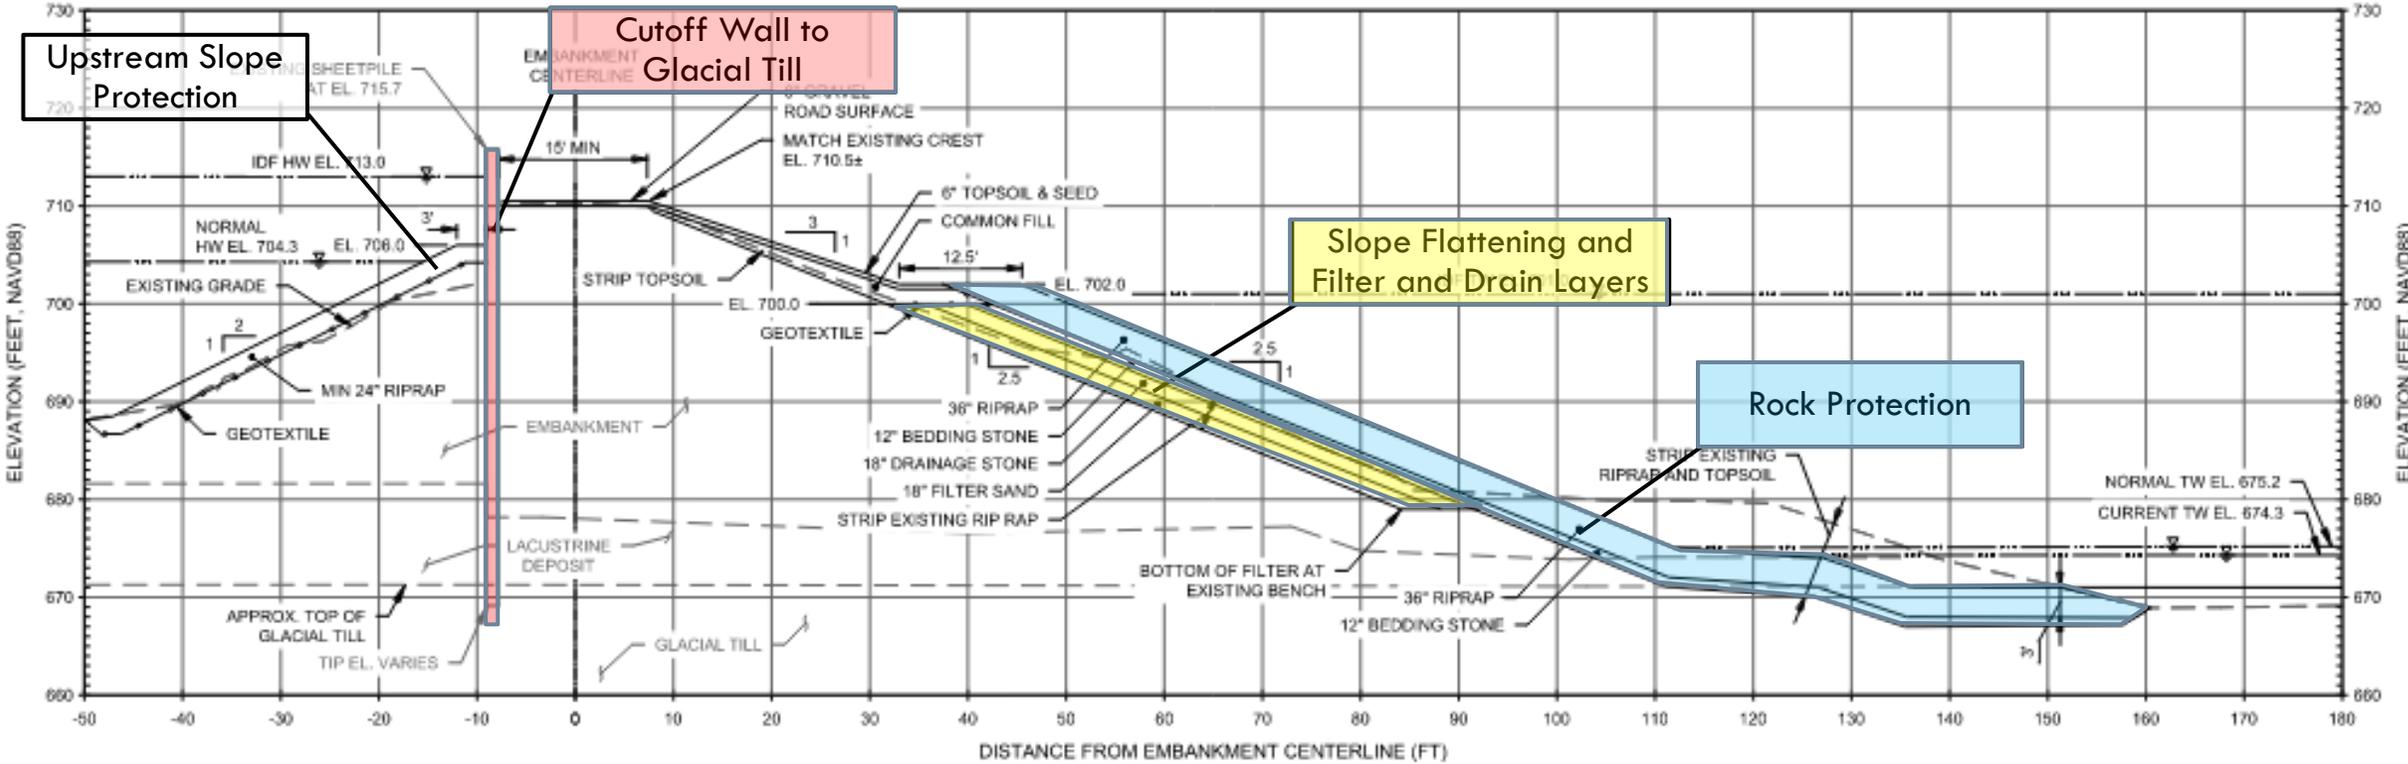
Secord and Smallwood Dams – Embankment Stabilization

D TYPICAL SECTION
C-05 LEFT EMBANKMENT

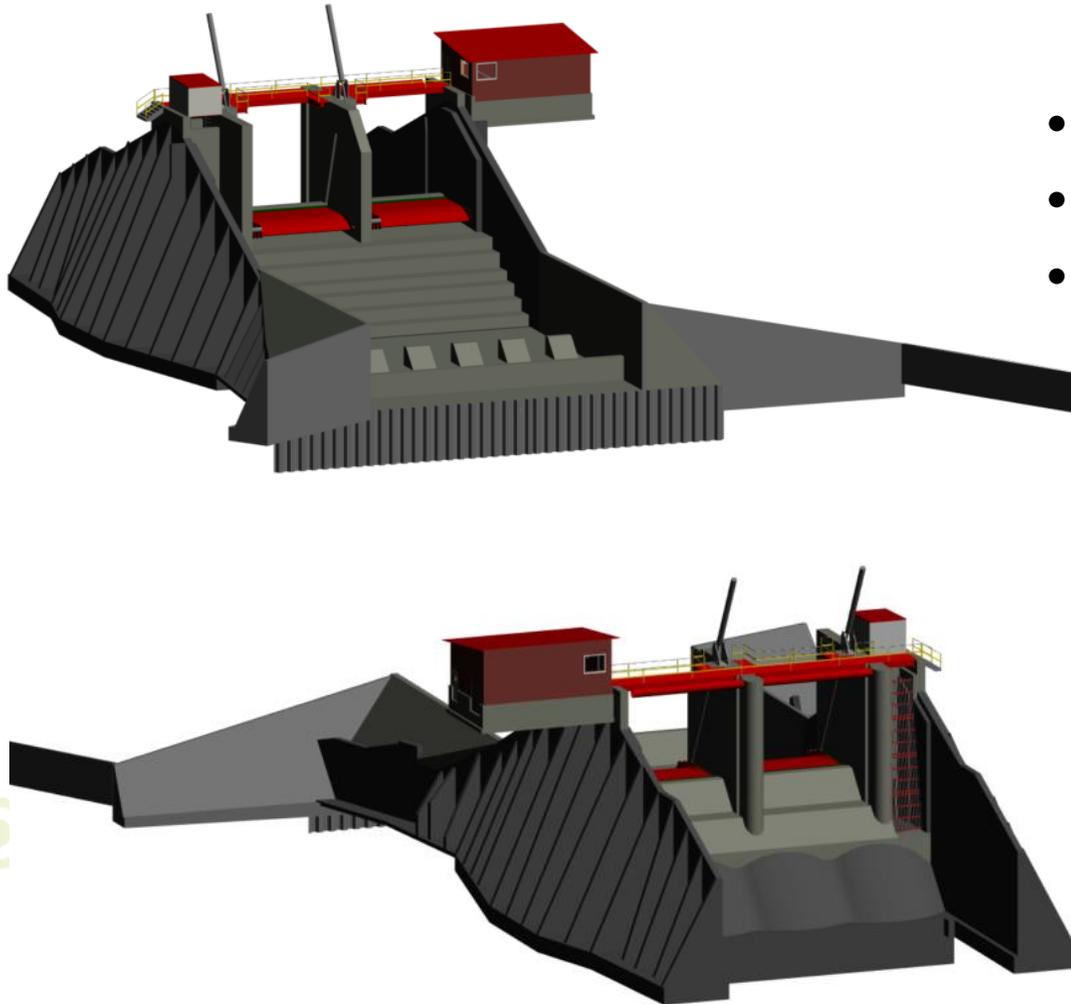
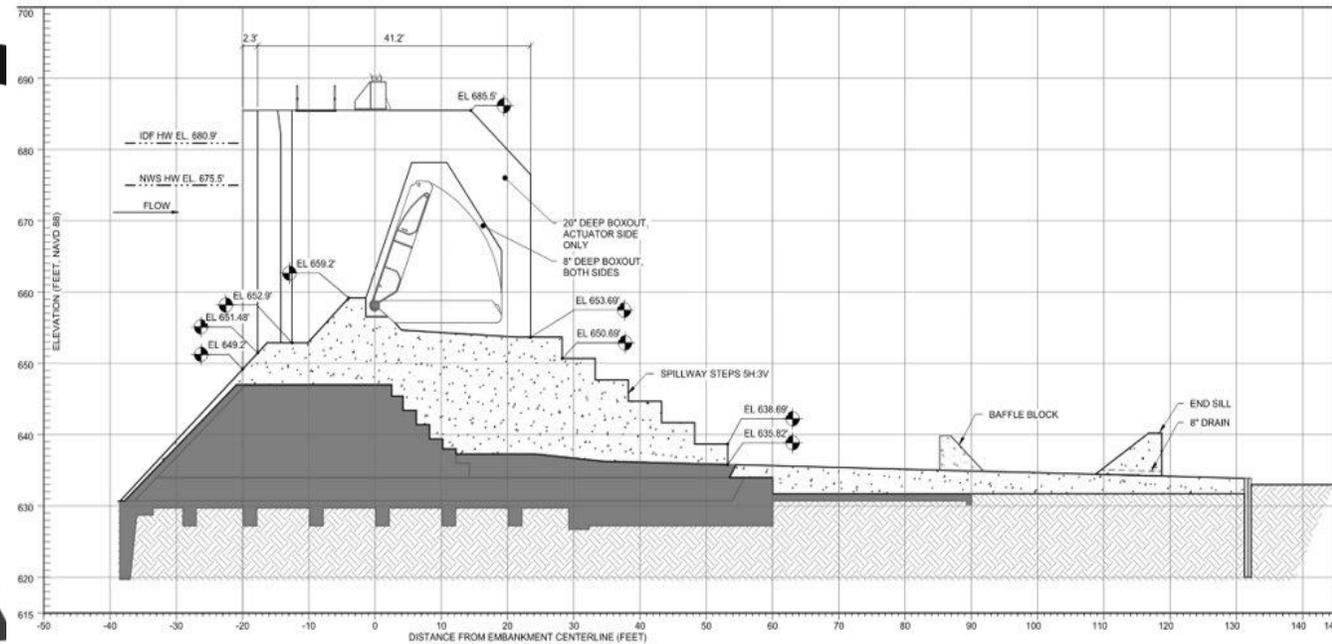
Tobacco Spillway | Summary of Improvements

- Construct two new 27-foot-wide, 16.5-foot-tall crest gates
- Construct one vertical 5x7-foot LLO gate
- Spillway mass concrete
- New stilling basin with baffle blocks
