Four Lakes Task Force Engineering and Technical Symposium

Session 3 - Design Engineering and Construction

October 20, 2022

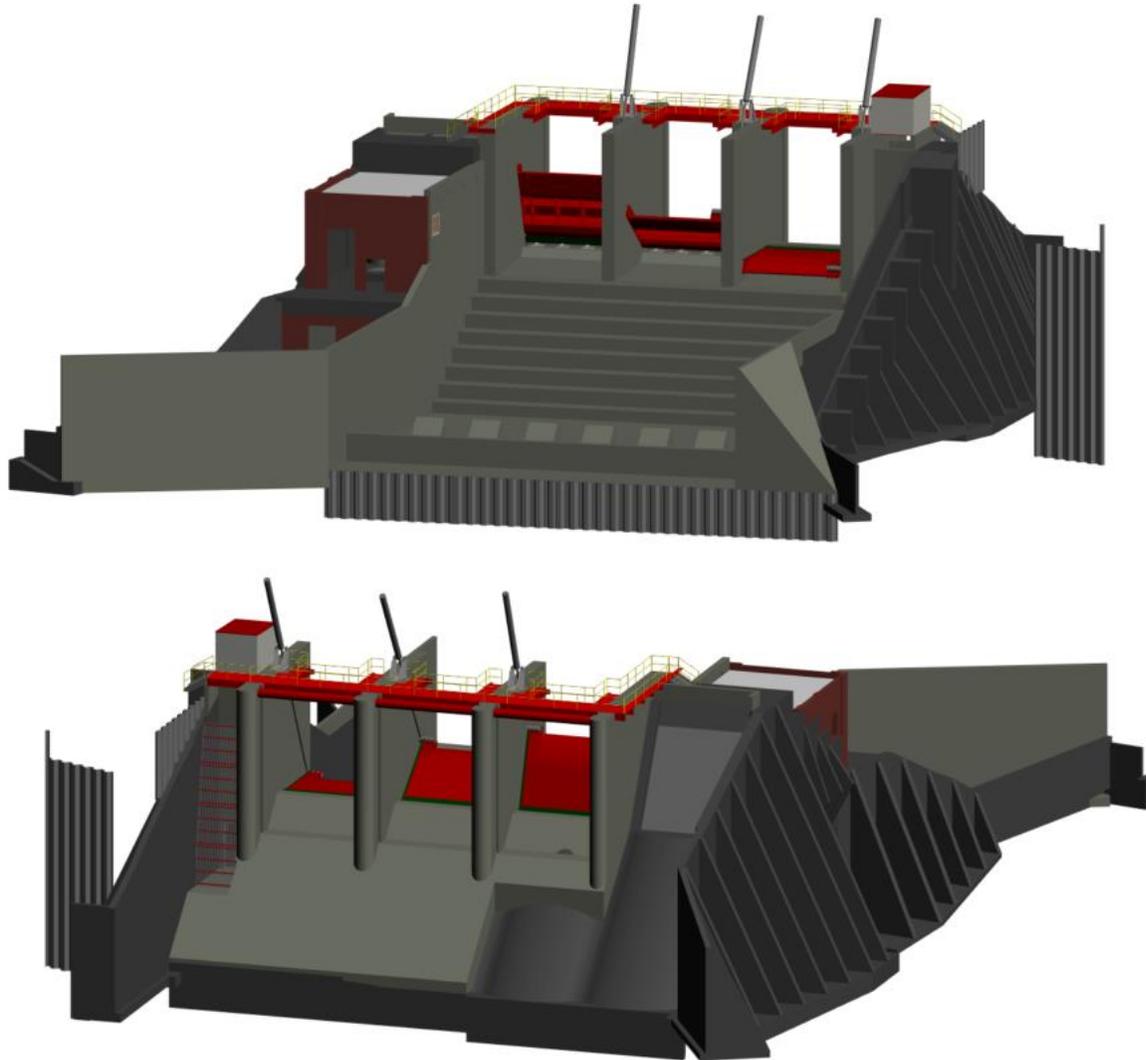
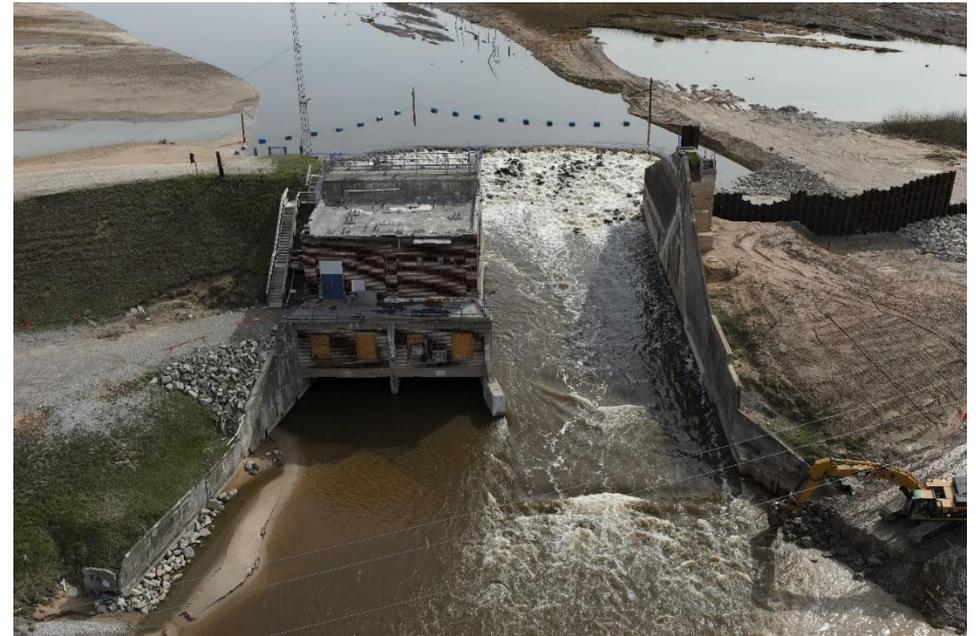
Tittabawassee Spillway | Summary of Improvements

- Demolish the left bay of the Powerhouse
- Construct three new 21.75-foot-wide, 16.5-foot-tall crest gates
- Construct one vertical 6x8-foot LLO gate
- Spillway mass concrete
- New stilling basin with baffle blocks

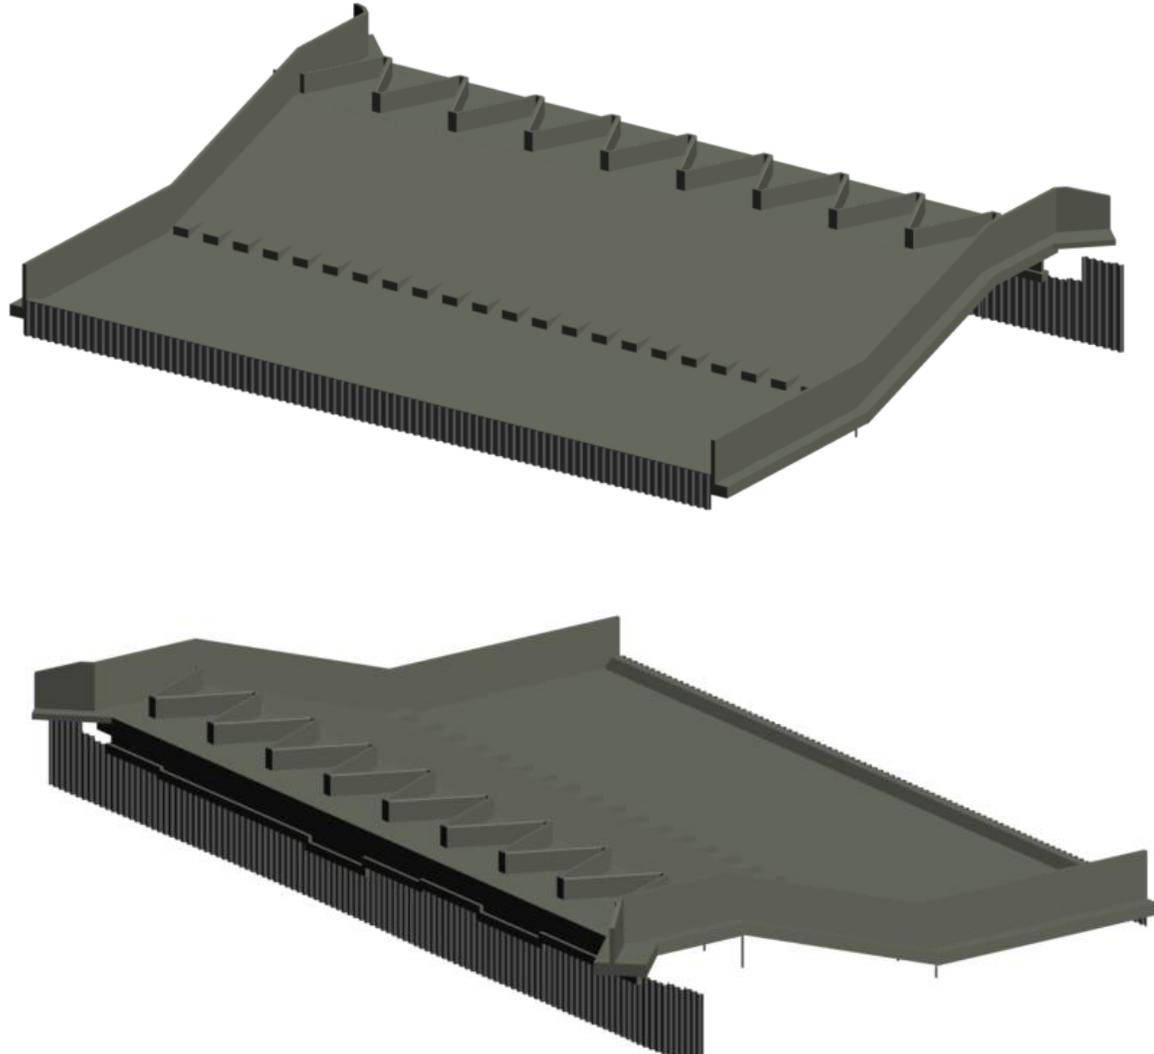
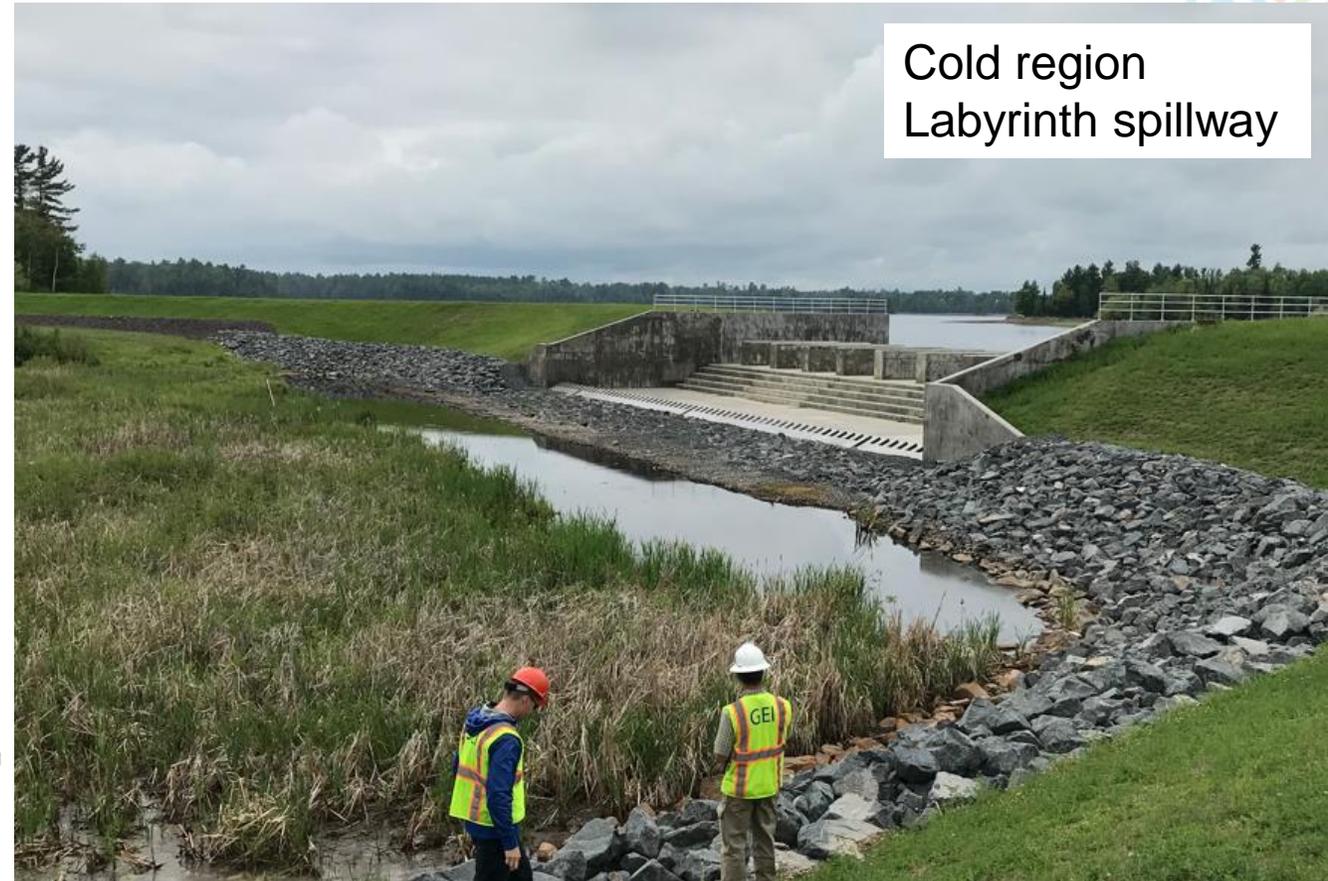
Tittabawasee Dam – New Labyrinth Auxiliary Spillway

- 275-foot-wide Labyrinth Spillway
- Located on TBW Left Embankment

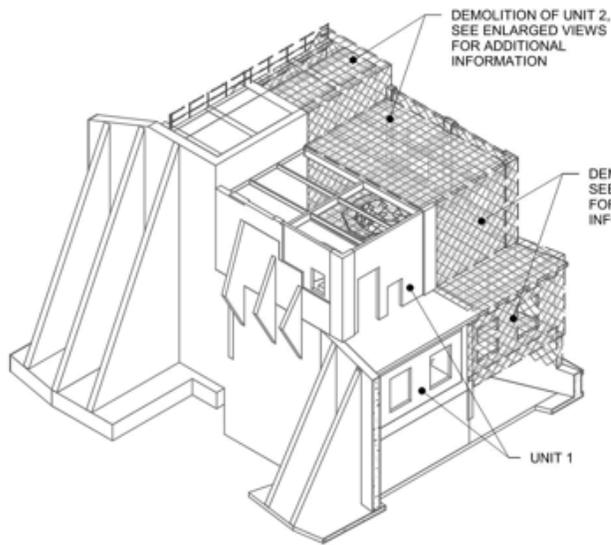
TITTABAWASSEE DAM -
DEMOLITION ISOMETRIC TASK
TW-A-4

Raze Unit 2 Superstructure

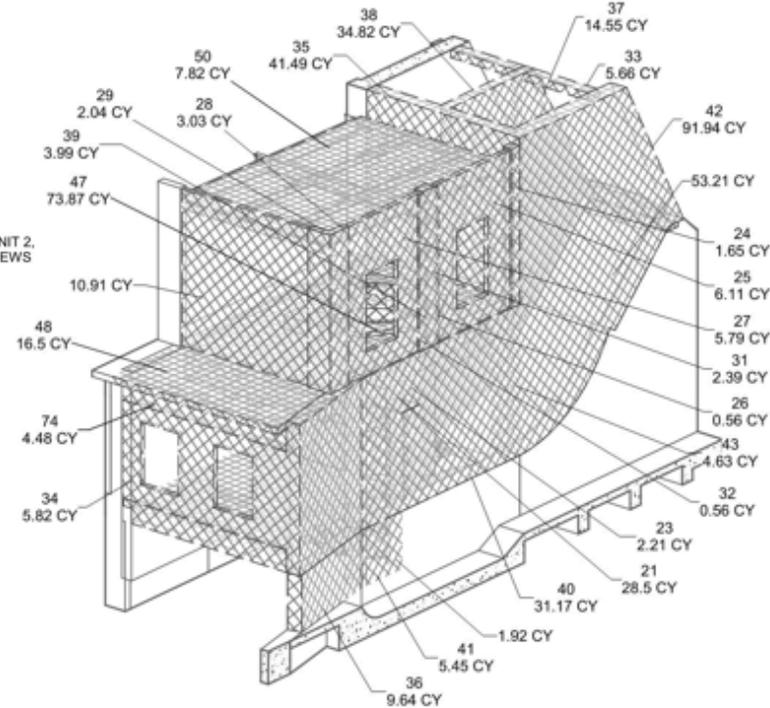
TW DAM DEMOLITION ISOMETRIC
TASK TW-A-4 - UNIT 2 EXTERIOR

Save Unit 2 Foundation Slab

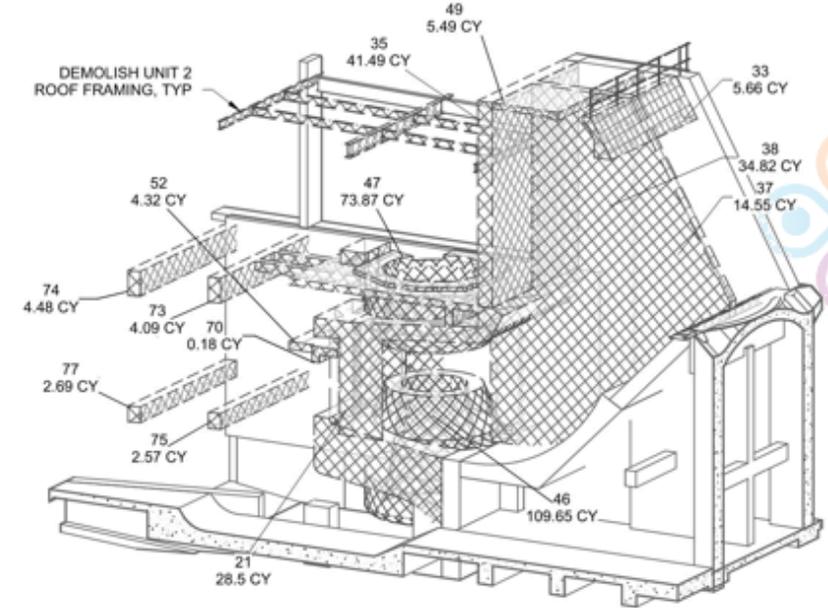
TW DAM DEMOLITION ISOMETRIC
TASK TW-A-4 - UNIT 2 INTERIOR

Fill Unit 1 Intake and Tailrace with Mass Concrete

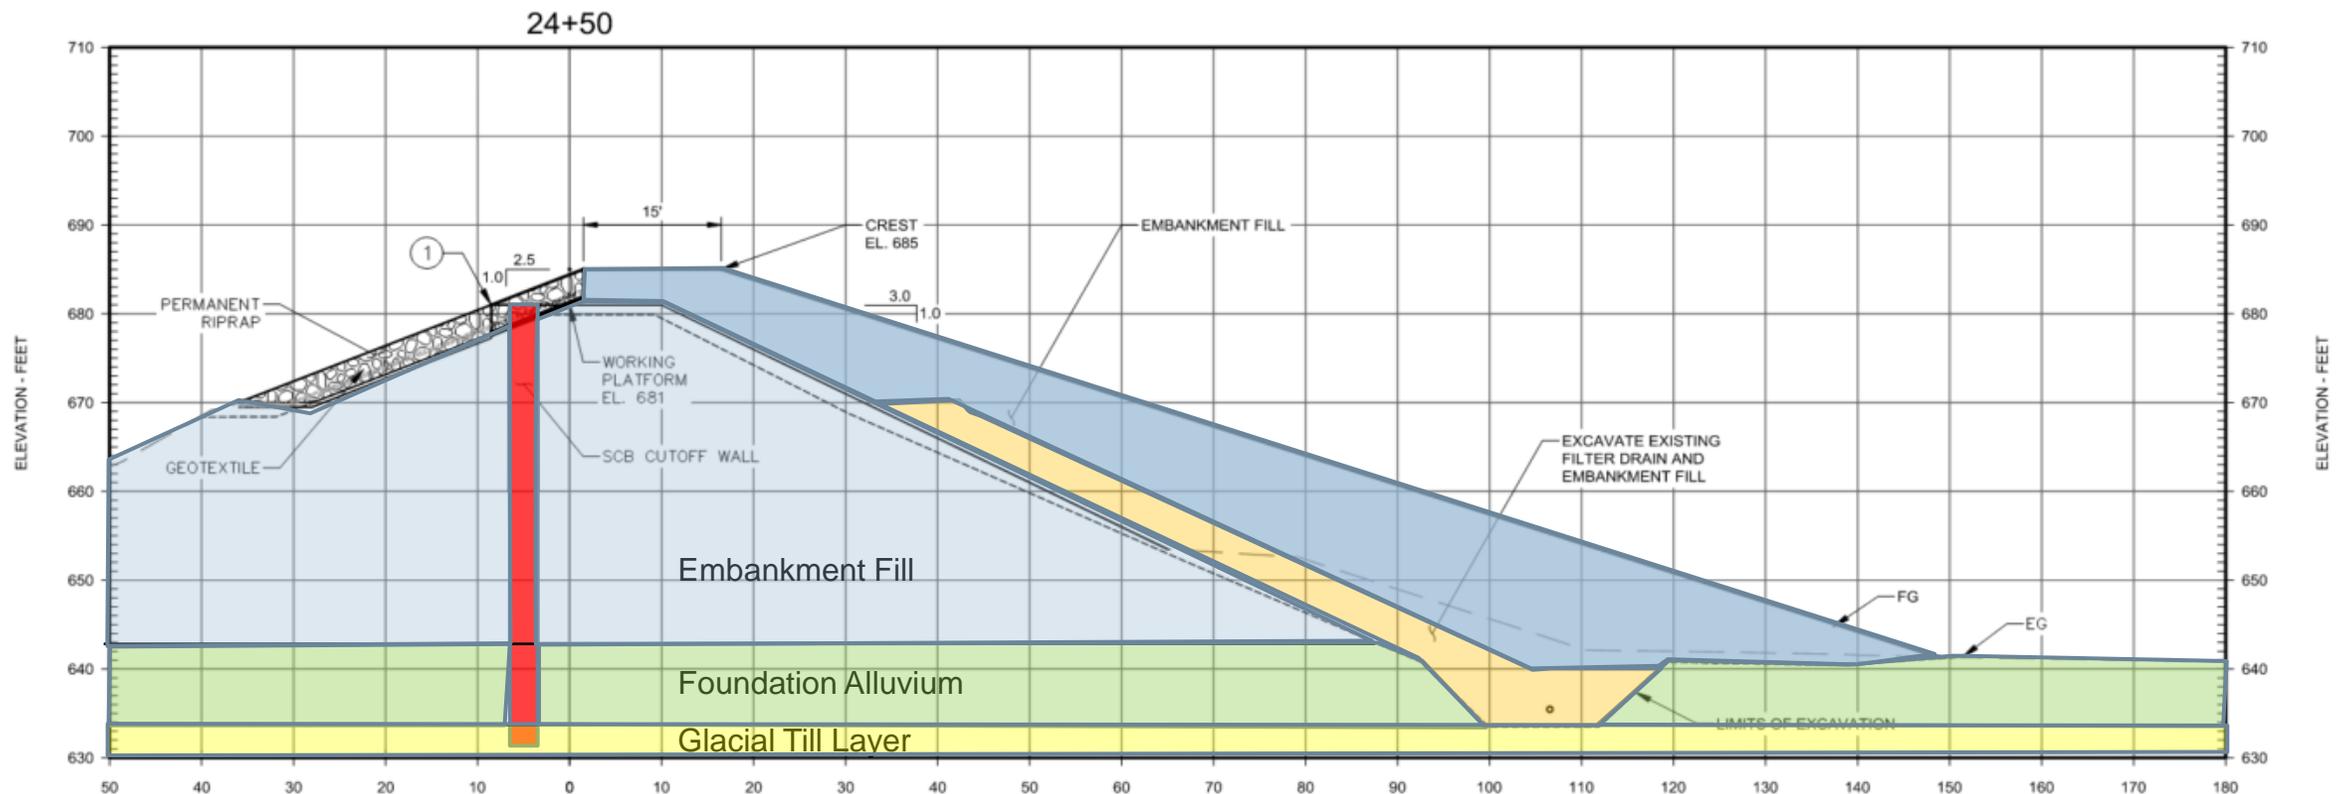
TBW and TBO Embankment Stabilization and Seepage Reduction

- Steel Sheet Pile or Mix-in-Place Soil-Cement-Bentonite Seepage Barrier Wall to glacial till
- Raise Embankment crests
- Install filter and drainage blanket material and new toe drain to collect seepage
- Flatten upstream and downstream slopes

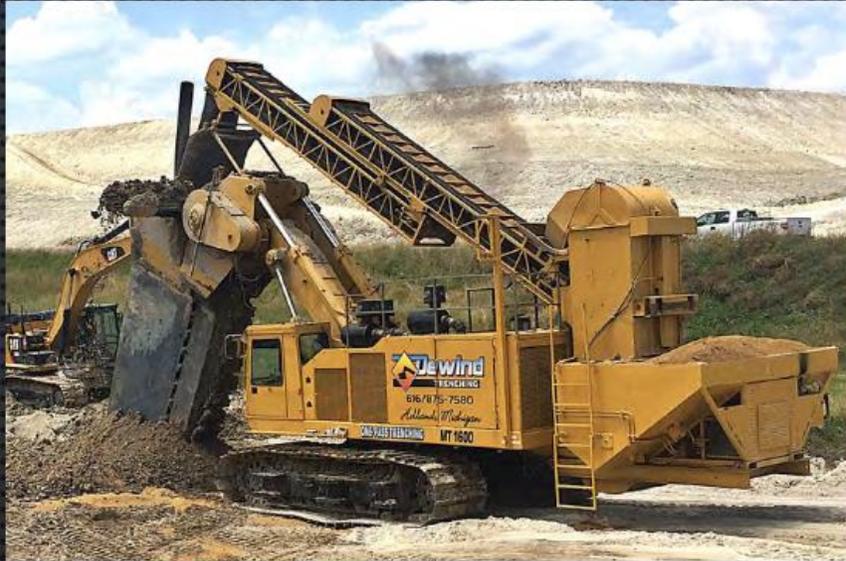
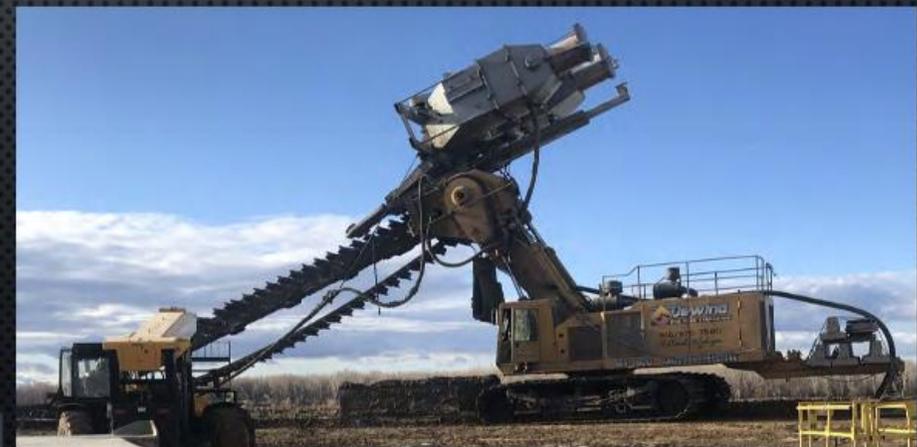
Seepage Barrier Wall – Deep Soil Mix Wall Rig

MID-SIZED TRENCHERS

- ✓ MT 1600X
- ✓ MT 2000

Trencher	Soil-Mixed Walls		Collection Trenches			
	Width	Depth	Width	Pipe Dia.	Backfill	Direct Bury
MT 1600X MT 2000	30"	80'	18"	4"	35'	40'
	36"	70'	24"	6"	35'	40'
	48"	65'	24", 30"	8"	35'	40'
	51"	55'	36"	12"	20'-25'	40'
			48"	18"	20'	20'-25'

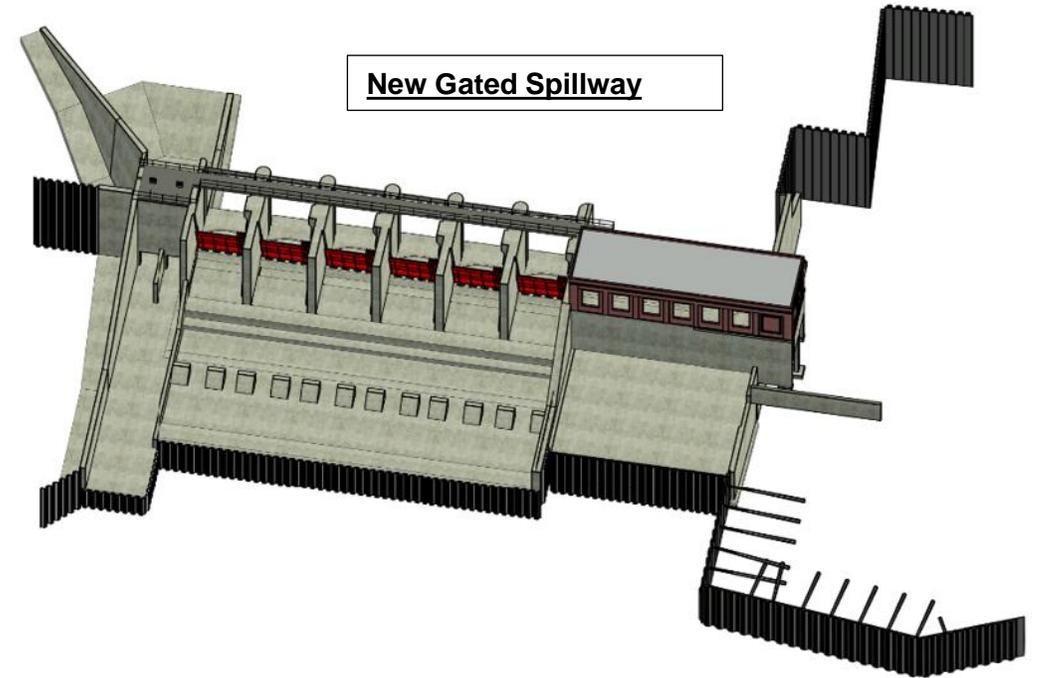
Sanford Dam Spillway Upgrades

- Existing spillway/powerhouse structures will be partially demolished
- Six new 16.5' high hydraulic spillway gates.
- Two new low level outlet sluice gates to pass base flows
- Reinforced concrete stepped chute

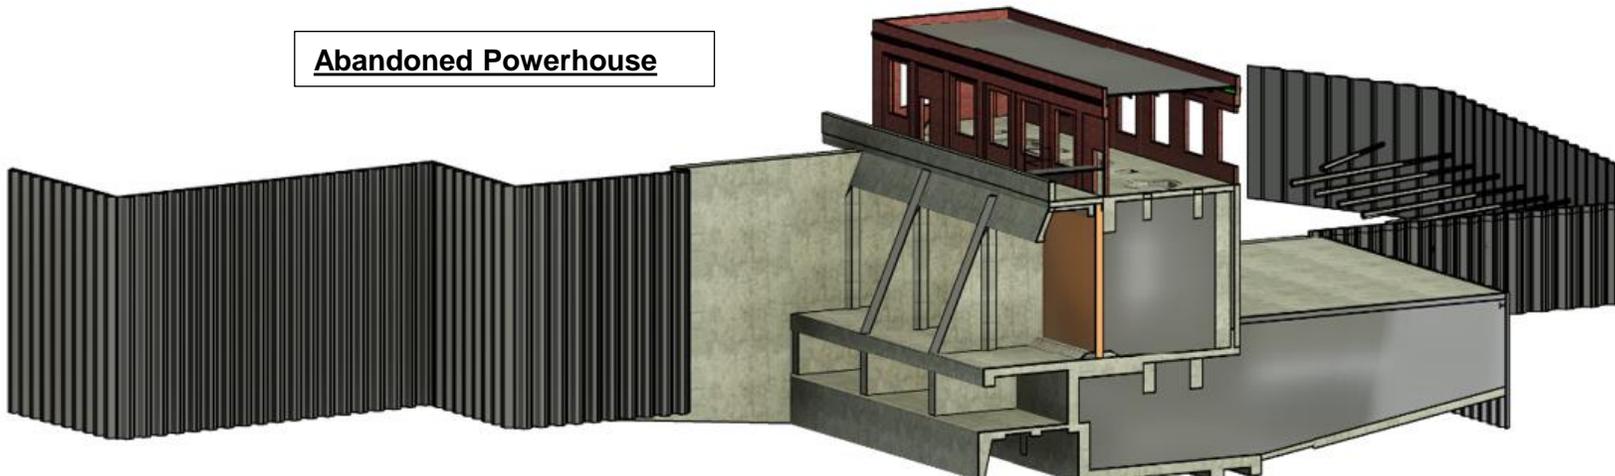
Abandoned Powerhouse

Remove turbines and generators and fill Units 1, 2 and 3 with Mass Concrete

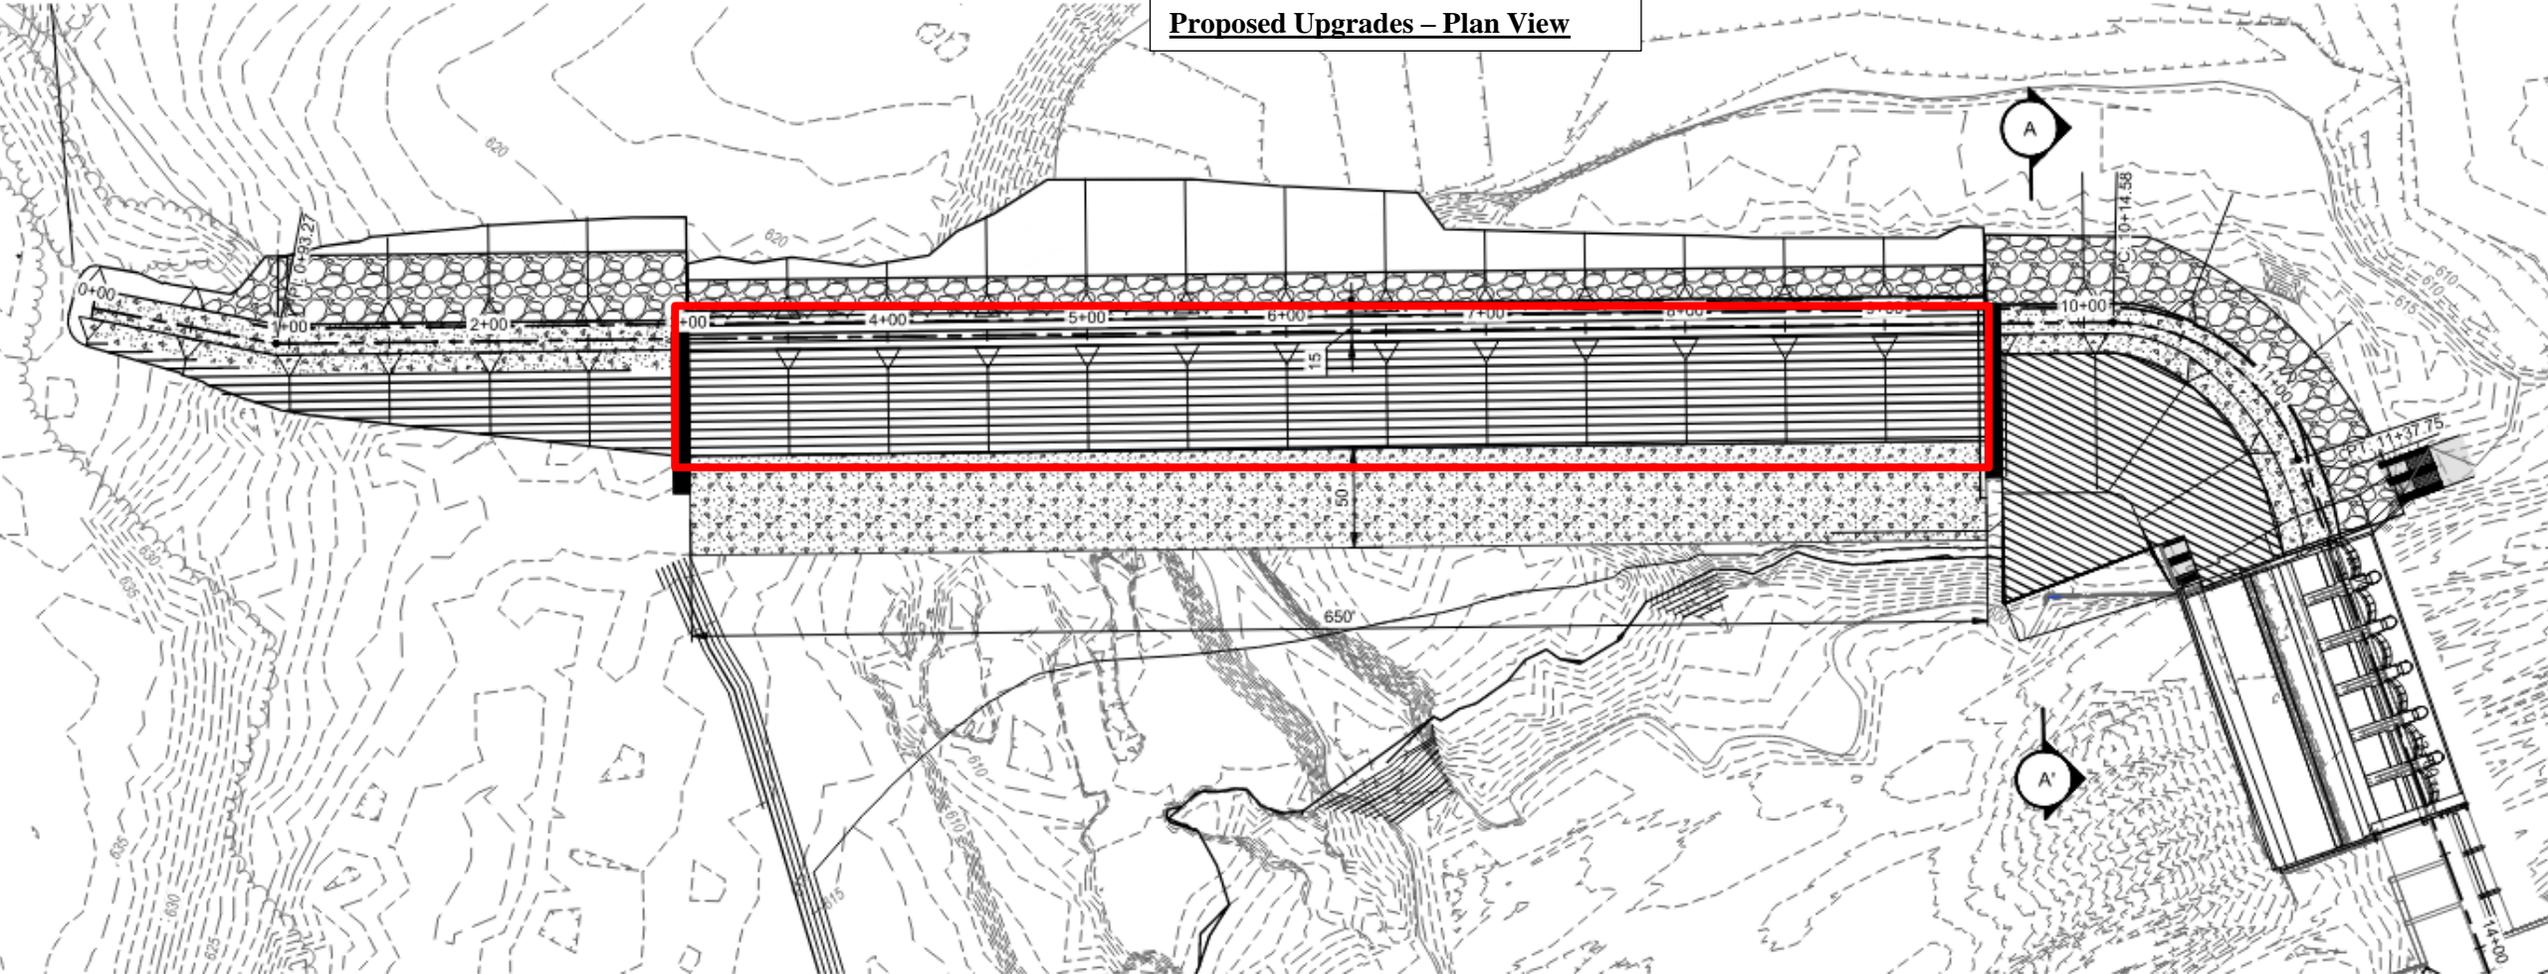
New 650-foot-wide RCC Auxiliary Spillway
