# **Conceptual Design Basis Report Rehabilitation of Secord Dam**

Gladwin County, Michigan

March 17, 2021

GEI Project No. 2002879, Task 4

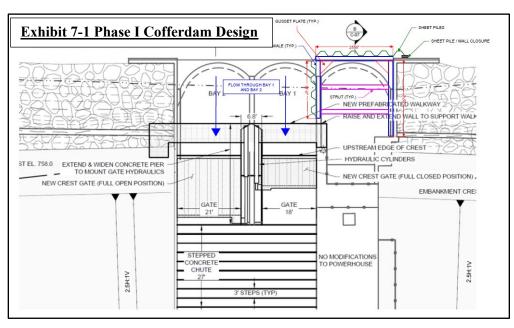
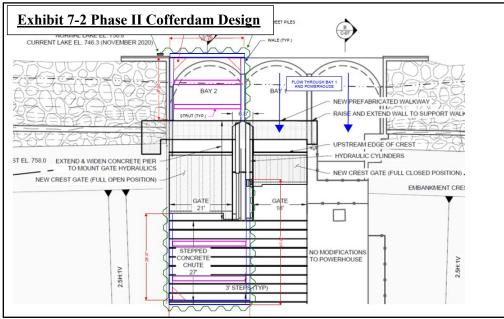
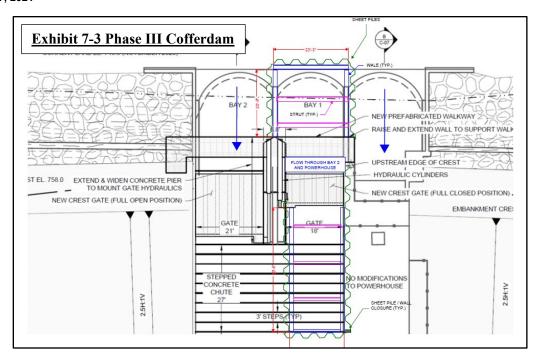
would remain open to pass base river flow. The upstream cofferdams will consist of steel sheet piles braced internally with three levels of walers and struts. The Phase II and III upstream cofferdam will require three levels of internal waler, cross-lot and corner bracing to be installed prior to dewatering, which will require some underwater diver assisted installation. The Phase II and III downstream cofferdam new two levels of internal bracing, Steel sheet piles running upstream and downstream will be cut within the barrel arch and require a closure connection using divers between the steel sheet pile and concrete barrel arch to create a "watertight" seal. The internal bracing will react against the end walls, the powerhouse, or the internal pier. The conceptual design is illustrated in **Exhibits 7-1** through **7-3** and included in **Appendix E**.

The proposed upstream and downstream cofferdam design consists of internally braced, hot rolled steel sheet pile (SSP) with interlock sealants. The cofferdam cells can be constructed in three (III) phases at the powerhouse and each bay. Phase I is constructed at the powerhouse to allow construction of the low-level outlet while the Tainter gate spillway bays remain open to pass base river flow. Phase I requires an upstream cofferdam only. Phase II requires both an upstream and downstream cofferdam and would occur at Spillway Bay No. 2 while the newly constructed low-level outlet and spillway bay No. 1 pass base river flow. Phase II construction includes the Spillway Bay No. 2 demolition of the concrete barrel arch and downstream rollway, concrete repairs, construction of the new concrete rollway and crest gates. Finally, Phase III would occur at the spillway bay No. 1 and like Phase II, while Spillway Bay No. 2 and the low-level outlet

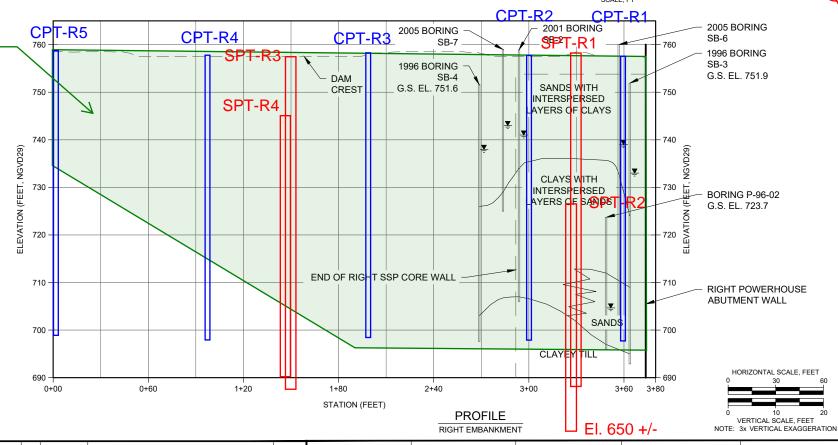
NOTES:

1. RIGHT EMBANKMENT SOIL PROFILE DEVELOPED FROM SECORD SUPPORTING TECHNICAL INFORMATION DOCUMENT, FEBRUARY 2006.

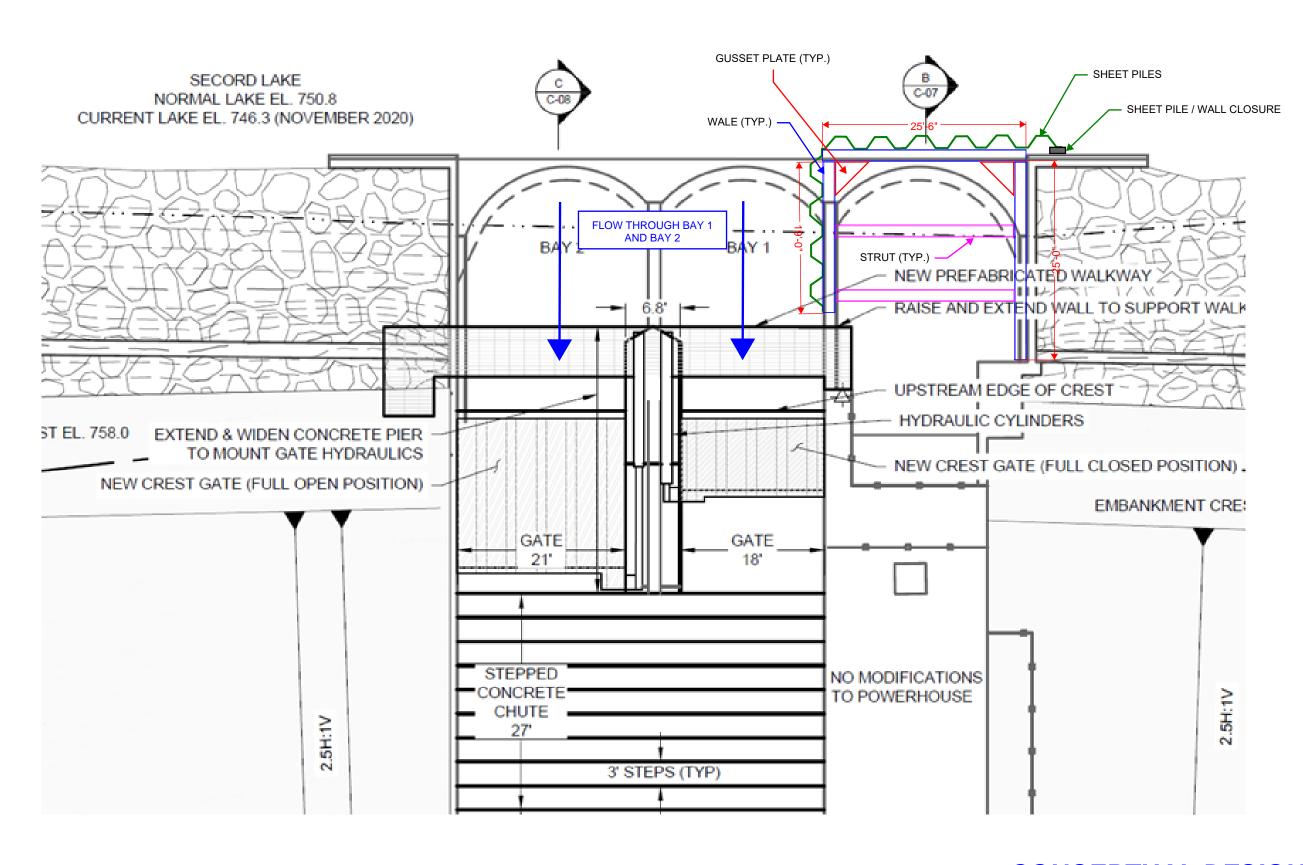
Fig. CD-01

**MATERIALS:**

**SHEET PILES:** PZC-26, 50 ksi min.

Our conceptual design for the cofferdam consists of sheet pile cells constructed in three stages at the powerhouse and each bay. Stage 1 is constructed at the powerhouse to allow conversion to the low-level outlet while the spillway remains open to flow. Stage 1 requires an upstream cofferdam only. Stage 2 would occur at one of the bays to allow replacement of the gate and concrete repairs. The opposite bay and the outlet at the powerhouse would remain open to flow. Finally, Stage 3 would occur at the last bay and similar to Stage 2 the opposite bay and the outlet at the powerhouse would remain open to flow. Stages 2 and 3 requires upstream and downstream cofferdams.

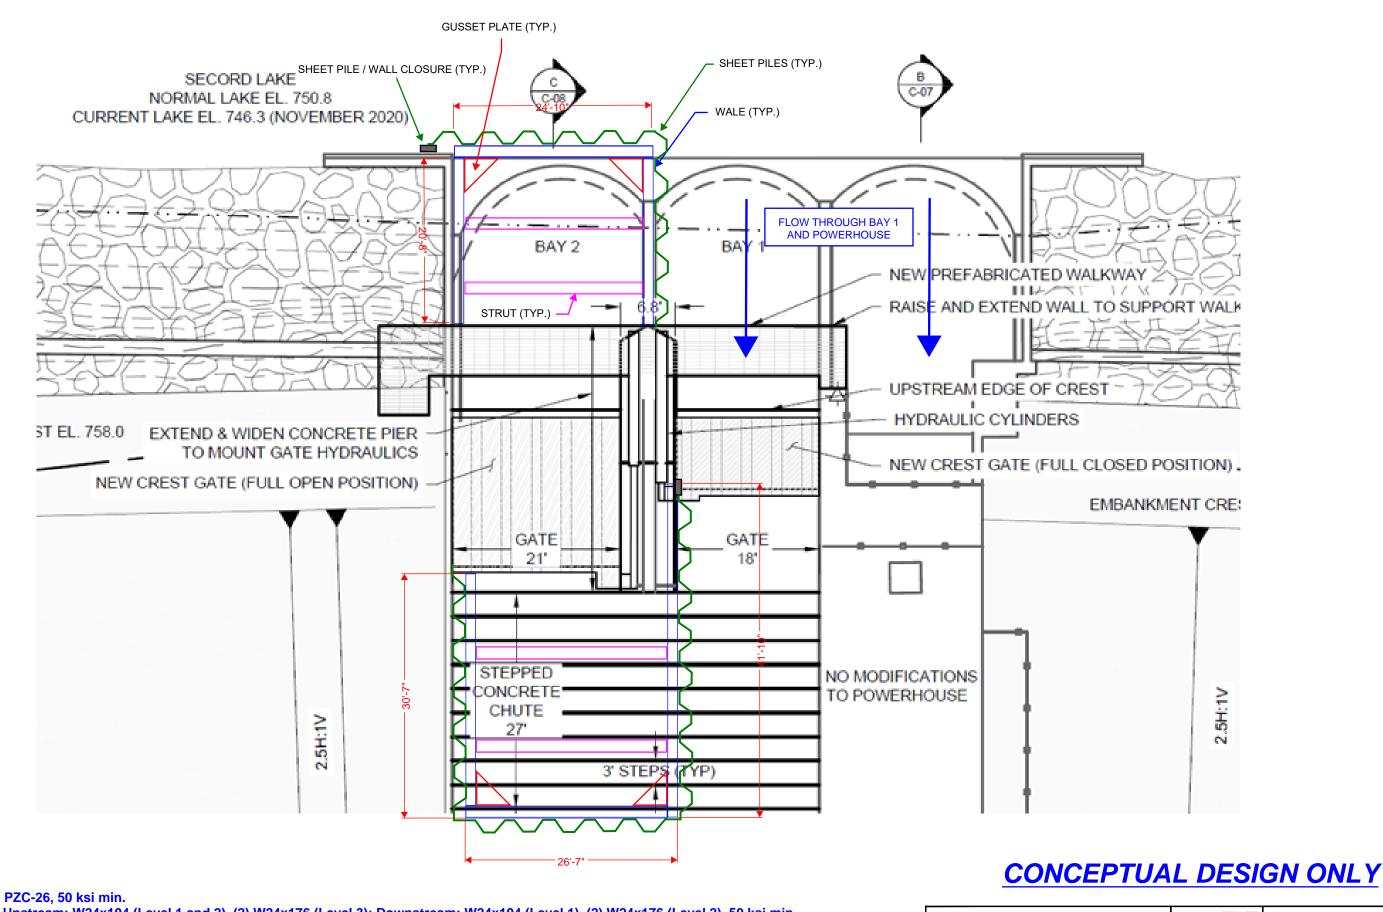
Fig. CD-02

**MATERIALS:**

**SHEET PILES:**

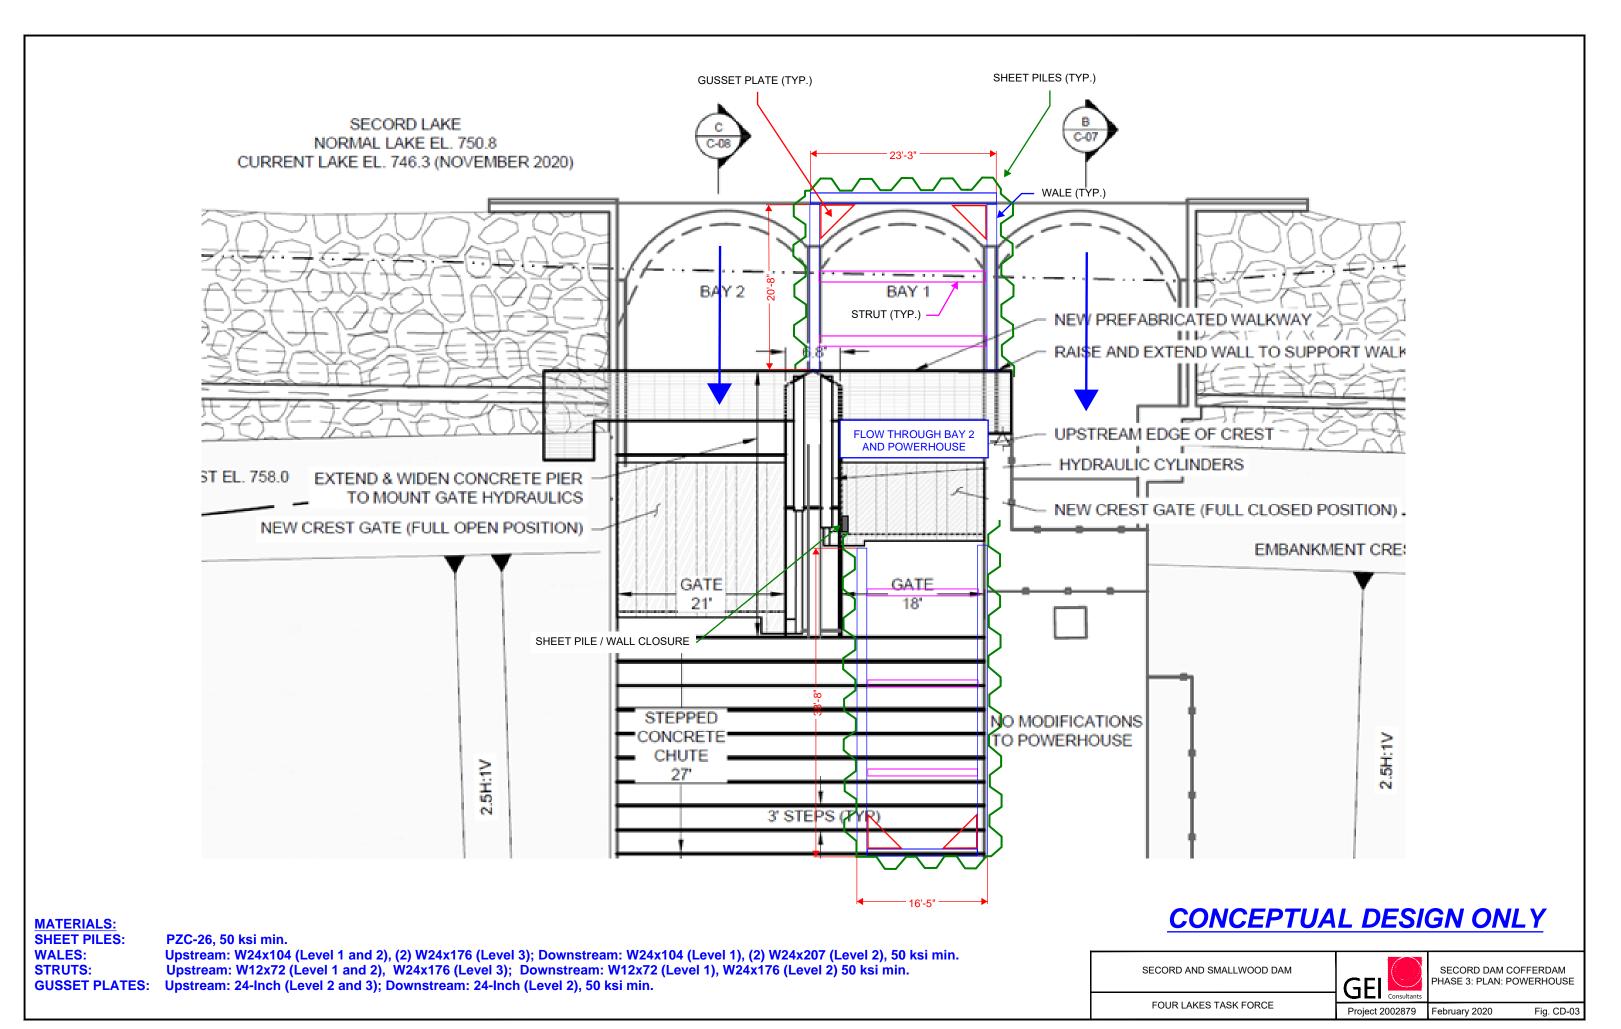
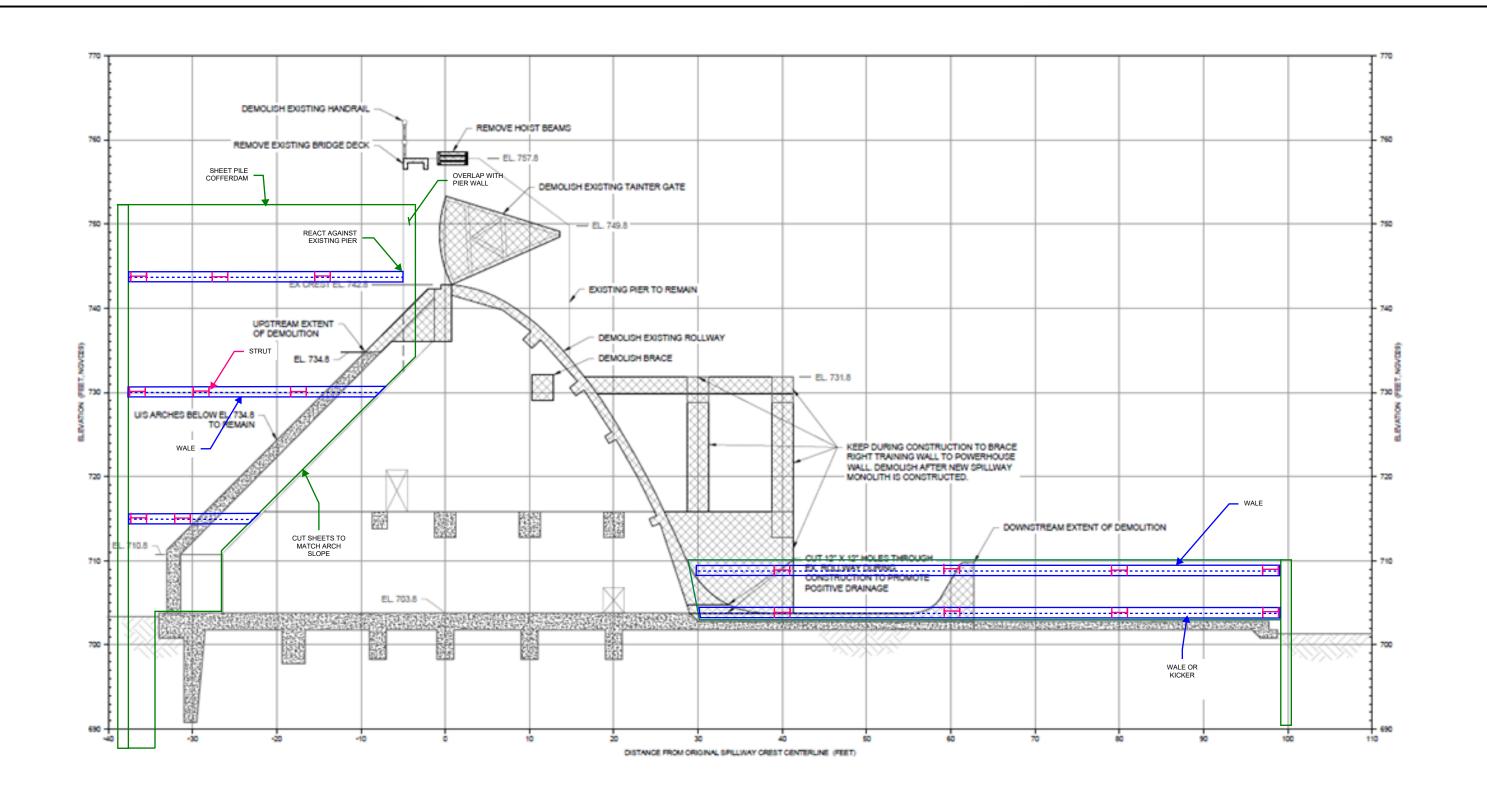
Project 2002879 February 2020 Fig. CD-04

SECORD DAM COFFERDAM
