Four Lakes Task Force: Smallwood Dam Rehabilitation Smallwood Dam, Midland County, Michigan

SMALLWOOD DAM CONCEPTUAL DESIGN

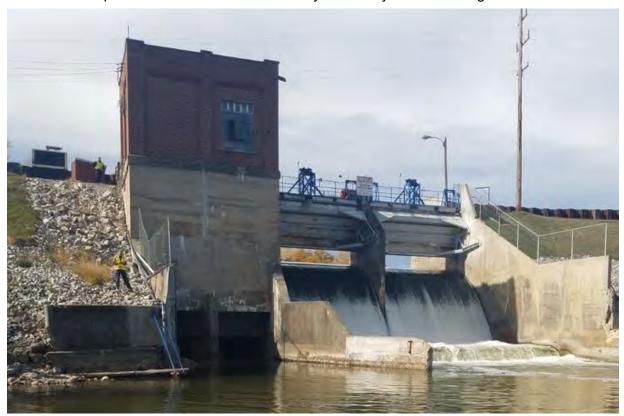
Photo 1. Smallwood Spillway and Powerhouse, October 2020.

The reinforced concrete spillway is a hollow reinforced concrete barrel arch and ogee-shaped rollway structure spanning to buttress piers and powerhouse wall and left spillway training wall with two Tainter gate bays (see Photo 1). Both the left and right Tainter gates are 25.4-feet-wide by 10-feet-high separated by a 1.5-foot-wide center pier. The spillway ogee crest sill is at El. 694.3 feet. A hydraulic hoist operates the gates with the operators located directly adjacent to the hoist above each gate on an elevated platform. The hydraulic gate chain and single cable hoist and reel system was installed in 2019, replacing the original electric hoist and trolley system. The gates are currently in the fully open position (10-feet) and dogged off to maintain a drawndown impoundment per Federal Energy Regulatory Commission (FERC) and EGLE orders and to prevent accidental closure in the event of gate hoist or hoist cable failure.

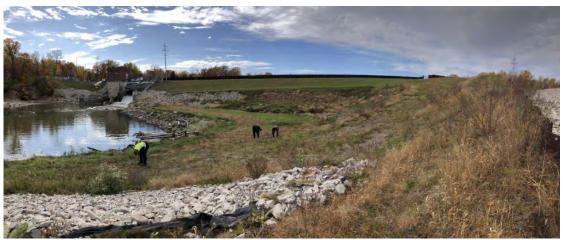
Photo 2. Smallwood Dam Left Embankment, December 2020.

The left embankment is approximately 1,000-feet long, with a maximum structural height of 38 feet near the spillway. The embankment consists of an approximately 320-foot-long non-overflow section nearest the spillway and an approximately 680-foot-long emergency overflow section. The original embankment was reportedly constructed of native silt, sand, and clay from onsite sources. The non-overflow section contains a steel sheet pile (SSP) cutoff constructed in 1999 along the upstream edge of the embankment crest. The SSP was driven through the embankment and foundation overburden soils into the glacial till and extends above the crest to El. 715.2. In 2000, the upstream SSP line was extended downstream to form a training wall between the non-overflow and emergency overflow sections. The crest of the non-overflow section was narrowed, and the downstream slope regraded and flattened in 2001 to satisfy global stability criteria. The left embankment non-overflow section and SSP are illustrated Photo 2. The crest elevation of the 680-foot-long left embankment emergency overflow section generally ranges from El. 709.0 to 711.5 feet. This section is intended to overtop during an extreme flood event.

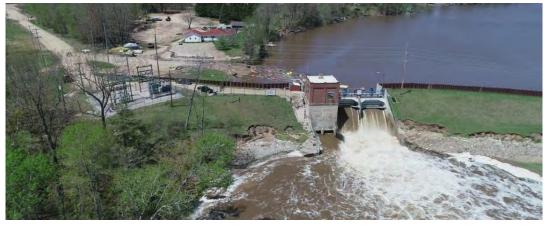
Photo 3. Aerial Drone Imagery of Smallwood Dam, May 2020.

The right embankment is 125-feet long, 38-feet tall and reportedly constructed of native silt, sand, and clay material. The right embankment also contains an upstream SSP seepage cutoff constructed in 1999 that extends approximately 250 feet beyond the end of the powerhouse abutment wall (see Photo 3).

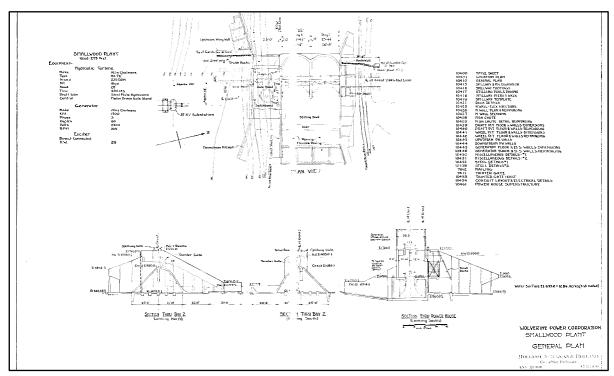
Figure 3. Original Plan Drawings of the Smallwood Dam, March 1924.

FLTF maintains a collection of historic photos taken during the construction of the Smallwood Dam, as well as sheets of construction plans and improvements (1920s), as-builts (1930s), and common lifecycle modifications (into the 2000s). Original plans for the Smallwood Dam are provided as Figure 3.

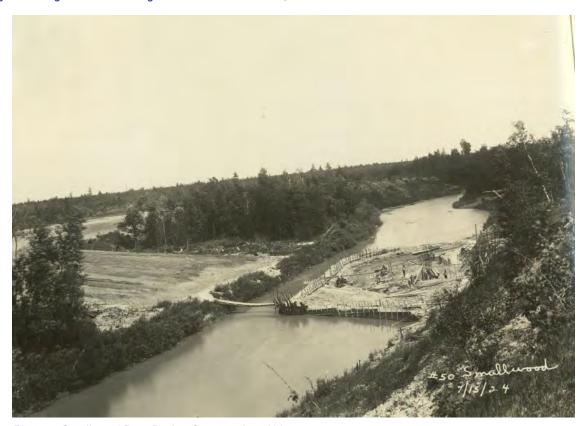
Photo 4. Smallwood Dam During Construction, 1924.

Spillway construction began in September 1923 (see Photo 4), followed by the powerhouse. Once the spillway structure was built, embankment dams were built using the native Michigan sand-clay materials for the fill, founded on the hardpan glacial till of the region. The powerhouse structure was built first and water diverted through it at which time the right half of the river was coffer-damned, and then the spillway structure was built. The lower portion of the powerhouse was used as the diversion structure. Once the concrete powerhouse and spillway structure were completed construction of the embankment dam was undertaken. Concrete work was completed in the summer and fall of 1924.

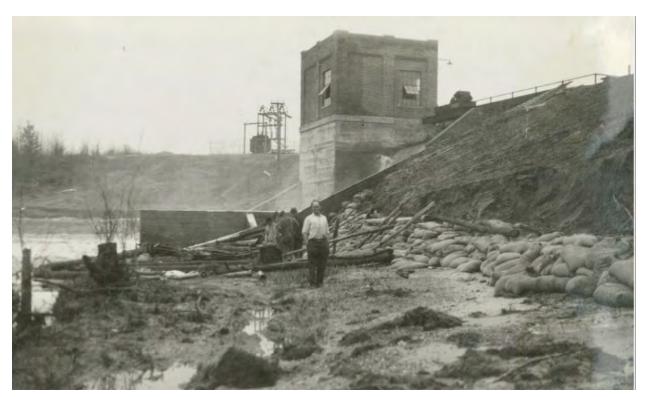
Photo 5. Smallwood Dam Post-Fire, 1927

According to historic documentation on file with the FLTF, modifications to the dam began in 1924 with changes to the bridge above the spillway. A fire in 1927 damaged the embankments, shown in Photo 5 below, however beyond historical photographs there is no record of the details of the impacts of the fire on the Smallwood Dam. In 1985 the spillway gates were repaired, and in 1998, the left embankment was cleared of vegetation, regraded, and flattened. In 1998 the spillway was upgraded. In 2001, the left embankment was modified, and sheet piling was added in 2013. In 2014, approximately 260 feet of the overflow section just left of the SSP training wall was raised to crest elevation 711.5 feet and a 20-foot-wide rip-rap channel was also constructed along the SSP training wall to prevent scour along the base of the wall during an extreme flood event that could overtop the embankment left of the SSP. There is no record of improvements or repairs made to the right embankment, other than installation of the SSP cutoff. In 2016 the plant facility was modified. Post-construction, modifications were performed on the Smallwood Dam embankment and Routine structural repairs included continual concrete repair on the structures, as well as gate repairs. All pre-disaster modifications were performed by Wolverine Power Company, followed by Boyce Hydro.

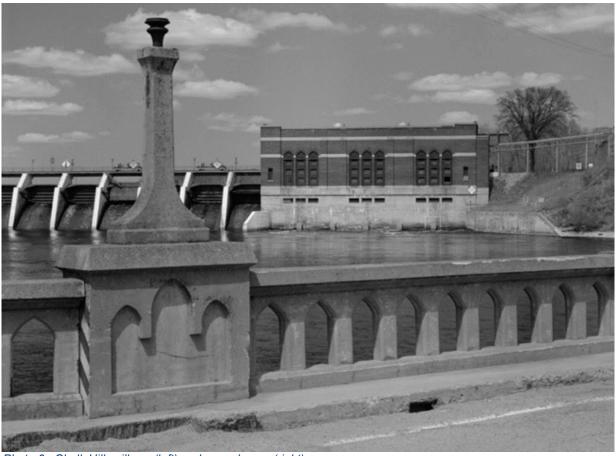
Photo 6. Chalk Hill spillway (left) and powerhouse (right).

Other properties designed by Holland, Ackerman and Holland, exhibit unique architectural elements such as stained glass within the powerhouse (Chalk Hill Dam) or sweeping arches (Victoria Dam). The Quaker Mill Dam, demolished in 2017, was previously listed on the NRHP due to a few unique characteristics, namely a monumental concrete fishway and a single Tainter gate with a manually operated hoist. While both the Chalk Hill Dam and the Tobacco River Spillway are hollow, the hollow nature of the Chalk Hill Dam was utilized to access the powerhouse, which is not present at the Smallwood Dam. The Chalk Hill Dam was also distinctive due to its large concrete fishway, its size (early 300 feet wide), and the decorative elements within the powerhouse (see Photo 6). Other than some being hollow and/or having multiple Tainter gates, unique architectural features and associated structures set these facilities apart from the Smallwood Dam.

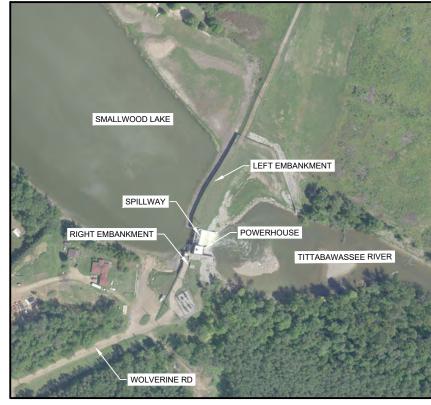
SITE AERIAL (NOT TO SCALE)
