Four Lakes Task Force: Secord Dam Rehabilitation Secord Dam, Gladwin County, Michigan

## SECORD DAM CONCEPTUAL DESIGN

GLADWIN COUNTY, MICHIGAN FOUR LAKES TASK FORCE

FERC PROJECT NO. 10809

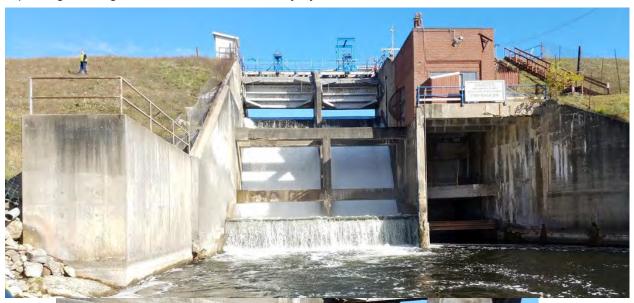
Photo 1. Secord Dam Overview, May 2021.

The reinforced concrete spillway structure is a hollow reinforced concrete barrel arch and ogee shaped rollway spanning to buttress pier supported structure with two Tainter gate bays (see Photos 1 and 2). The left Tainter gate is approximately 20.5-feet-wide by 10-feet-high and the right Tainter gate is approximately 23.8-feet-wide by 10-feet-high separated by a 2-foot-wide center pier. The spillway ogee crest is at approximate El. 742.8 feet. The gates are operated by a hydraulic hoist with the operators located directly adjacent to the hoist above each gate on an elevated platform. The hydraulic gate chain and single cable hoist systems were installed in 2019, replacing the original electric hoist and trolley system.

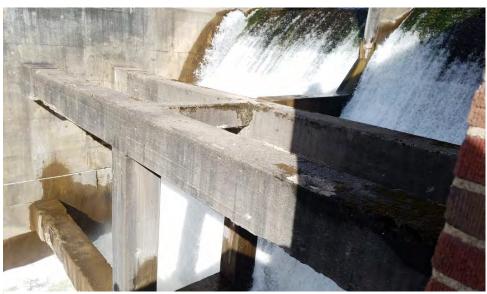
Photo 2. Secord Dam Spillway

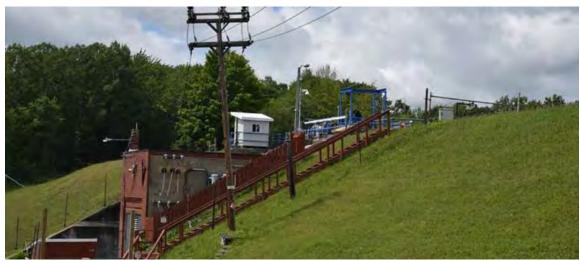
Photo 3, Secord Powerhouse and Left Embankment, August 2019.

The powerhouse consists of a reinforced concrete substructure and brick superstructure with one vertical Francis unit. The powerhouse is 25-feet wide (left to right) and 36.5-feet long (see Photos 3 and 5). A 1.2 MW vertical Francis style unit is installed in an open pit layout. A vertical trumpet-shaped draft tube is installed in the lower portion of the powerhouse, allowing discharge of the outflow into the spillway stilling pool. The stilling poll is formed by a downstream wall which also functions as the flip bucket. The original water diversion for the construction occurred by use of the lower now inactive portion of the structure, which now houses the draft tube cone. This area once had three intake openings to the upstream which was used as the diversion watercourse while the embankments were built. The powerhouse substructure is built of reinforced concrete and is integral with the spillway structure located to its right. Both structures are founded on glacial till using a base slab ribbed in two directions. The slab also has an upstream and downstream cutoff wall integral with the slab. The powerhouse measures approximately 50.75 feet by 21 feet in plan and is 57 feet in height.

The left and right embankments are approximately 650 feet and 350 feet long, respectively, with a maximum structural height of 56 feet near the powerhouse and spillway (see Photos 3-5). The original embankments were reportedly constructed of a mix of clay and poorly graded sand, and are founded on native soils consisting of interbedded layers of clay and silty sand with some gravel overlying glacial till. The upstream and downstream slopes were constructed at 2.5H:1V and 2H:1V, respectively. In 2005, the embankment crest was re-established to the design elevation of 757.8 feet. Portions of both embankments immediately adjacent to the powerhouse and spillway contain an upstream seepage cutoff wall consisting of hot rolled ball and socket interlocked steel sheeting installed into foundation soils with a reinforced concrete cap. The seepage cutoff wall has a top elevation of approximately 753.8 feet and extends approximately 96 feet left of the powerhouse and 82 feet right of the spillway. In 2008, leakage along the abutment/sheeting contact was repaired. Both embankments also contain lateral finger drains that extend under the downstream embankment shell at the embankment/foundation contact and discharge into a drainage ditch located at the downstream toe. A toe berm was reportedly constructed on the left embankment downstream slope to improve stability and address seepage. No record of these repairs were found. There is no record of improvements or repairs made to the right embankment.

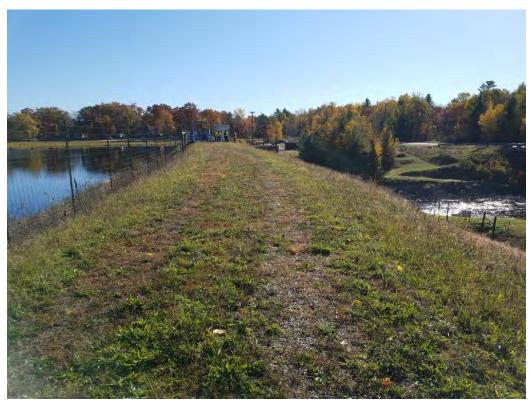
Photo 4. Secord Dam Left Embankment, 2021.

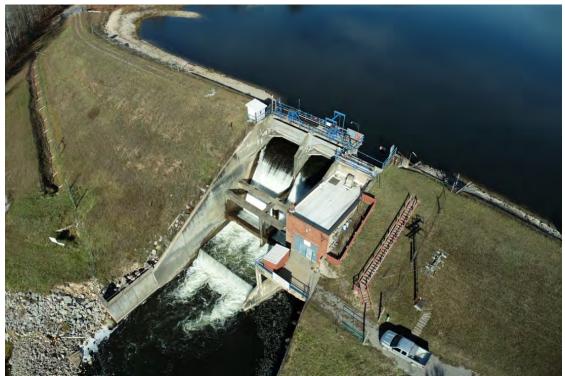
Photo 5. Aerial Drone Imagery of Secord Dam, 2020.

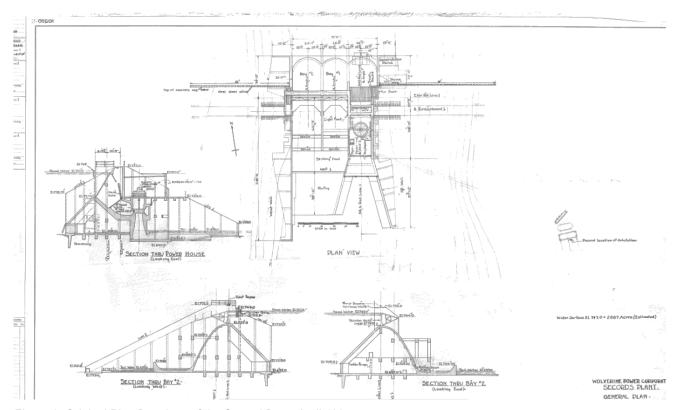
Figure 3. Original Plan Drawings of the Secord Dam, April 1924.

Frank Wixom founded the Tittabawassee Power Company in 1906 with a vision to dam the Tittabawassee and Tobacco River to provide cheap electricity to farmers and the local community and to create a recreational area for the greater region. Although the initial plans were not financially feasible at the time for Wixom's power company, the Wolverine Power Company was formed in 1923, with Wixom as president. Sponsored by Wolverine Power Company, construction of the Secord Dam, designed by consulting engineers Holland, Ackerman & Holland, was completed in 1925 to provide storage and headwater control for the purpose of hydroelectric power generation. Original plan drawings and a photograph taken during construction of the dam are provided as Figure 3 and Photo 6.

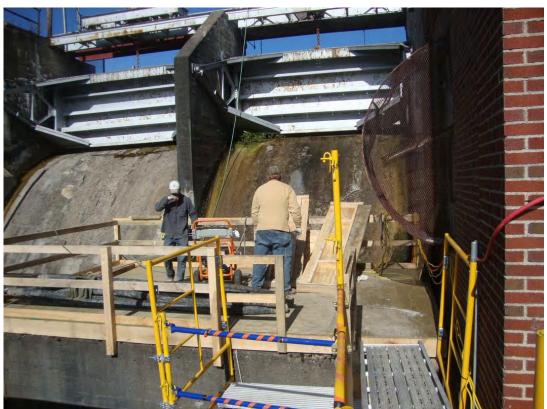
Photo 8. Spillway Resurfacing, 2012.

According to historic documentation on file with the FLTF, modifications to the dam began in 1935 with the installation of steel sheet pile cutoff walls. In 1947, a fire destroyed the powerhouse and it was rebuilt. In the mid-1990s, the area downstream of the stilling basin was rip-rapped. In 1996, a significant concrete repair was completed with an overlay of the west spillway training wall, with a small amount of concrete rehabilitation completed on the rollaway slab at the crest. The most significant modifications occurred in 2012 when the spillway was resurfaced. Post-construction, modifications were performed on the Secord Dam following every significant flood. Structural repairs included continuous concrete repair on the structures, as well as gate repairs. All pre-disaster modifications were performed by Wolverine Power Company, followed by Boyce Hydro.

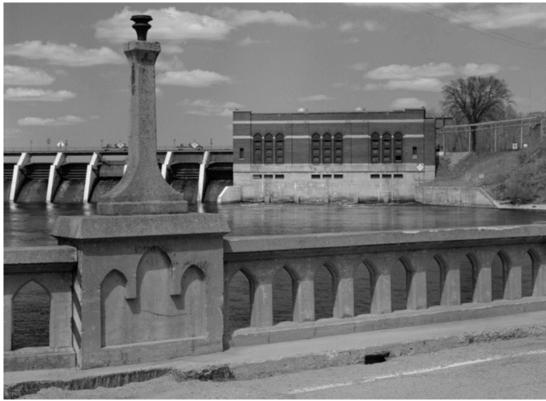
Photo 9. Chalk Hill spillway (left) and powerhouse (right).

Other properties designed by Holland, Ackerman and Holland, exhibit unique architectural elements such as stained glass within the powerhouse (Chalk Hill Dam) or sweeping arches (Victoria Dam). The Quaker Mill Dam; demolished in 2017, was previously listed on the NRHP due to a few unique characteristics, namely a monumental concrete fishway and a single Tainter gate with a manually operated hoist. While both the Chalk Hill Dam and the Tobacco River Spillway are hollow, the hollow nature of the Chalk Hill Dam was utilized to access the powerhouse, which is not present at the Secord Dam. The Chalk Hill Dam was also distinctive due to a large concrete fishway, its size (early 300 feet wide), and the decorative elements within the powerhouse (see Photo 9). Other than some being hollow and/or having multiple Tainter gates, unique architectural features and associated structures set these facilities apart from the Secord Dam.
